## Factsheet no. 5: UPT Steel Structures Laboratory, Timisoara, Romania

### Project summary

Client: Politehnica University of Timisoara  
 Architect: Arh. Mihai Mutiu  
 Structural engineers: BRITT Ltd.

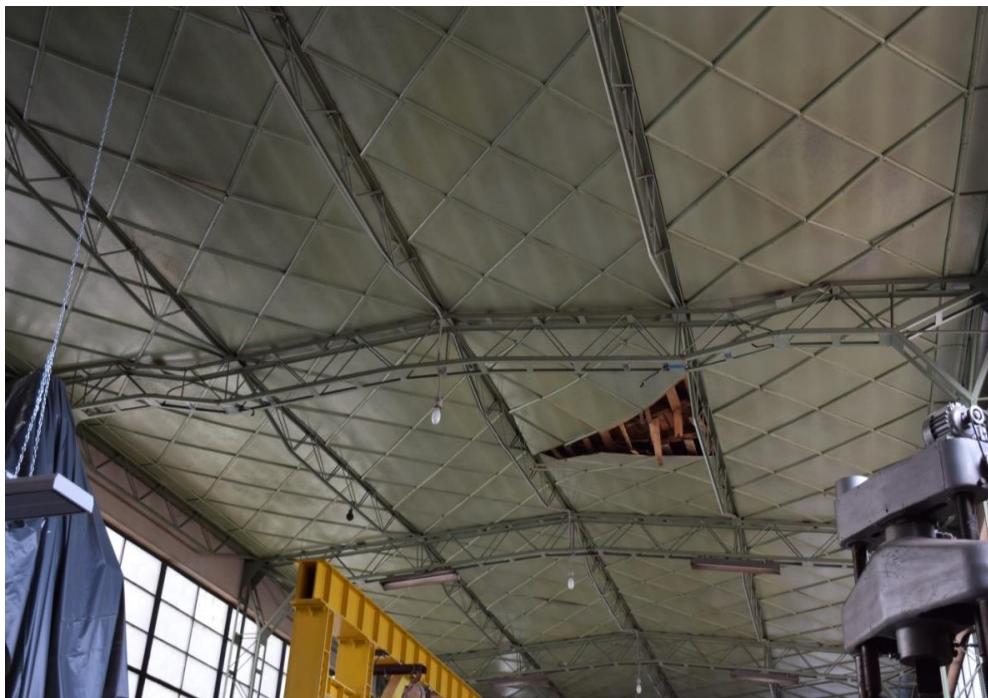
Moreover, a part of the primary structure was damaged during a heavy storm in September 2017 (two girders of the main frames from axes 4 and 5 and the whole roof cladding), making the rehabilitation even more important and urgent. A part of the damages caused by the storm can be observed in Figures 6 and 7 (frame from axis 4). The frame in axis 5 presents similar damages (cracking of weld and buckling of diagonals). However, the girder is only slightly deformed, unlike the girder in axis 4, which has a significant plastic deflection.

**Fig. 6. The damaged roof and deformed shape of axis 4 frame after the storm**

A partial rehabilitation of the damaged frames was proposed, consisting of welding steel plates (10mm thickness, S235) in the regions where the cracking of the welding occurred (in order to ensure the continuity of the angles) and replacing the buckled diagonals with new angles (L45x45x5, S235). By this partial rehabilitation, the capacity of the frames before the storm is restored.

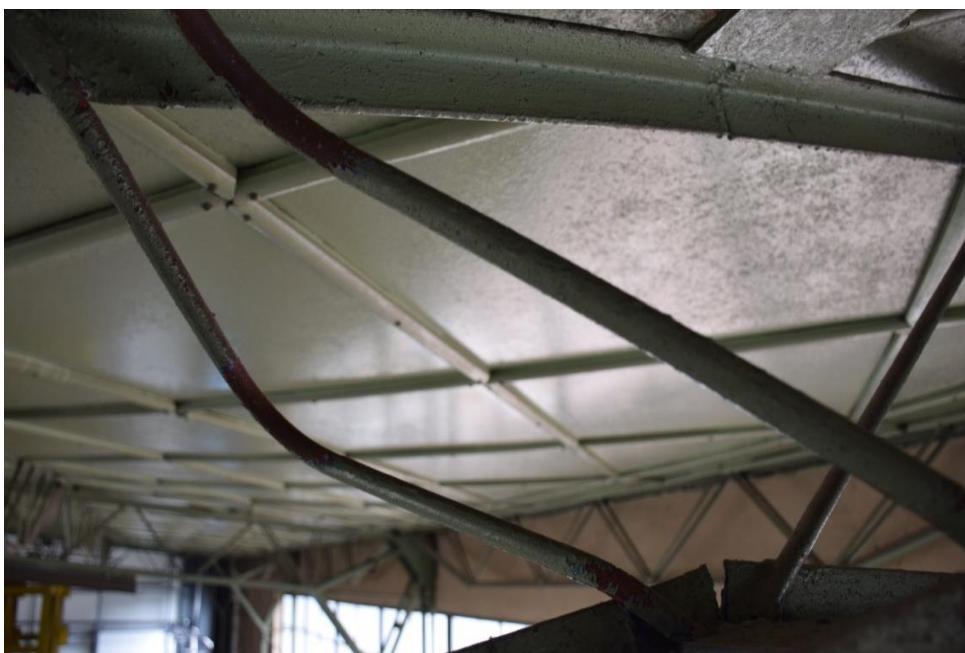
**Fig. 7. Right hand side node of frame in axis 4: cracking of the butt weld and buckling of the diagonals**

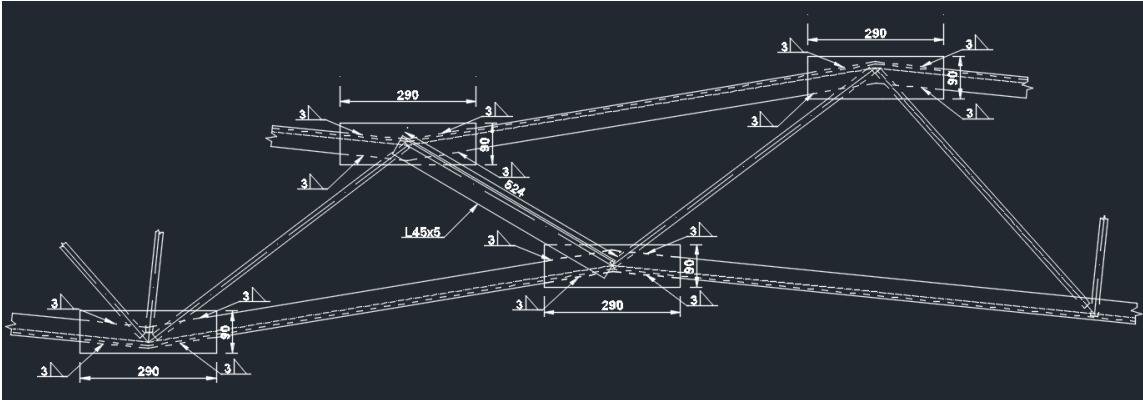
**Fig. 10. Schematic representation of the partial rehabilitation (right node of the frame of axis 4)**

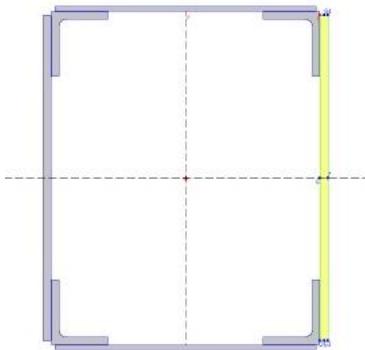
**Fig. 11. Cross-section of girders and columns after rehabilitation**

For the final rehabilitation, parts of the damaged girders will be replaced with new ones, having the same configuration. The degree of reuse of main and secondary structure is 100%. Steel plates will be welded on all sides of the cross-section of girders and columns to obtain a box section (see Figure 9). New bracing system, Z purlin system for the roof (keeping the existing ones) and envelope will be provided.
