# PROGRESS

PROVISIONS FOR GREATER REUSE OF STEEL STRUCTURES

## Report on deconstruction of a single storey hall for reuse

Deliverable: D7.1a Report on deconstruction of a single storey hall for reuse

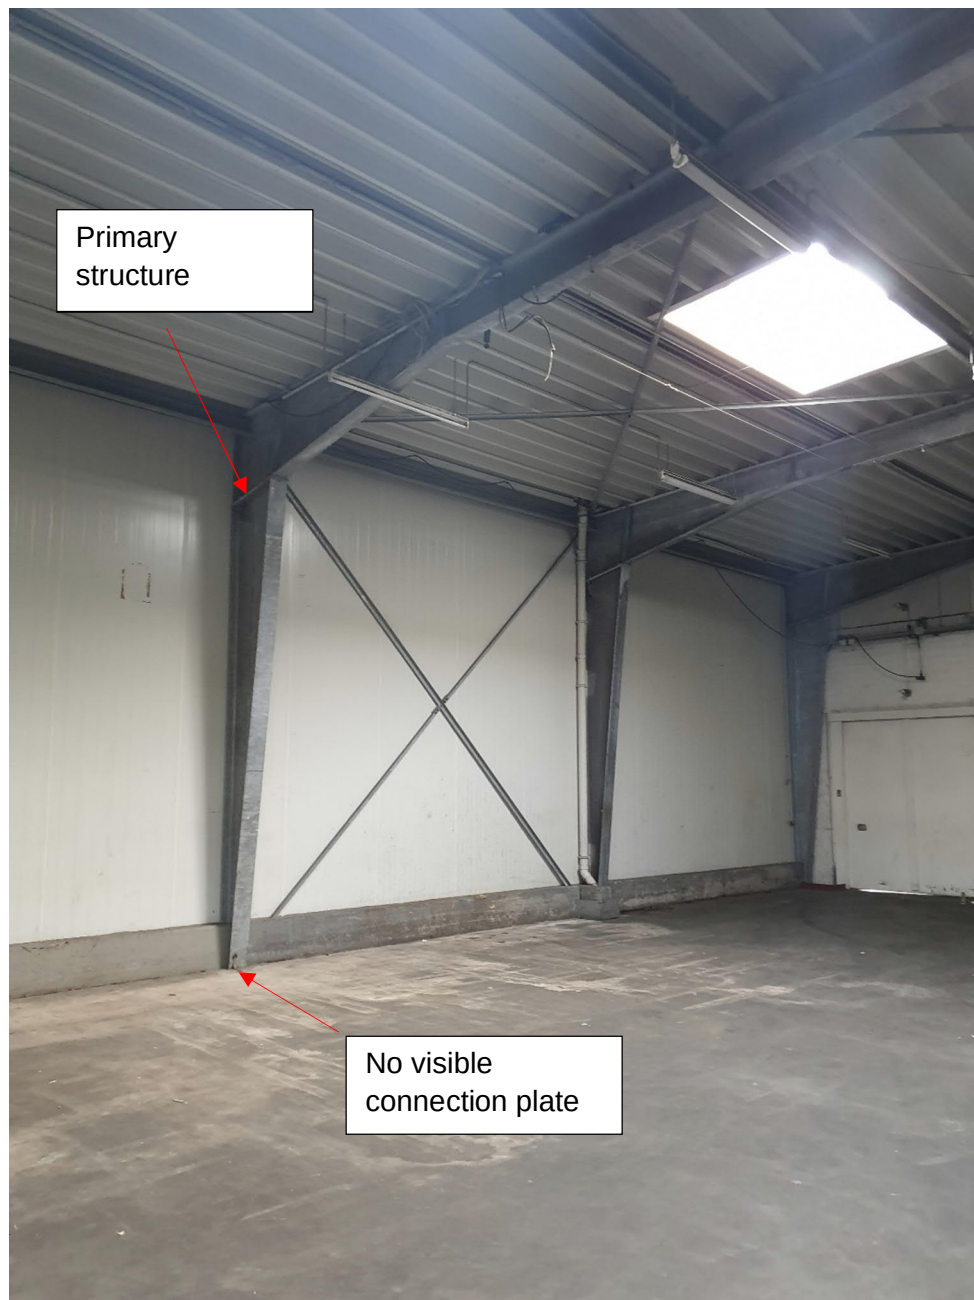
*Figure 4: Steel structure: The primary structure is made of 4 steel frames. There is no visible connection plate on the ground. Obviously, the columns are grouted with the concrete.*

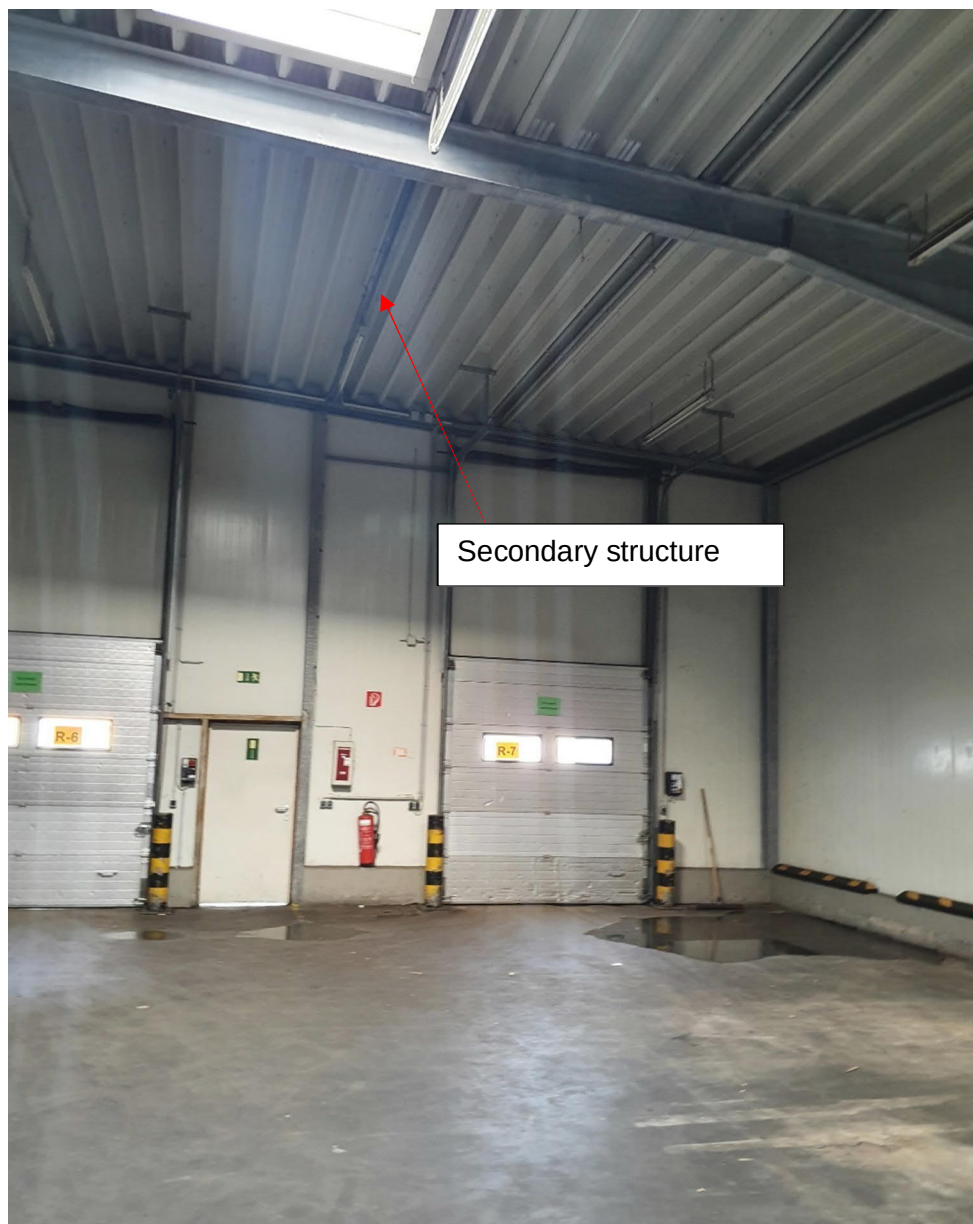
Figure 5: Between each of the frames smaller cold-formed steel beams as a secondary structure are visible. The connections are screwed.

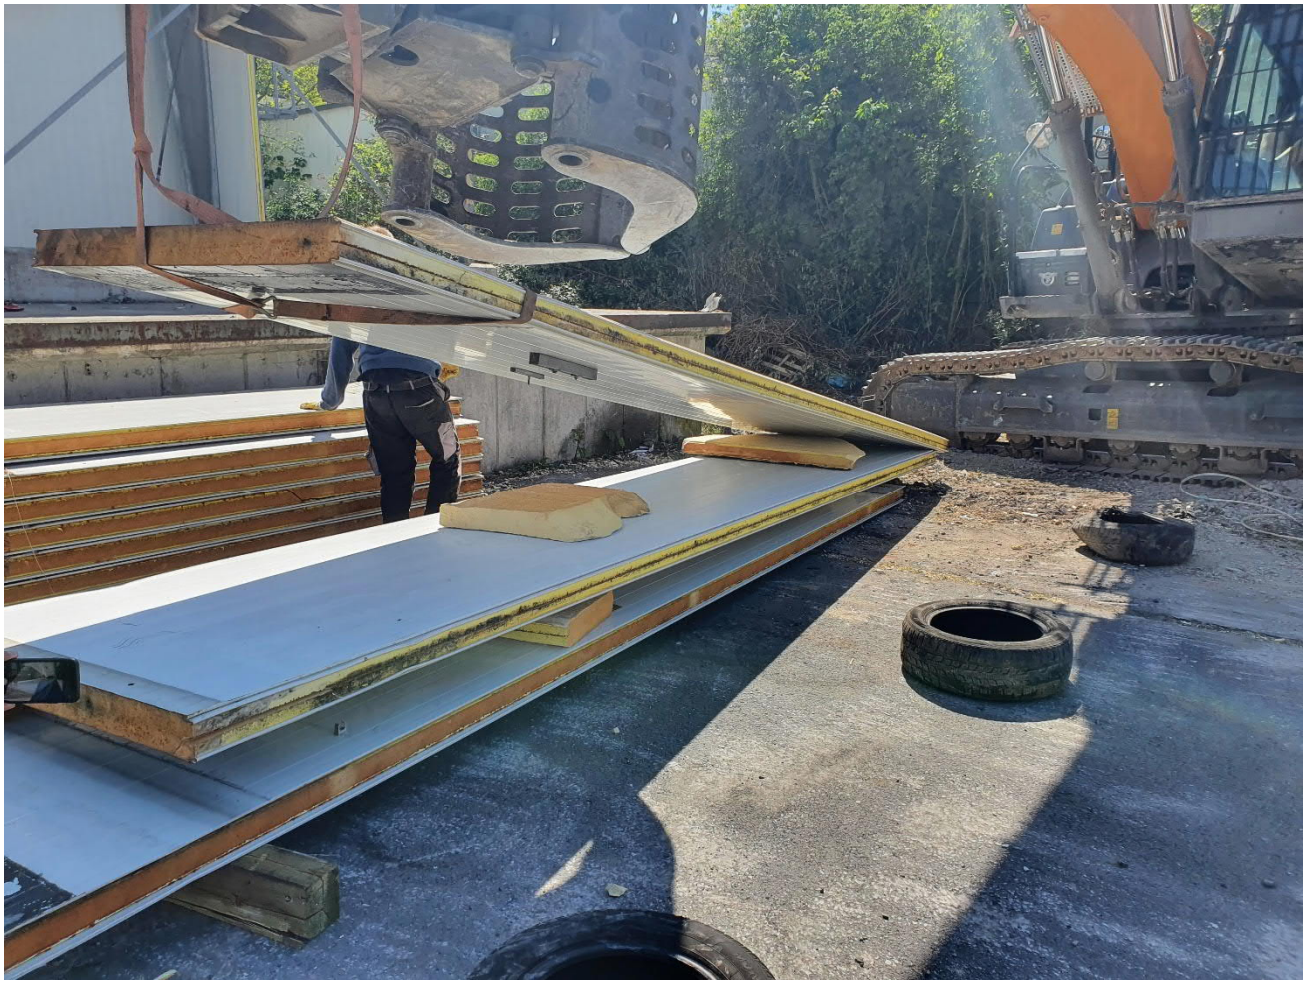
*Figure 14: Dismantling of sandwich sheets. Testing of reusability. Technically, safe dismantling is possible by excavators. Reuse might not be recommended since the glue between metal and insulation is weathered. Besides, the metal sheets have many holes e.g. from attached lamps, signs and other inventory attached to the sheets.*

Thus, although in this example the sheets could not be reused, in general a dismantling technique open for reuse is recommended for the sheets. Even if reuse seems not practicable separating the materials will be easier if the elements are not deformed yet.

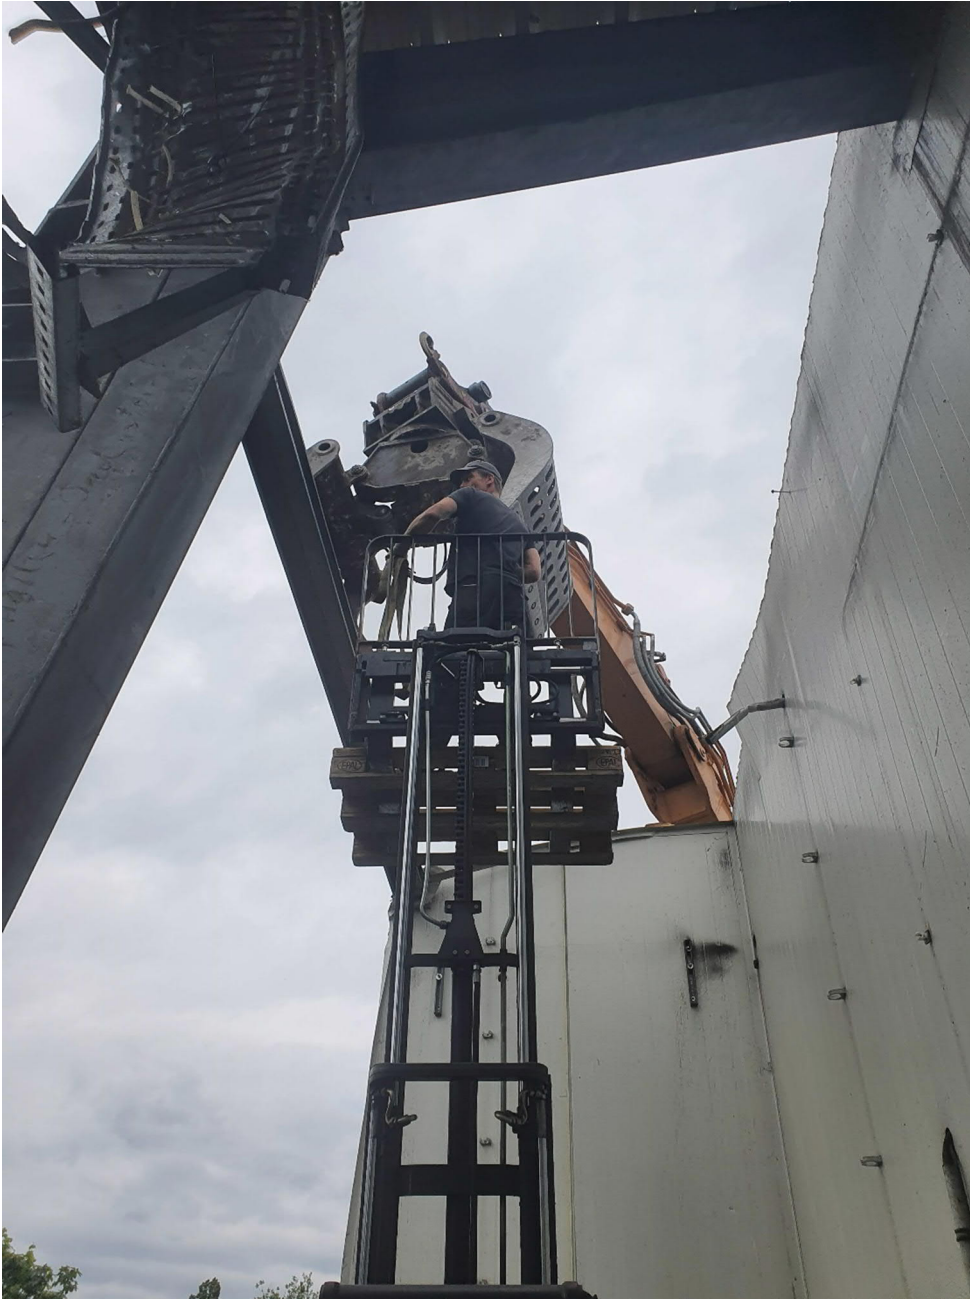
Figure 18 illustrates the dismantling procedure: The excavator is used as a crane with chains to prevent unwanted falling of the part. Workers release the connections of the beams to the primary frames. After releasing all connections, the beam is lifted and removed.

*Figure 18: Dismantling of secondary structure. These parts are still too thin, that handling with an excavator only would result deformation. On the other hand, these parts are not tending to deform as long as dismantled manually. In opposite to the cladding, only five elements between each section are to dismantle.*

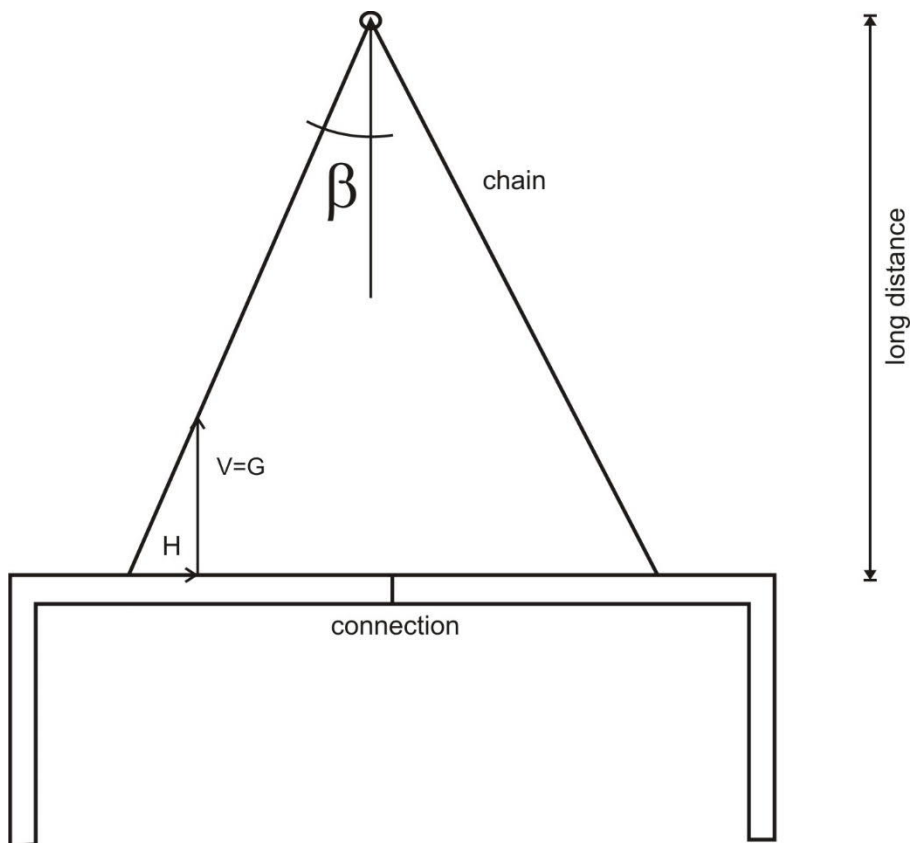
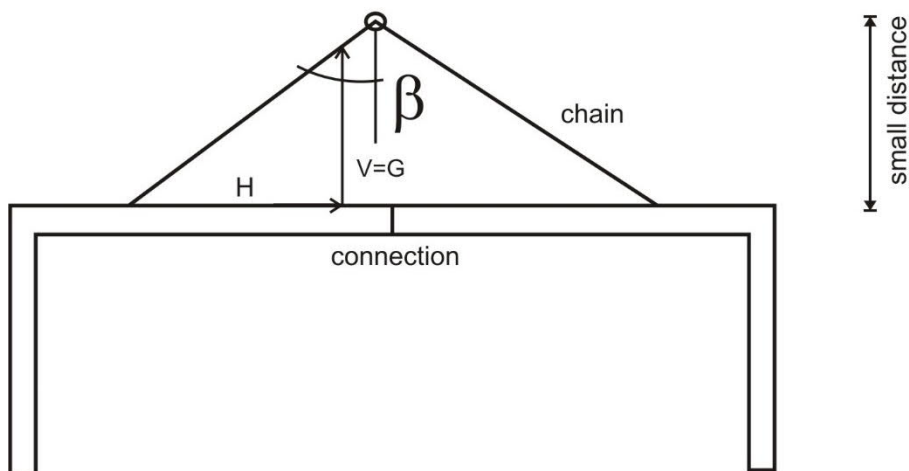
Nevertheless, the higher the distance between the structure and the excavator, the little horizontal forces are (see. Fig. 20). Especially if the frame is made of connected parts additional forces should be avoided. It was chosen to pull the frames down by two parallel working excavators.

Figure 20: Forces in dependence to the vertical distance of the crane. The smaller the distance becomes, the more horizontal forces arise. It may affect the connections so that other techniques are needed instead of classical up lifting by excavators.

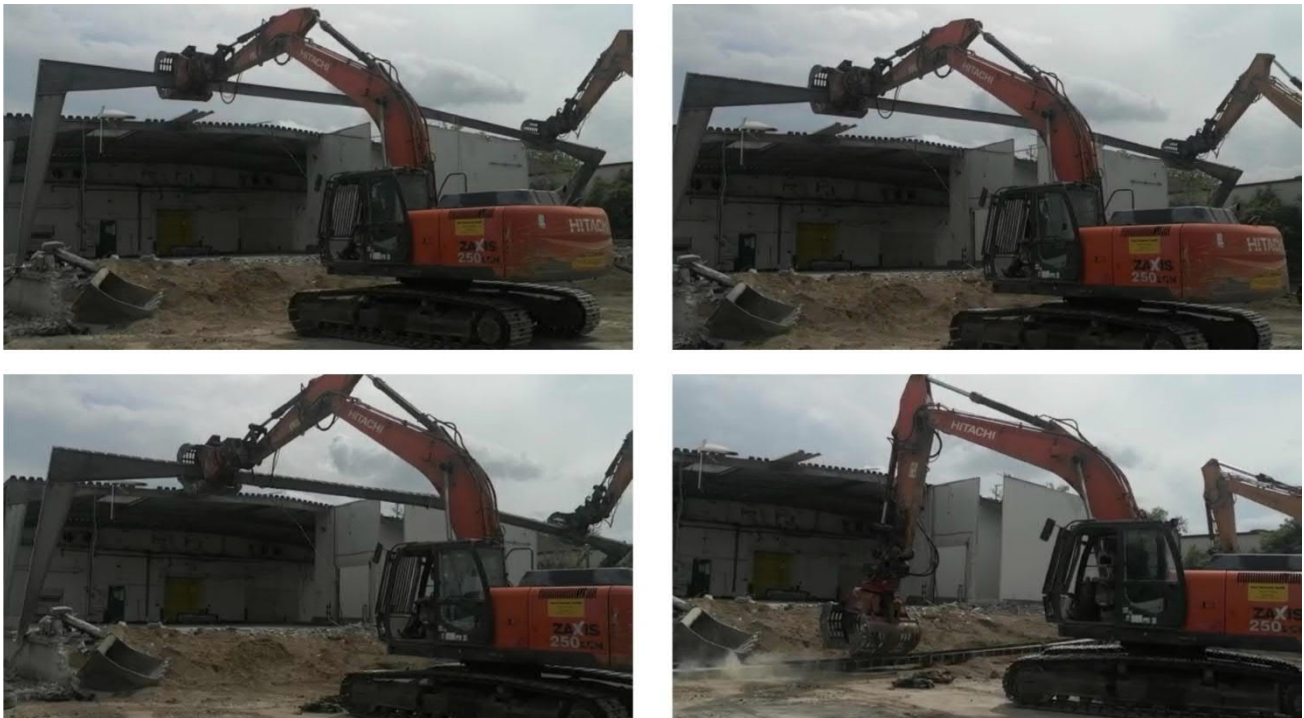
*Figure 21: To avoid instabilities, two excavators carefully pull down the structure to the ground.*

Figure 21 shows the solution: Lifting the whole frame up by one excavator would affect the connection point in the middle of the frame and is not recommended. Instead two excavators were used with grabbers to slightly pull down the frame. On the ground, all connections were released without the danger of collapse of parts of structure.

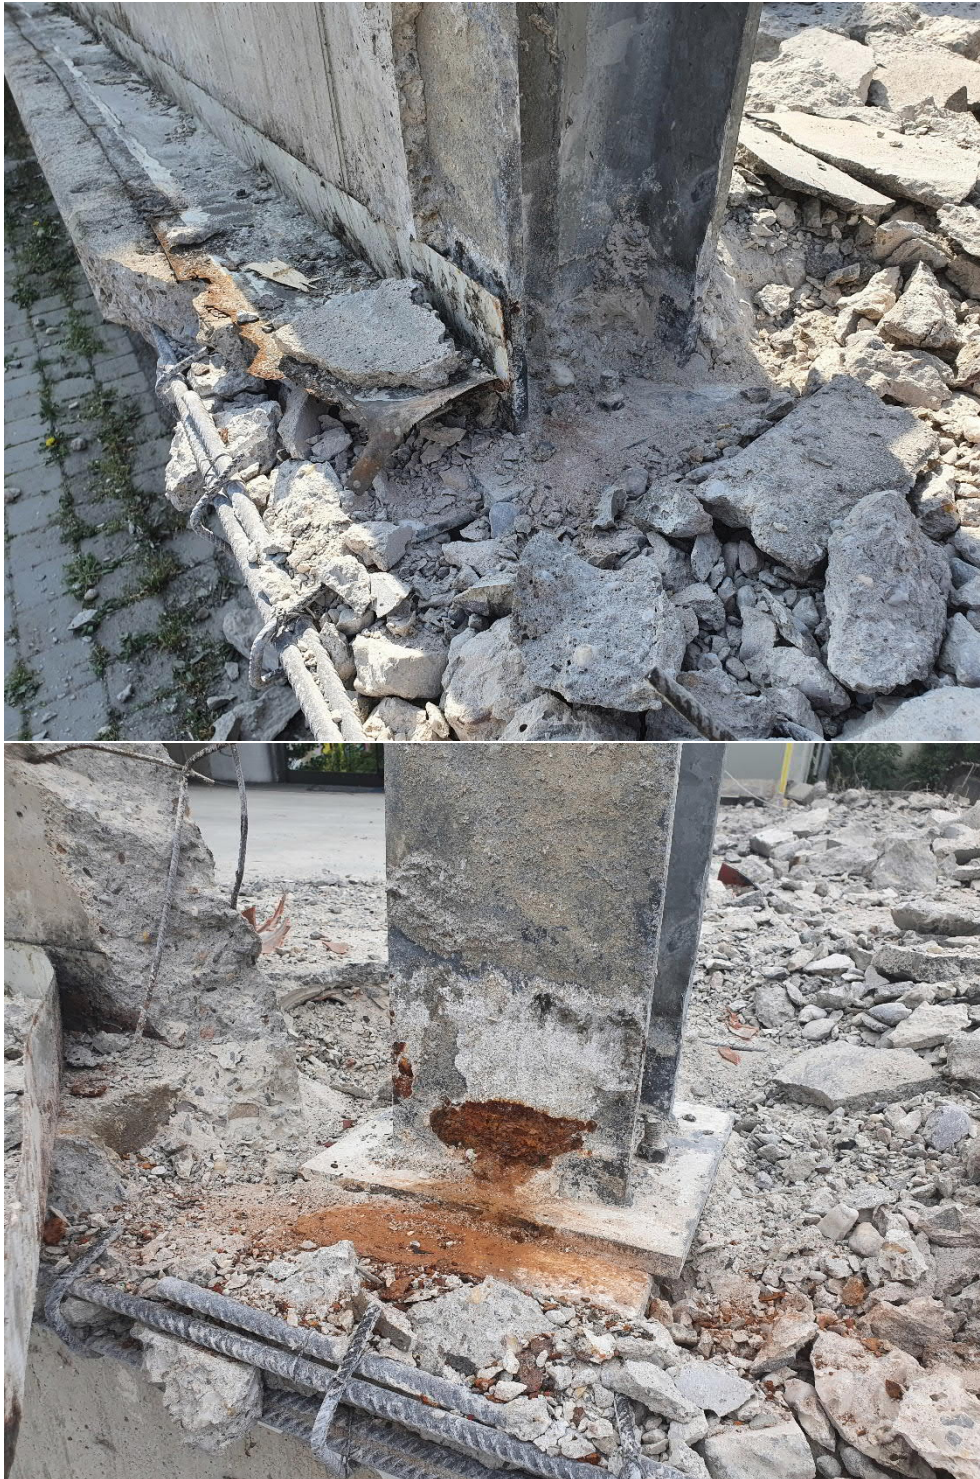
Figure 22 and 23 demonstrate the anchoring of the steel columns. After creating the fundaments, the construction of the steel frames was set up. When the primary / secondary construction was finished, the floor plate was made. The anchoring points were hidden underneath the concrete. During the planning it was discussed to cut the steel just above the concrete slab. That would cause that the reusable hall will be some smaller than before. After the exploration of the connection all anchoring points were uncovered so that the parts kept their original length.

*Figure 22: Removing concrete at jointing of steel frames. The steel connections was shed below the floor plate directly on the fundaments. Afterwards the connections was shed into the concrete of the floor plate. To release this connection, the concrete was removed partly around the anchoring.*

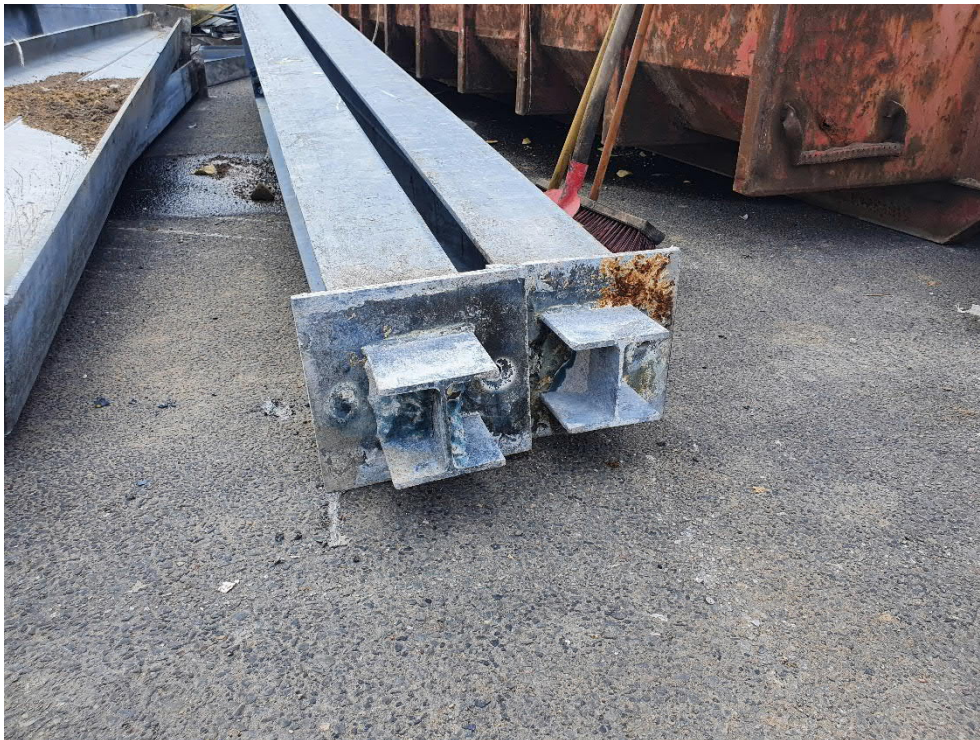
*Figure 23: View from the downside of the connection. The plates were connected to the fundamentals and shed into the concrete of the ground floor plate.*

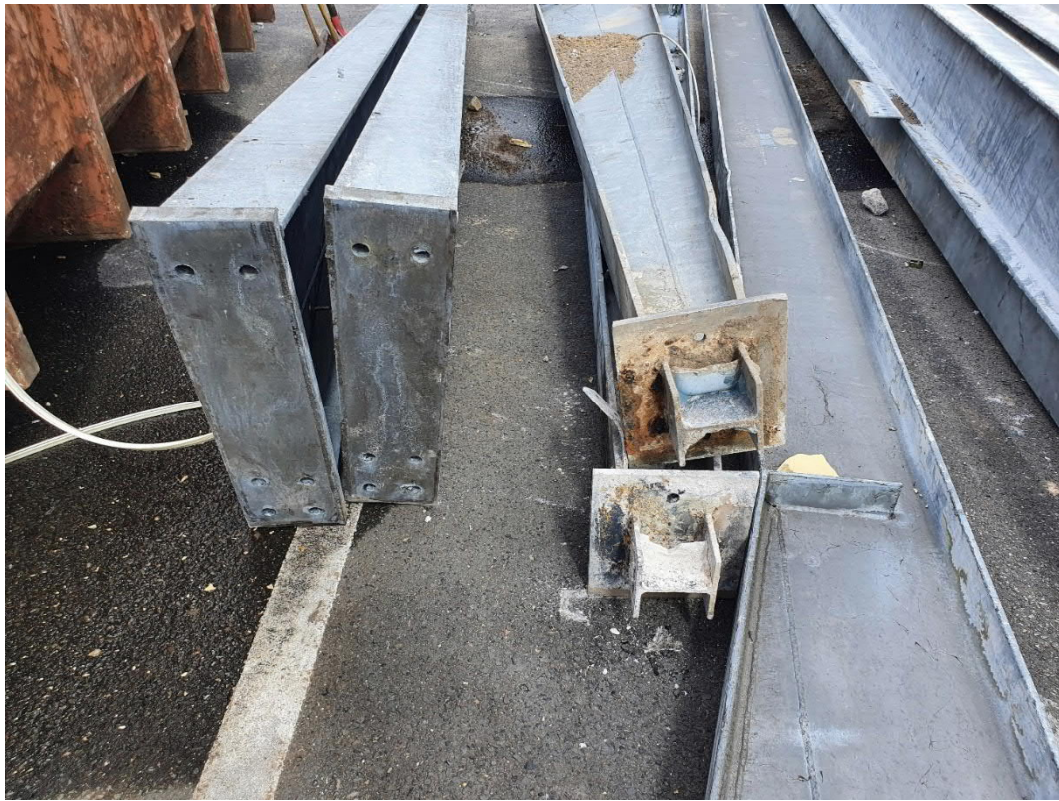
All parts identified for reuse needed to be checked afterwards. In general, all parts suited the quality needed. No parts were deformed. Some screw holes were damaged during flame cutting. Flame cutting was used, if unscrewing was not possible due to rust, mechanical errors, or impaired supply of the threaded rods.

*Figure 26: deconstructed parts of primary structure ready to be reused.*

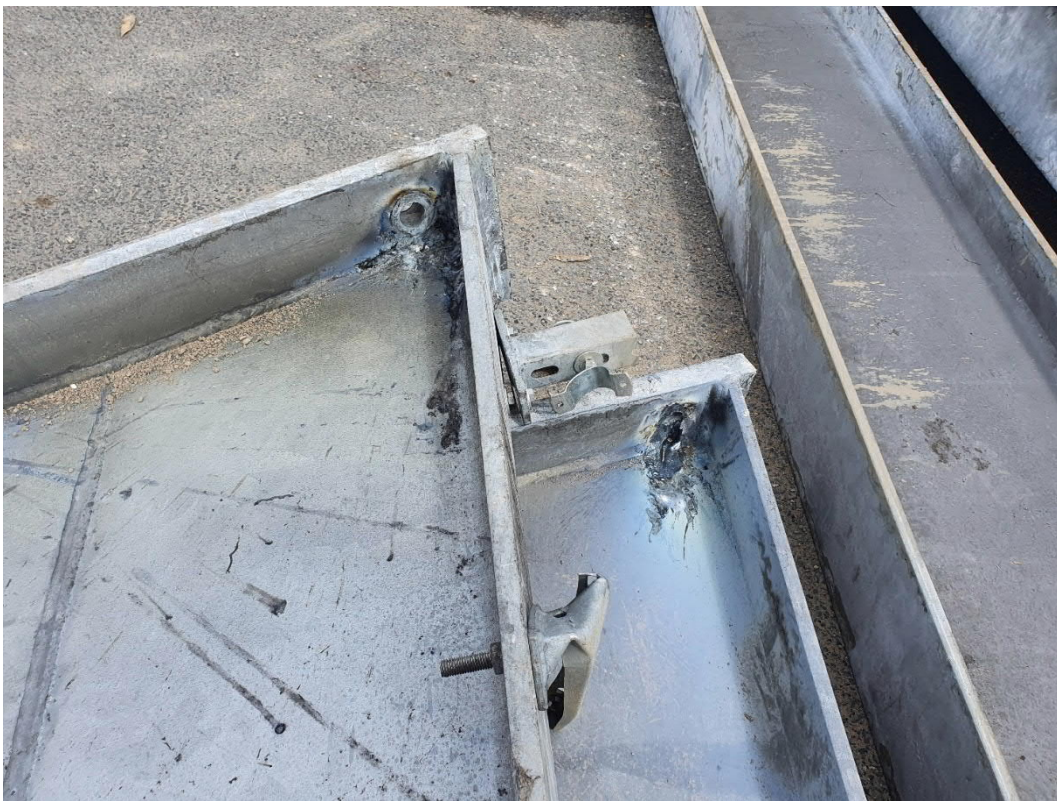
*Figure 29: Detail: Small damage due to flame cutting.*
