2017-2020  
**PROGRESS**  
PROVISIONS FOR GREATER REUSE OF STEEL STRUCTURES

Experiences  
and  
Lessons  
learned from the past

***Viorel Ungureanu***

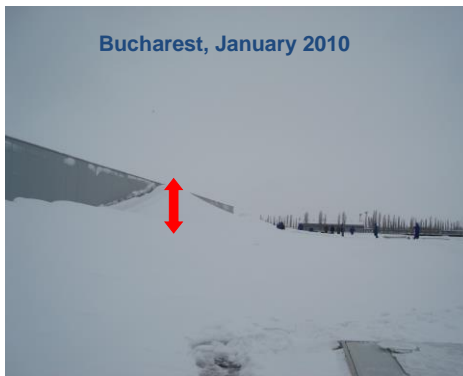
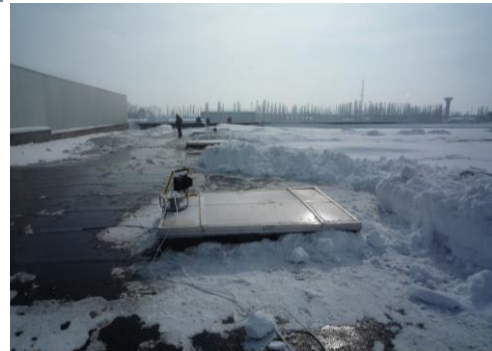
- Two adjacent buildings
  - 120x80m, 13.0m height
  - 180x80m, 9.5m height
- ←
- Snow drifting
- Accumulation up to **4.0m** of snow
- Undrifted snow 1.0m
- Very large deformations of the roof, purlins and roof panels severely damaged
- Structural collapse prevented

- Snow was removed from the roof in the drifted area
- 
- Repairing, upgrading necessary:
  - Purlins will be replaced
  - Panels will be replaced or strengthened
  - Local strengthening at main girders

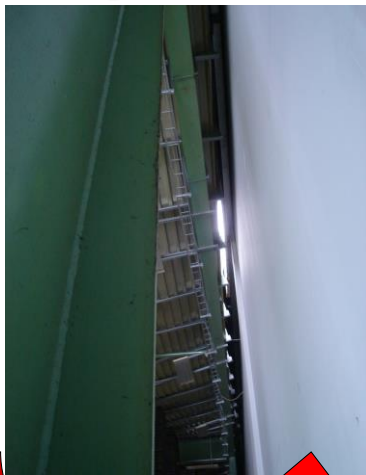
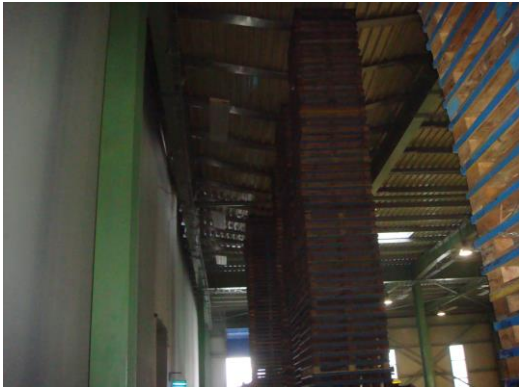
**Damages**

**Twisting of the beam from the gable frame**

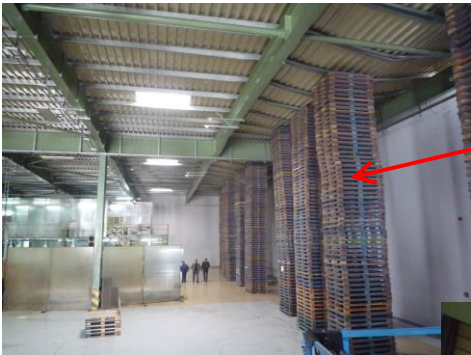
**Supports for the roof**

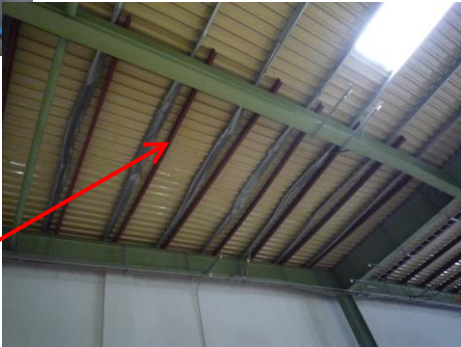
**Damages**

**Supplementary purlins**

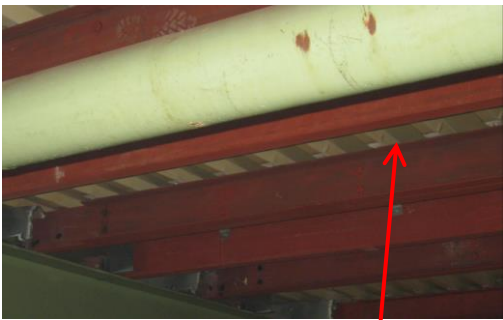
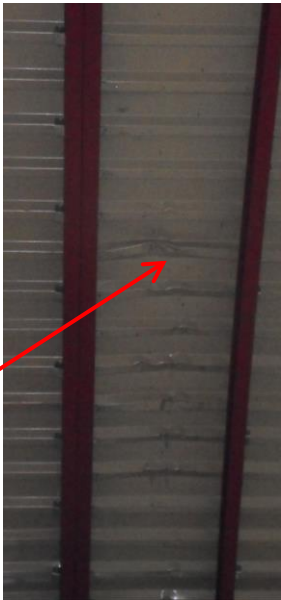
**Damages**

**Web crippling of the corrugated sheet under exceptional snow**

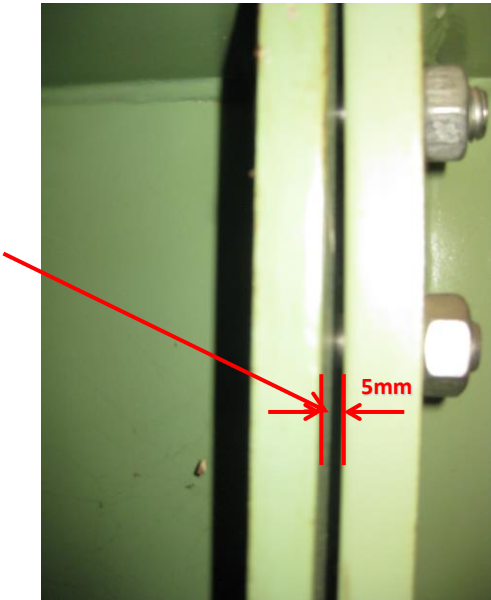
**End connection**  
⇒ 5mm gap

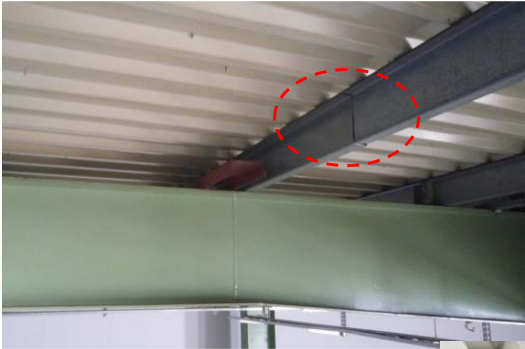
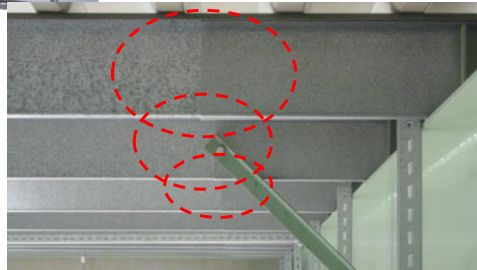
**Lack of bolts which connect purlins at the end of overlaps**

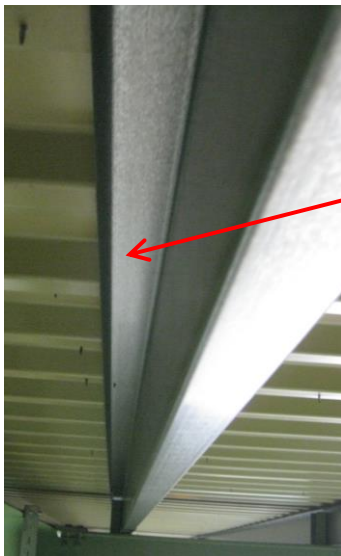
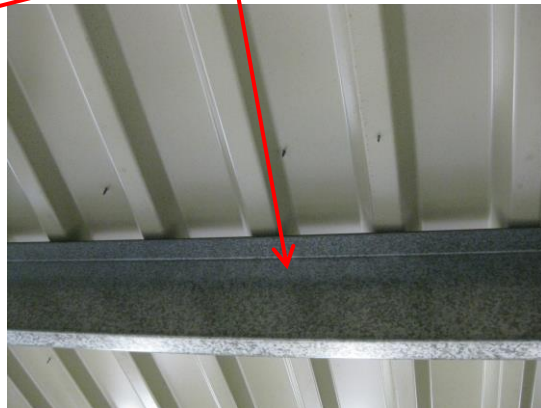
**Self-tapping screws are missing at the connection between purlins and corrugated sheet**

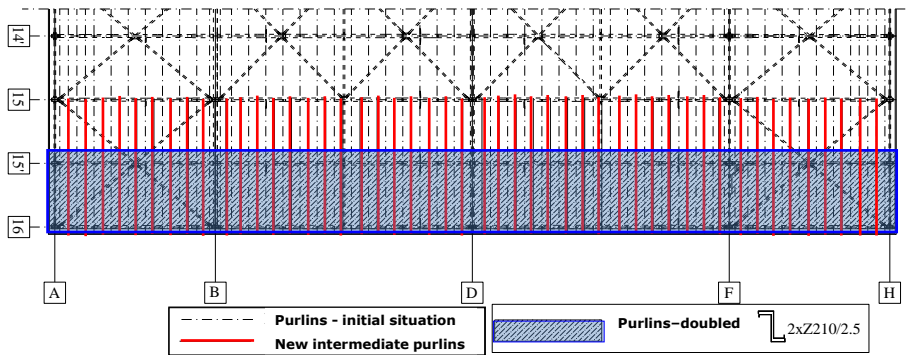
The capacities of purlins and corrugated sheets, between axes 15'-16, are not on the safety range both at ULS and SLS

Increase the capacity of roof structure (bays 15-15' and 15'-16) :

- To introduce intermediate purlins Z210/2.5 between the existing ones for the first two bays and to double ones in the first bay (2xZ210/2.5)
