## Factsheet no. 6: MEXX DAY hall, Timisoara, Romania

### **Project summary**

**REUSE OF STEEL**

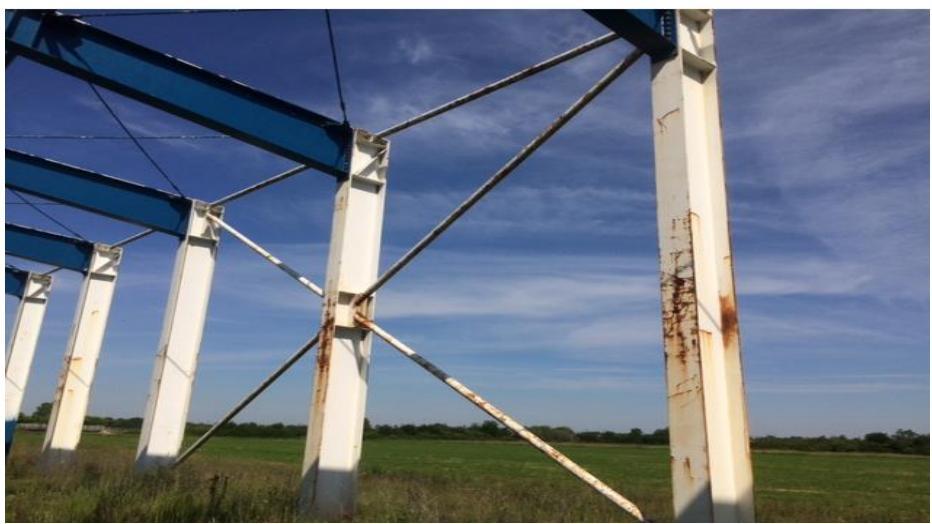
Fig. 8. The longitudinal bracing system

Although the entire structure was erected, the full corrosive protection was applied only on half of the structure, the other half being only partially protected. For the unprotected half, some of the elements have been affected by corrosion (see Figures 8 and 9).

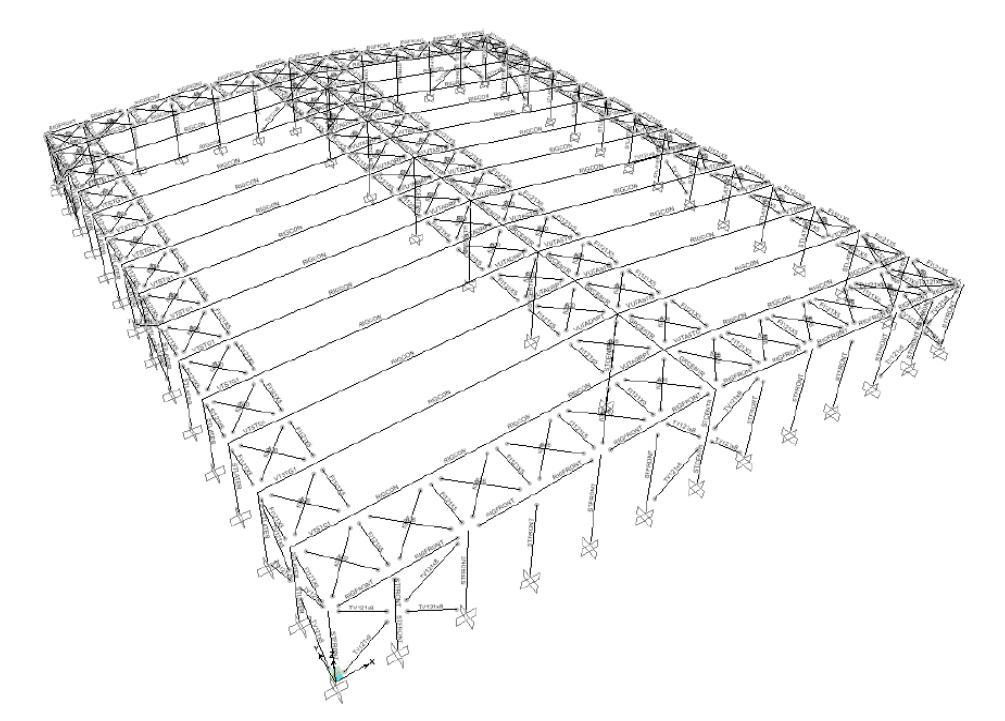
Fig. 10. 3D model used for the structural analysis

Following a technical examination of the structure, a series of weaknesses were identified in the initial design. A structural analysis was performed using the 3D model, as shown in Figure 10 that highlights the necessary interventions. In order to strengthen the initial structure (without considering for the moment the mezzanine), the following measures have to be taken (the view of the strengthened structure without the mezzanine can be seen in Figure 11):

- the braces having circular hollow section of 121x8 are replaced with ones having the cross-section of 135x8, made of S355 steel;
- longitudinal beams with circular hollow section of 121x5 are provided in the plane of the roof, in the axes C, D, E, I, J and K;
- fly bracings at 45° are provided at 3 m, connected to the bottom flange of the transversal beam and to the longitudinal beams or purlins;
- the flanges of the ridge haunches are strengthened by welding additional steel plates with a thickness of 12 mm;
- additional bracings are provided in the roof, with a cross-section of φ24 (S355 steel grade), in the axes A7-A8-A9 and M7-M8-M9;
- the column base connections of the columns in axis G has to be strengthened by providing additional stiffeners (see Figure 12).
