Factsheet no. 1: NTS building, Thirsk, UK

Project summary

Project description

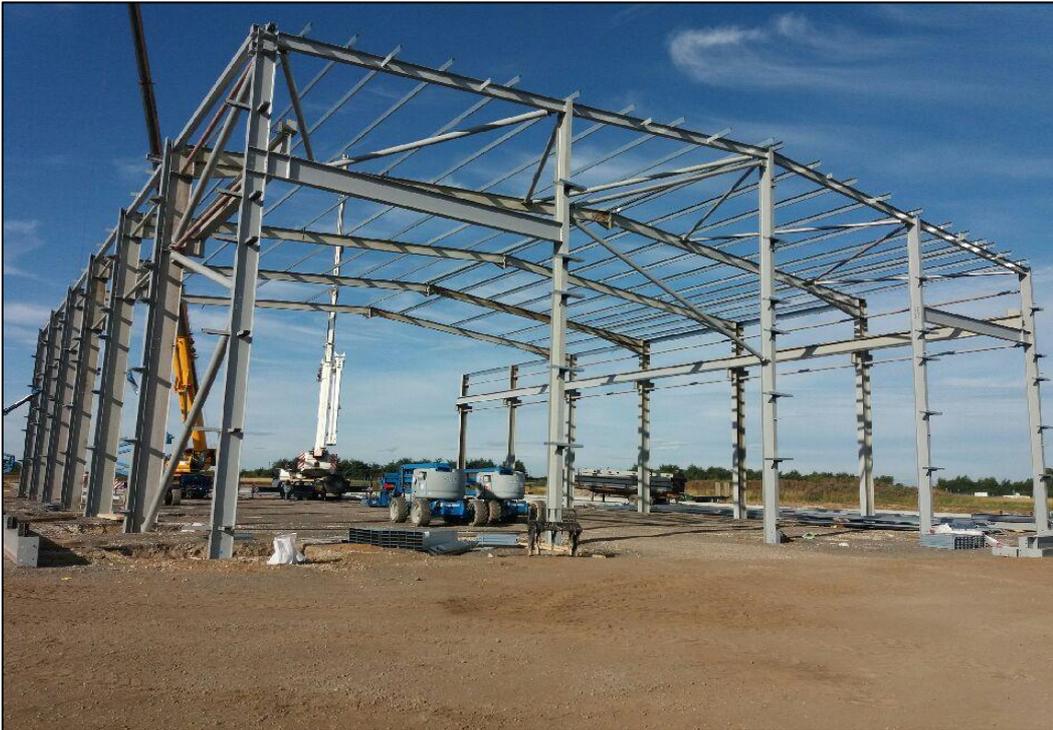
Figure 1 Erection of the NTS building primary structure (summer 2017)

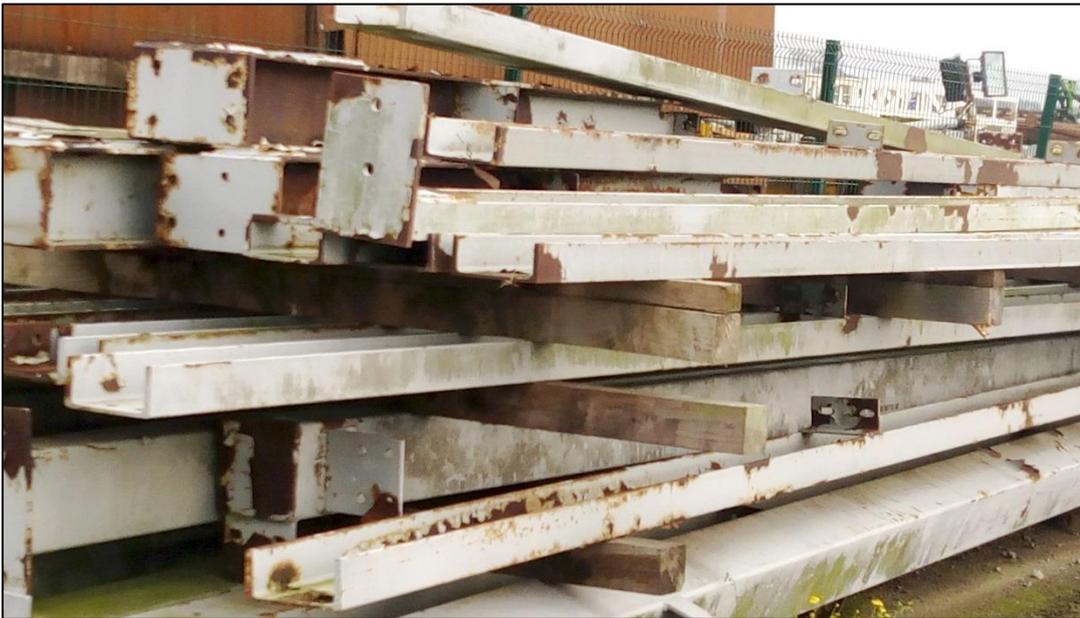
The original building was designed and fabricated by Fisher Engineering (part of Severfield plc) at their Thirsk facility in the UK. Since the original order was cancelled in 2008, the fabricated structure was stored, outside, at Severfield's Thirsk site. Figure 2 shows the condition of the steel (fabricated in 2008) in 2017.

Figure 2 The original steelwork (fabricated in 2007-8) in September 2017

The original coating on the steelwork was epoxy. Following fabrication in 2008, the structural members were left outside for around 10 years and showed significant deterioration, see Figure 2. The steelwork required shot-blasting to remove the loose and flaking paint and repainting before erection.

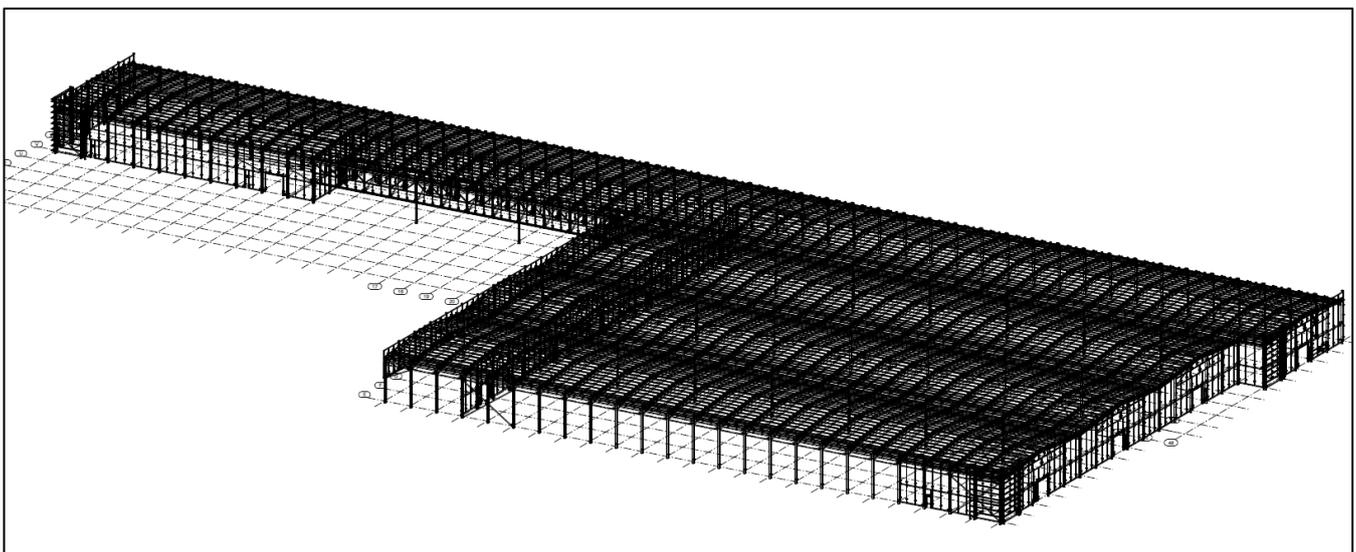
The design of the original building is shown in Figure 3. In 2013, the fabricated steelwork for the building was divided into four parts (lots) and sold at auction. NTS purchased one lot. The steelwork was to be erected as a new warehouse for NTS on their neighbouring site in Thirsk. It is understood that the other three lots were also sold at auction and were reused although no details are available.

Figure 3 The structural model of the original building

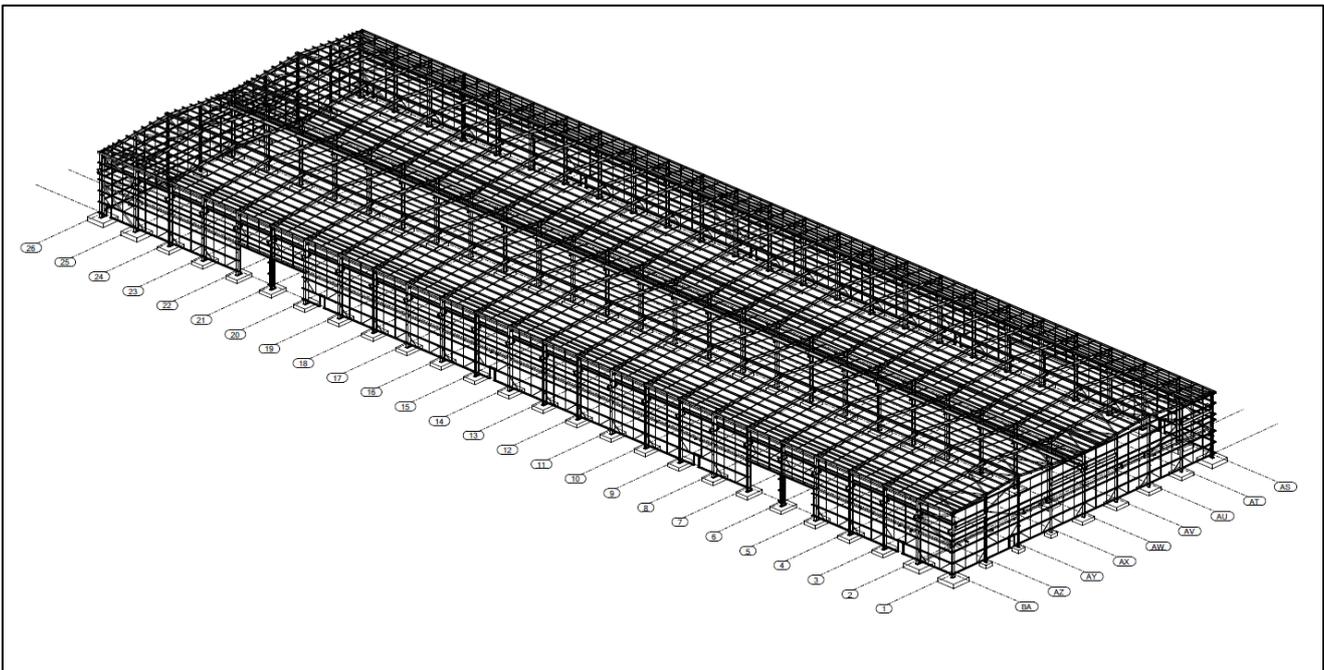
Figure 4 shows the structure of the new (reused) part of the building. The new building measures 195m x 60m and comprises a double-bay portal-framed structure. Column spacing is 7.5m and the height to eaves is 11m. The total floor area is 11,700 m². The primary structure was erected by WHL Building Services in just three weeks during the summer of 2017. Figure 1 shows the structure during erection during the summer of 2017. The new building is configured with the long axis running NE to SW.

Figure 4 The structural model of the new NTS building

In the original building, the eastern column line of the new building (grid line BA in Figure 4) was an internal column line and therefore required stiffening to limit deflection tolerances in the new building configuration. This was achieved by welding a T-section (T 305x152x49 split from a UC) to all 26 columns (UB 610x229x101) on this grid line – see Figure 5.

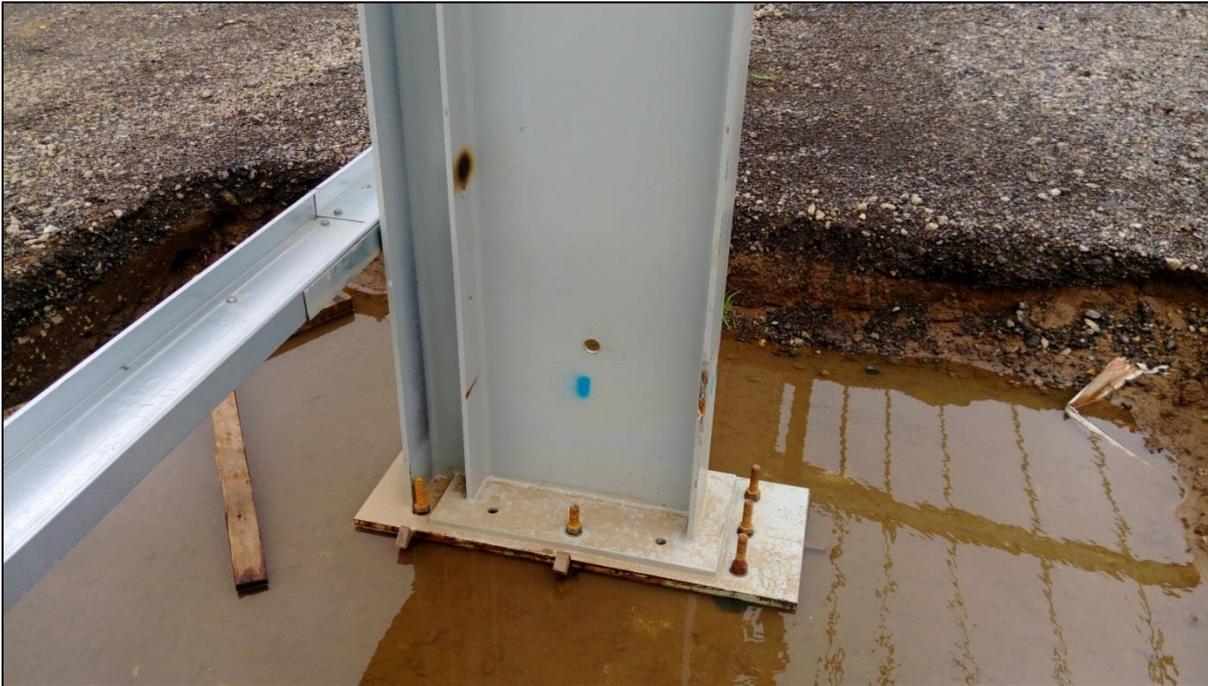
Figure 5 Strengthening of the columns on grid line BA using a welded T-piece and the larger base plates

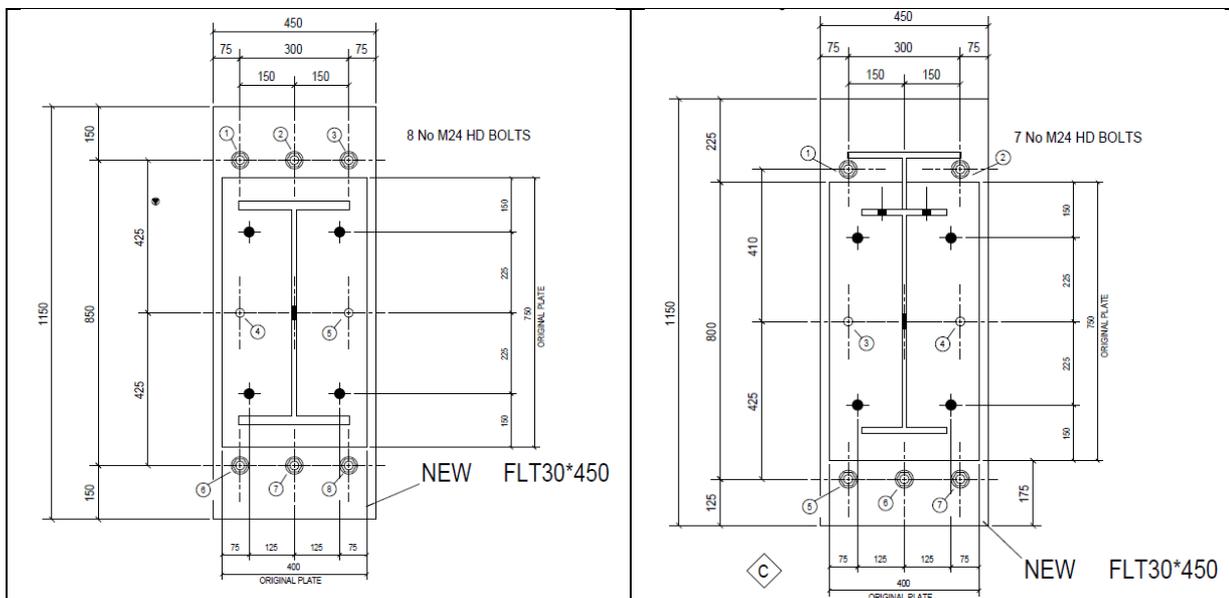
In addition, the base plates for the outer column lines AS and BA required redesign. The original base plate design (750x400x25) was retained for the central valley line (AW) however larger base plates were used for the two external column lines. The base plates and holding down bolt configurations are shown in Figure 6. The pad foundations for the external wall columns were 3.5x2.5x0.6m deep. The pads for the central (valley) line of columns was 2.8x2.0x0.6m deep.

Column line AS Column line BA
 Figure 6 New base plate and holding down bolt arrangement for the external column lines AS and BA

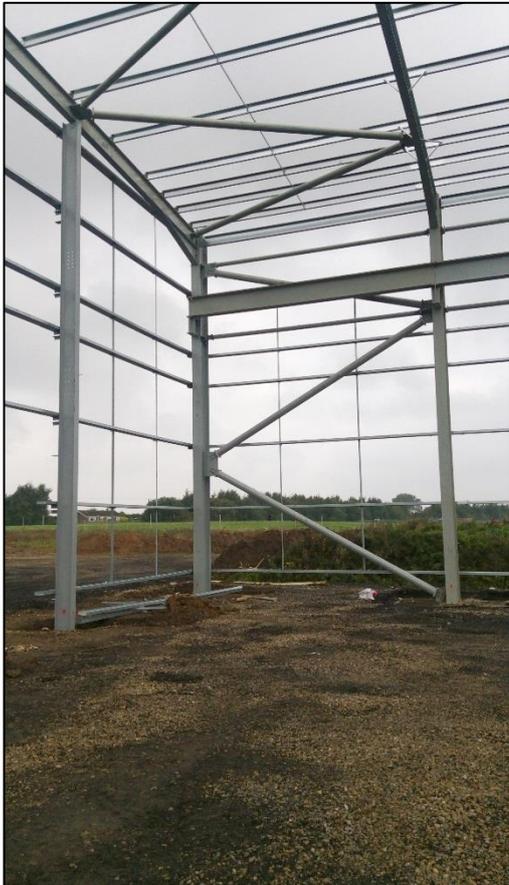
At the Southern end of the building (portal 26), the original gable wall was replaced with a portal frame to enable the building to be extended if required, in the future – see Figure 7.

Figure 7 Southern end of the building (grid line 26) showing the haunched portal and the vertical bracing in the end bay

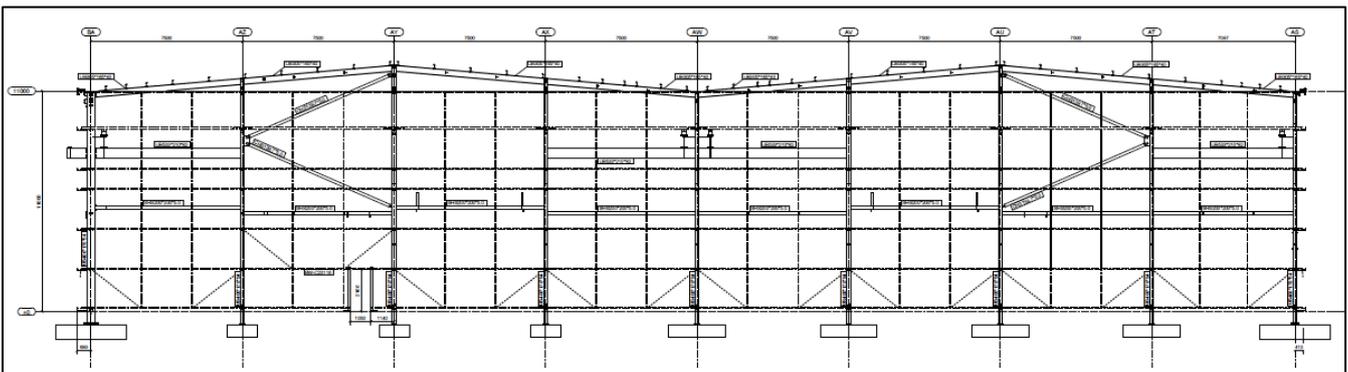
Figures 8 and 9 show the design of the southern (grid line 1) and northern end (grid line 26) of the new building.

Figure 8 Elevation of the gable wall structure at grid line 1

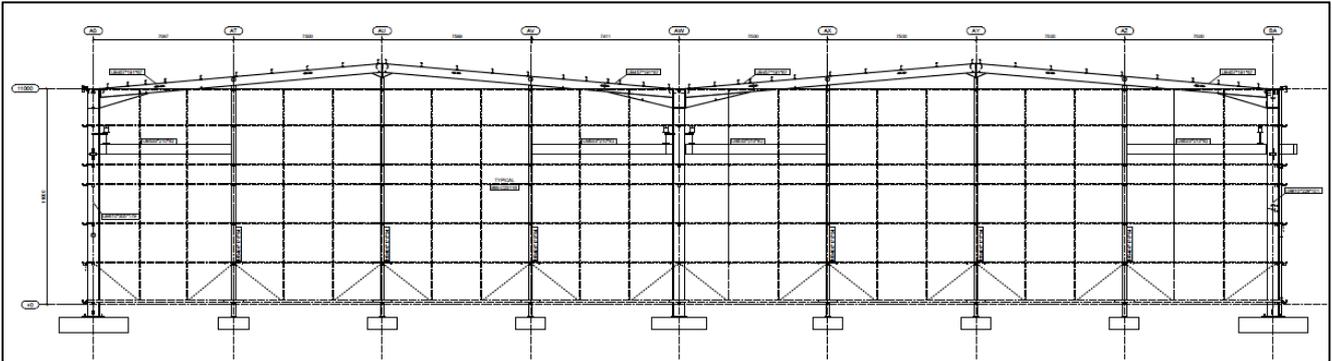
Figure 9 Elevation of the portal frame gable structure at grid line 26

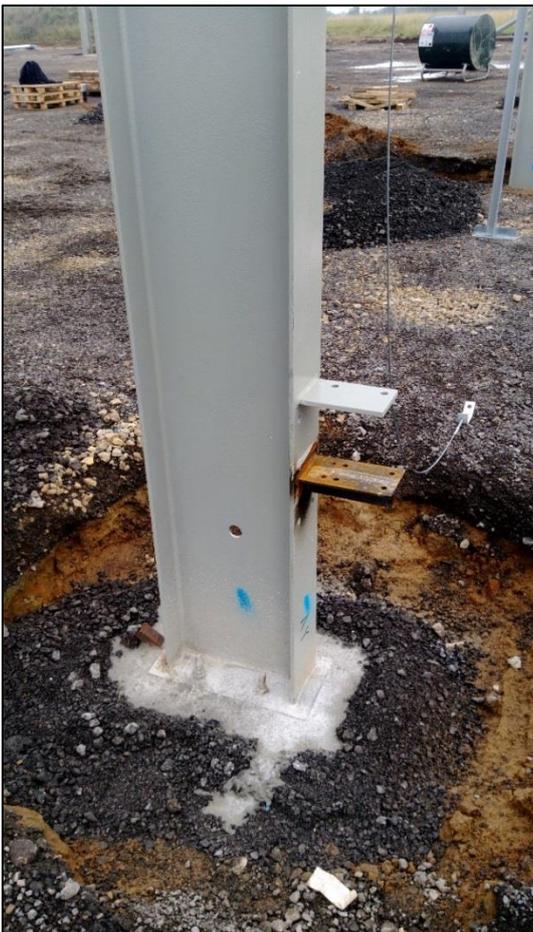
New cleats were welded onto the columns to support the side rails. This was because the original cleats were for an unknown but non-standard wall cladding system and did not match the new Tata Steel Trisomet cladding. Some cleats were also missing. In addition, the original cladding was to be hung horizontally whereas on the new building, the cladding will hang vertically. The side rails are a single-span, sleeved system.

Figure 10 New cleats to support the cladding rails (grid line AS)

The rafters had been drilled to fix the purlin cleats and these were used for the new purlins. The gutter support brackets were re-drilled to accommodate the different gutter system on the new building and new cleats fixed to the columns on grid lines AS and BA.

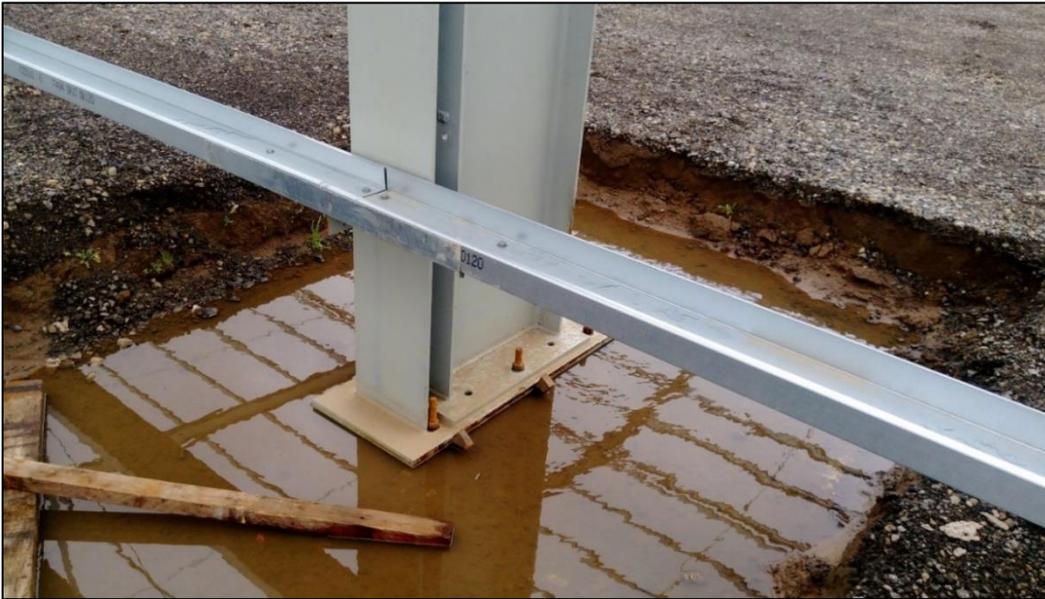
Figure 11 Cladding rail fixed to one of the strengthened columns on grid line BA

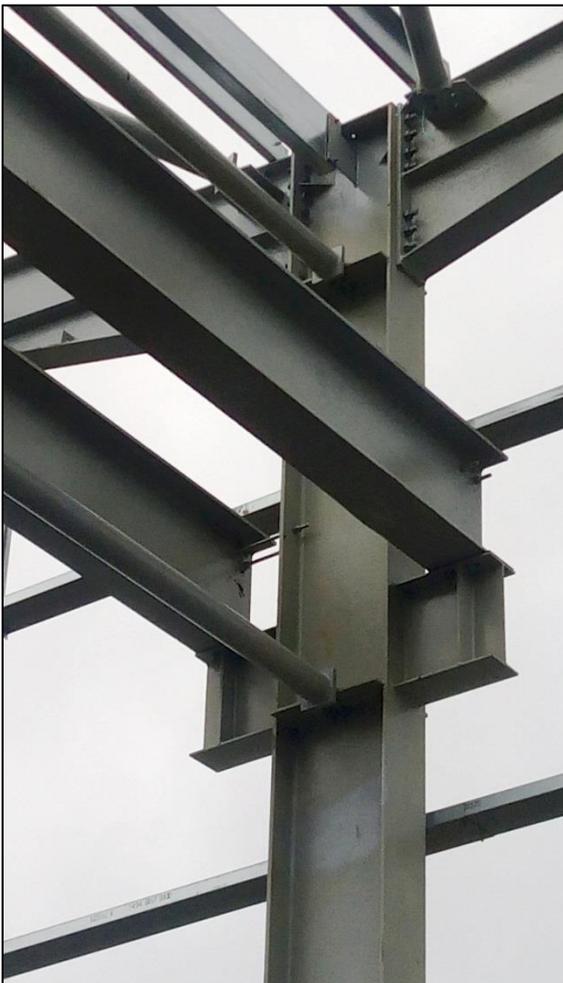
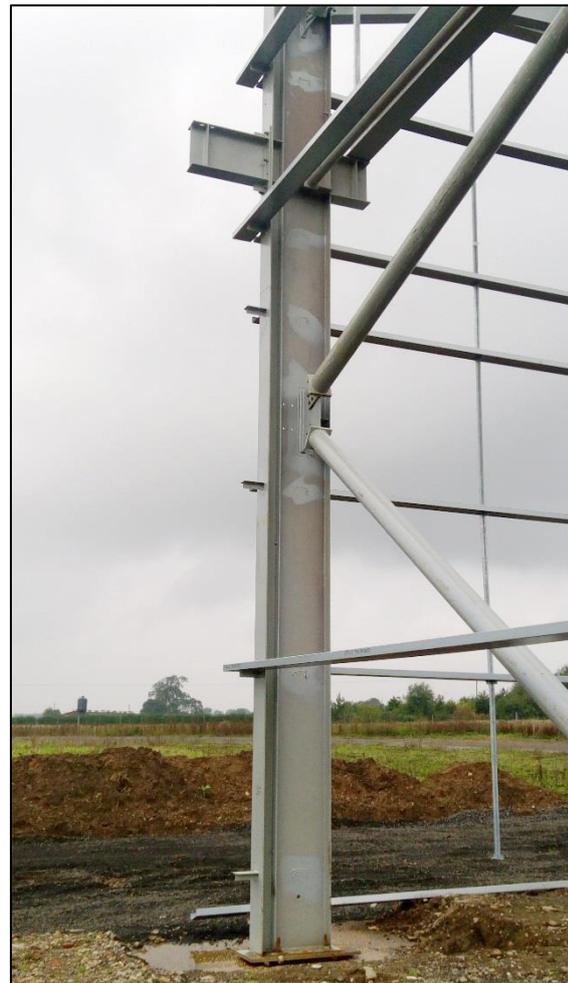
Crane rails (UB 610x305x149) for 10 and 20 tonne EOTC (electric overhead travelling crane) are provided on all three column lines. In addition, to the east of the building (column line BA), steelwork has been provided to support an external gantry crane – see Figure 12.

On the central column line

Supports for an external gantry crane (grid line BA)

Figure 12 Crane rails

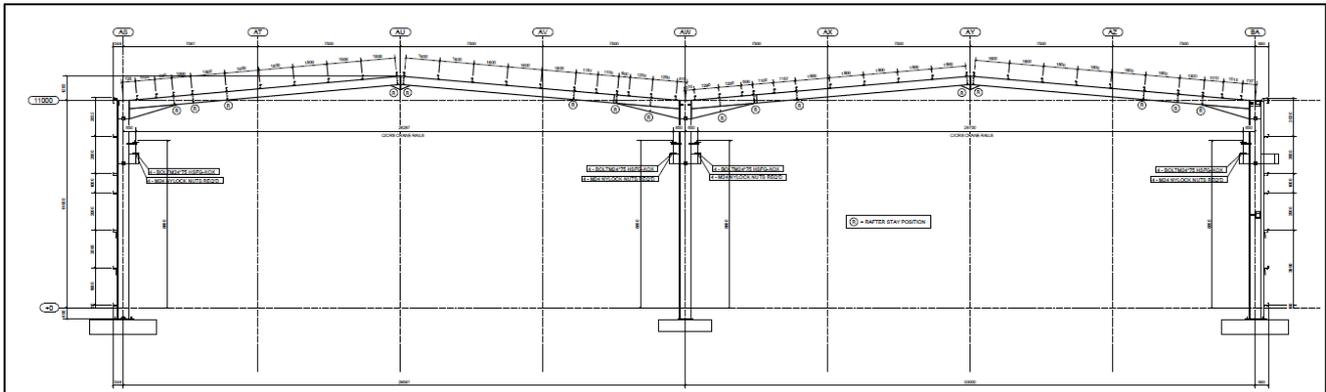
Figure 13 Crane rail locations

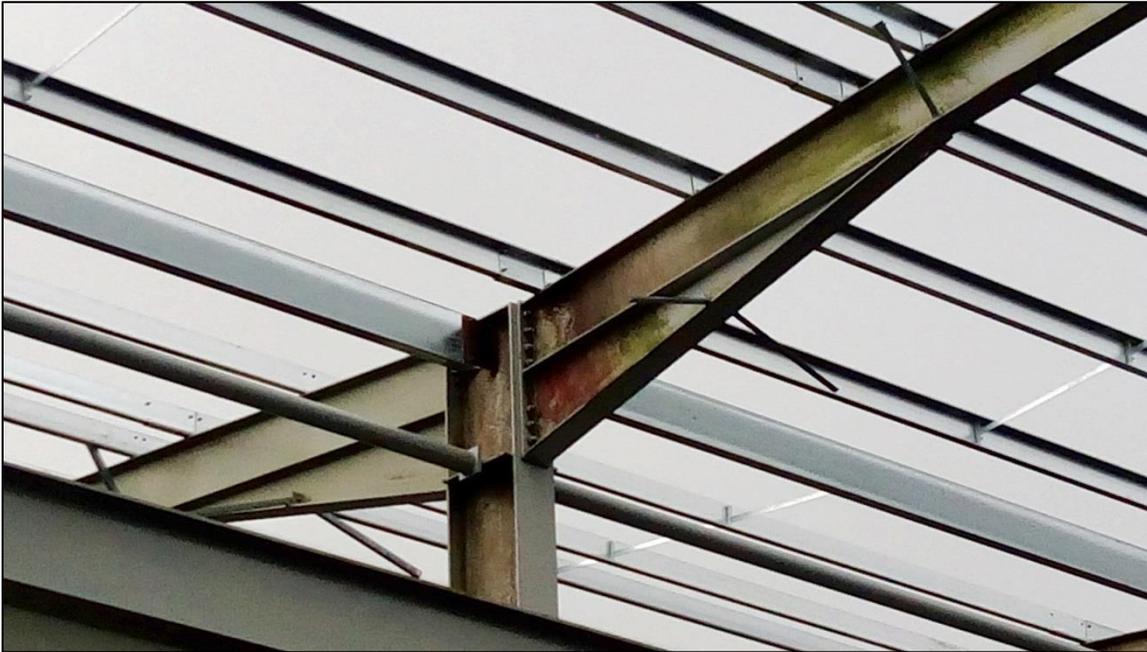
Repainting the steelwork started in summer 2016 and, as shown in Figure 14, some of the repainted steelwork is already showing some deterioration (as at September 2017) and will be 'touched up' using a roller, on-site when the building has been clad and is water-tight.

Figure 14 Central column showing the haunched rafters, eaves struts (CHS), purlins and purlin stays. Note the condition of the repainted steelwork in September 2017

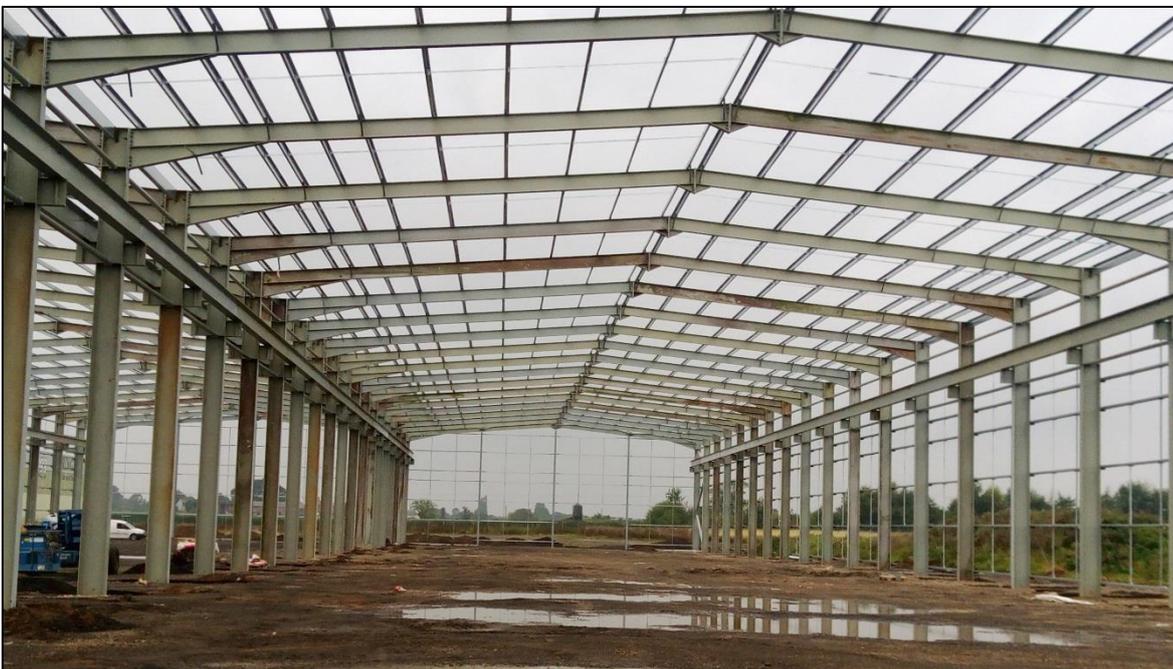
Figure 15 Fully erected structure as at September 2017

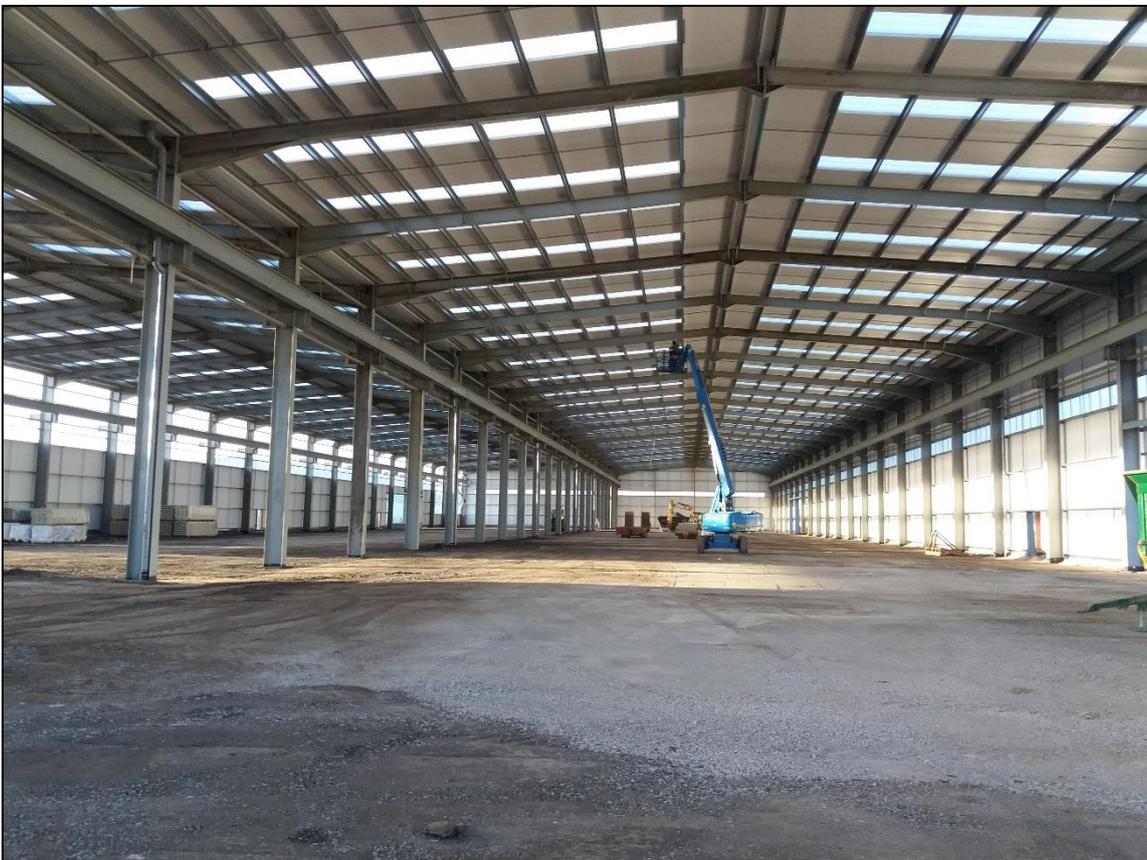
Figure 16 Cladding of the building January 2018

No information on the design of the original cladding was available. Tata Steel Trisomet composite panels are to be used for both the roof and wall cladding of the new building.
