Factsheet no. 2: SEGRO warehouse, Slough, UK

Relocated warehouse building – Slough, UK

Project summary

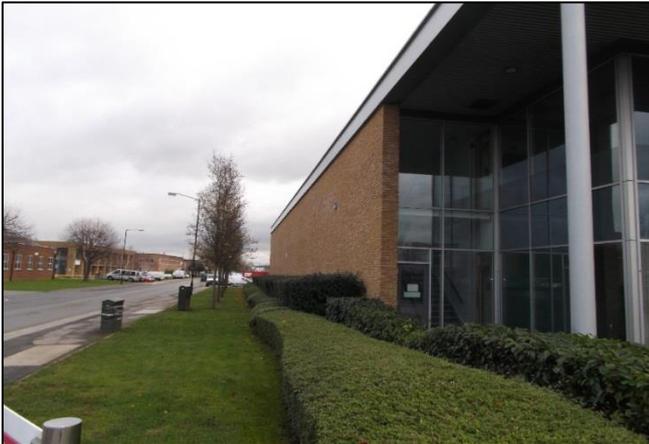
Original location (Leigh Road) – brick cladding

The relocated building was built in 2000 and relocated in 2015. It is a warehouse building with offices to the front elevation. Floor area is 3,320 m². The original building was brick-clad on three sides with full height curtain walling to the front elevation. The building was relocated to a new plot, on the same business park, 1.6km away. The new site for the building had poor ground conditions including potential ground contamination, close proximity to an aquifer and complicated underground services for the neighbouring power station. The new site was also narrower than the original site necessitating some changes to the access yards, loading door positions and soakways.

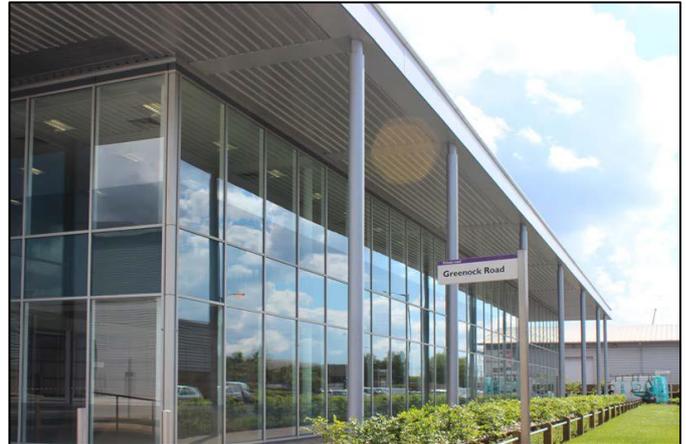
New location (Cambridge Avenue)

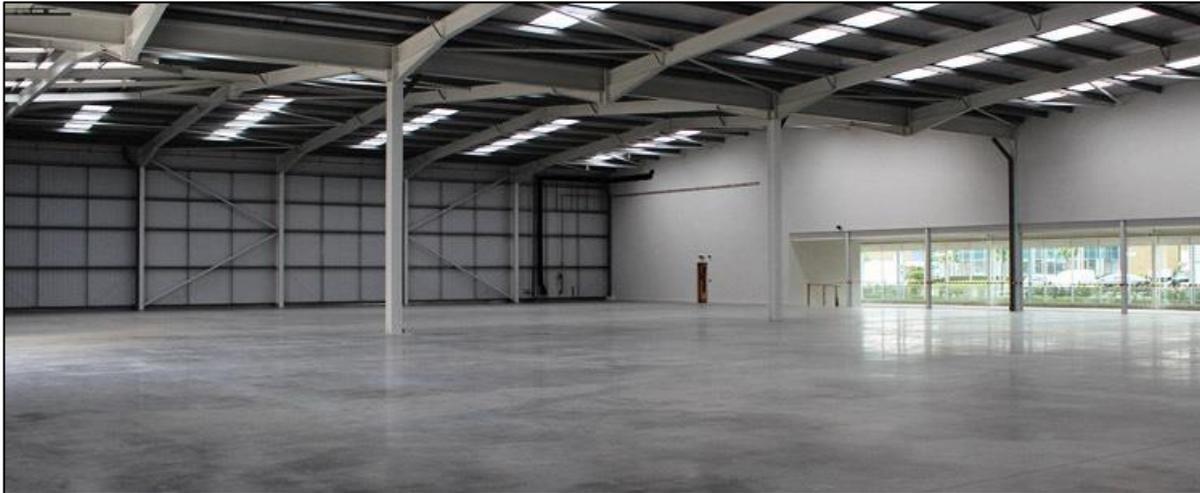
Internal view of the relocated building

Relative to other parts of the building that were reused, the primary steel structure was easy and were few problems. The contractor reported that no problems were encountered in undoing bolts but noted that pecking out column base plates was time consuming. In terms of the primary steel structure:

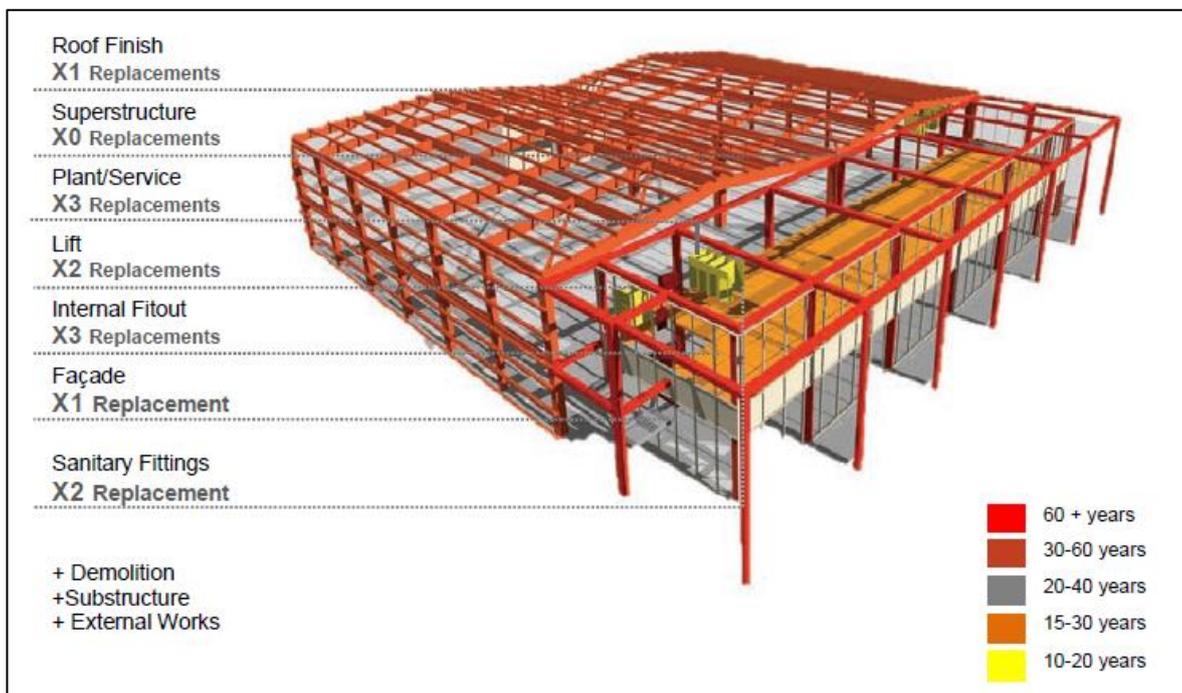
Schematic of the relocated building (Sturgis carbon profiling)

In the relocated configuration the cores in the office areas were ‘flipped’ around; new sheeting rails were fixed to the re-erected steel frame and the plant room, which was internal, was moved outside in the relocated building.

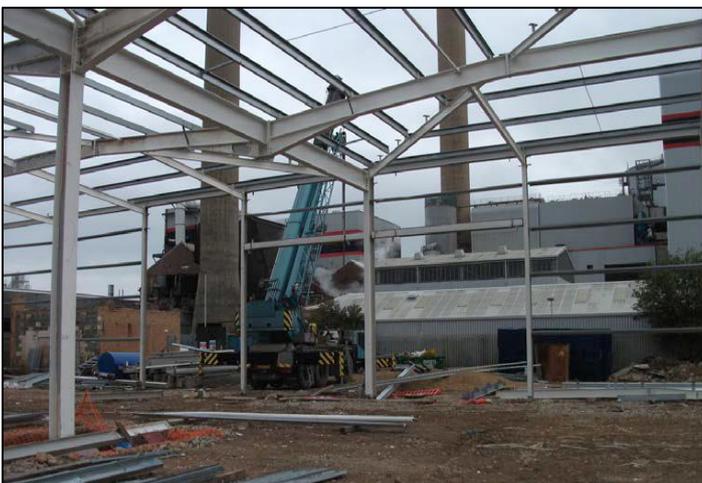
Reuse of the primary steel structure

- The steel structure was left unprotected, following dismantling, for some time. (Other products were stored in vacant buildings on the trading estate; SEGRO reported that double-handling of products was wasteful)
- Cleats were welded onto the primary steel frame to fix the rails for the new composite cladding system.
- Originally the primary structure was coated with grey primer and was fire protected with intumescent coating. During deconstruction, the frame was left exposed for some time and the coatings got wet which made it easy to manually remove the intumescent coating. The re-erected frame was touched-up and repainted on-site.

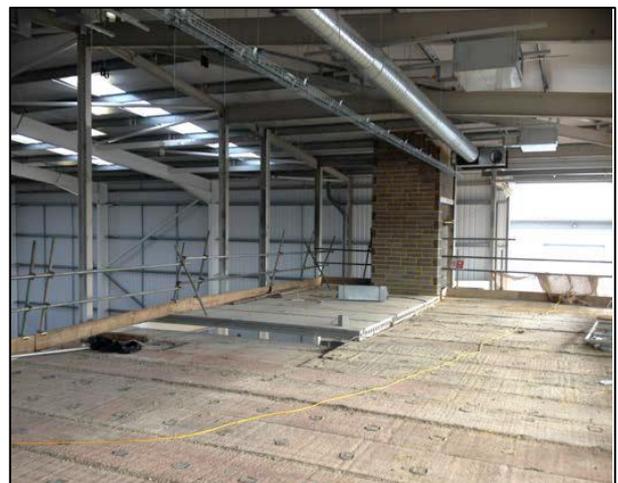
Reuse of the precast floor slabs

The precast concrete planks used for the floors in the office areas, were 300mm thick and 12m long. There was concern that these would be difficult to remove, transport and re-erect because of their fragility but this was not the case. The planks had 50mm gaps between them, no rebar and were grouted together with a relatively dry-mix which was easy to rake out. Two or three new, small planks were required to fit around the cores in the reconfigured building. [Note the structural engineer reported that some of the recast planks were damaged during removal and required repair.]

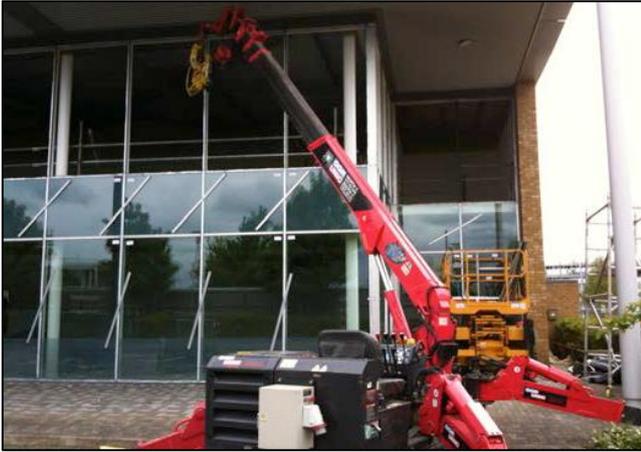
Careful reclamation of the curtain walling

Reclaiming and reusing the curtain walling was complex and challenging. Of the 80 units, six cracked in stillage following deconstruction. These units were disassembled and reglazed before being reused.

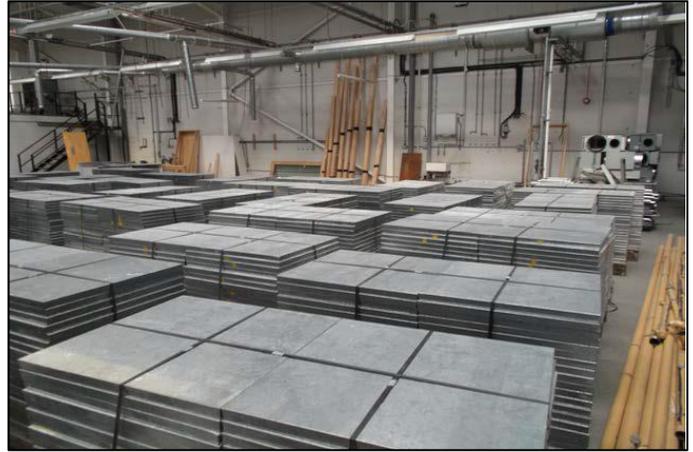
Raised access floor panels in storage

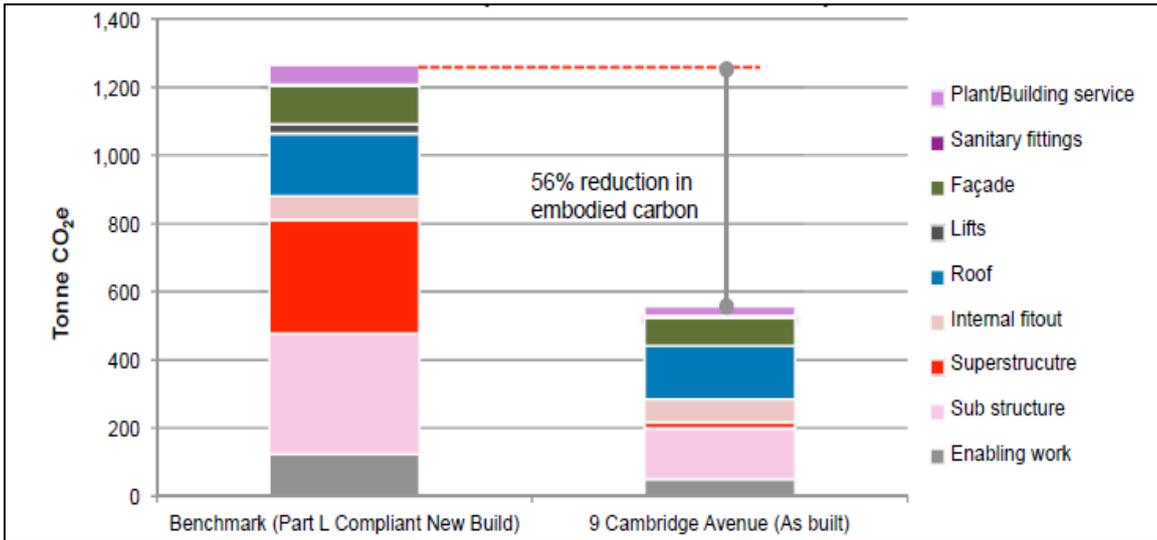
The graph below shows the embodied carbon savings achieved by reusing and relocating the elements of the building described above. According to the authors of the report, the overall embodied carbon saving at completion is 56% and the cost saving was 25%.

Embodied carbon comparison at practical completion

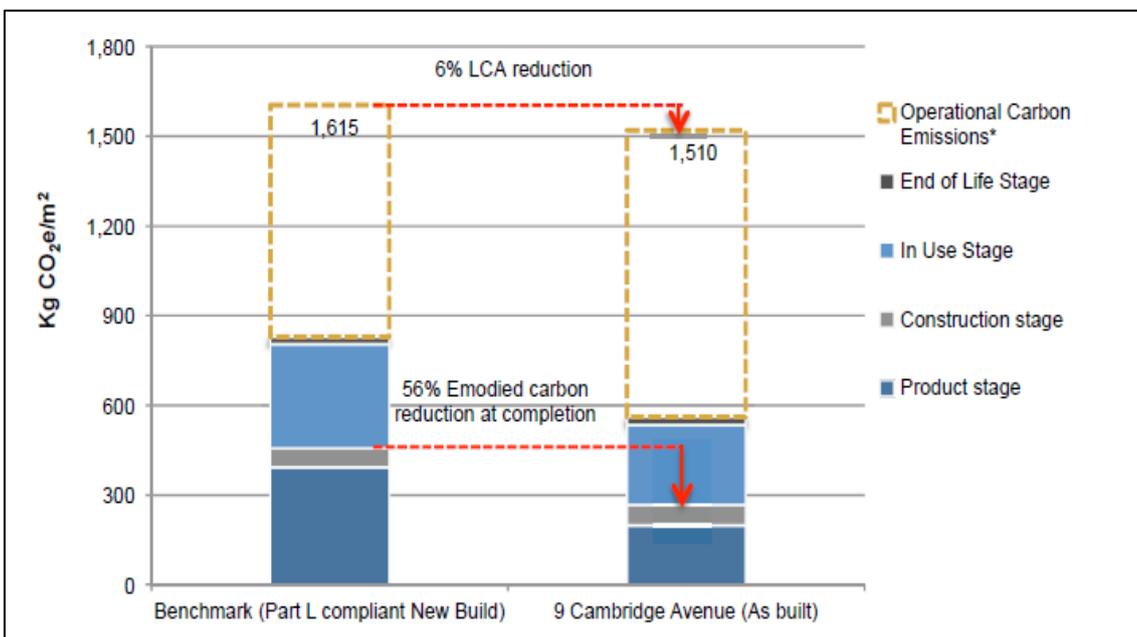
‘Whole Life Carbon’ is the combined assessment of both embodied and operational emissions over the life of the building (assumed as 60 years), including the original construction and final disposal. The Whole Life Carbon footprint of 9 Cambridge Avenue based on ‘As-built’ information is about 4,820 tonnes. The Carbon footprint is split between embodied emissions, which are 1,770 tonnes and operational emissions, which are 3,050 tonnes.

The operational energy emissions of 9 Cambridge Avenue are 23% higher than a Part L compliant new build (as at 2014). This is because the building fabric fails to meet the 2014 performance standards, mainly due to the reused curtain walling façade. However, over the whole life cycle of the building, this negative impact is offset by the benefit of having a much lower embodied carbon footprint. The overall carbon footprint is 6% less compared to the benchmark new build, a saving equivalent to 330 TCO₂e, achieved with no financial cost.

60-year whole life carbon footprint comparison
