Factsheet no. 9: Metis canopy, Otočac, Croatia

Project summary

Client: Metis d.d., www.metis.hr
Architect: URED OVLAŠTENOG ARHITEKTA, Slobodan Petrović, dipl.ing.arh.
Structural engineer: STABILNOST d.o.o., Daniel Repac, dipl.ing.građ.
Duration: ~ 5 months

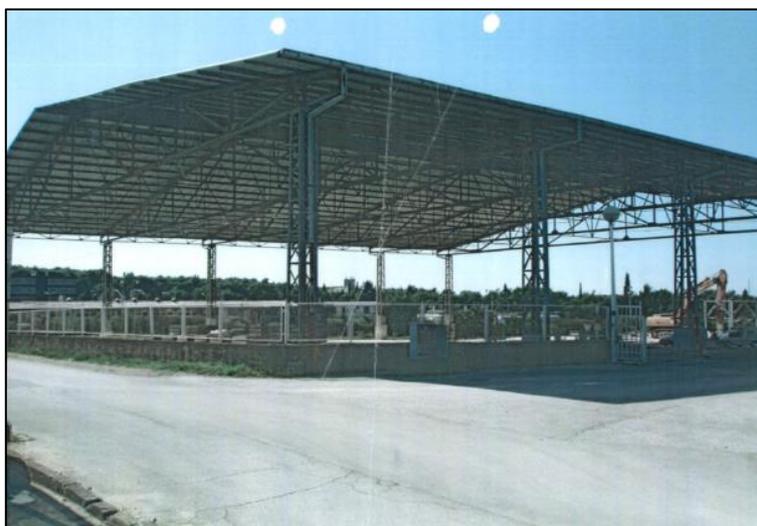
Figure 2. Original location – Pula, Croatia

The construction of the new facility included the removal of the Metis canopy from Pula and reassembling it in Otočac. Below the canopy, an administrative building and underneath the elevation $\pm 0,00$ the weighbridge was built independently of the canopy. The canopy was relocated in 2011 to a new location 266 km away. The existing double-pitched canopy was a steel structure with a trusses every 10.00 m with a span of 50.00 m. The condition of the steel structure was rusty, but without significant reduction of the steel profile section area. The steel grade was C 0.361, or in accordance with EN 10025 steel grade S235.

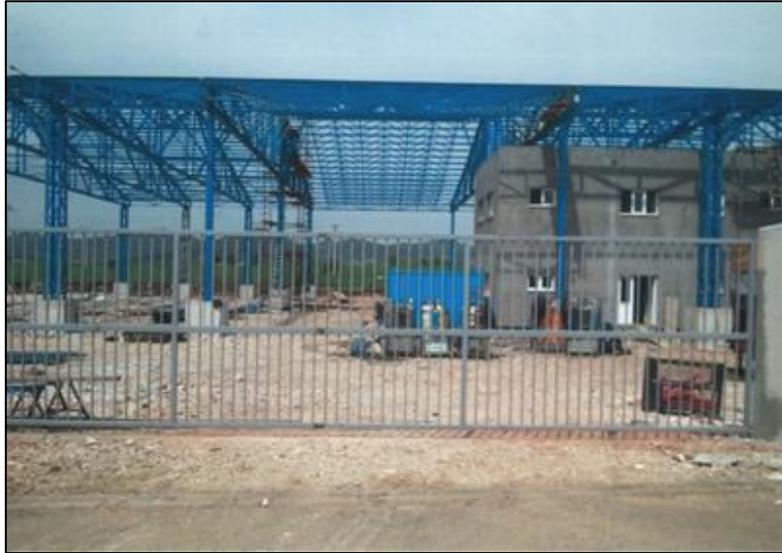
Figure 3. New location - during construction– Otočac, Croatia

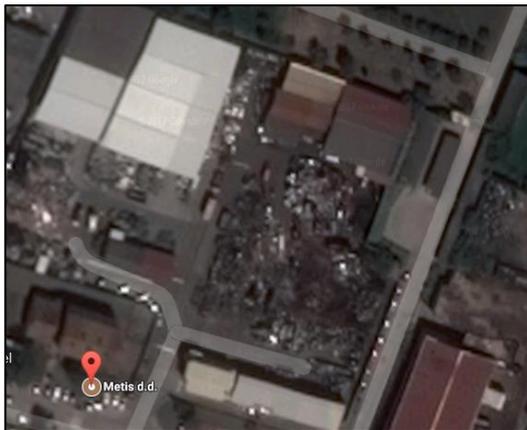
Figure 4. Original location – Valica 8, Pula

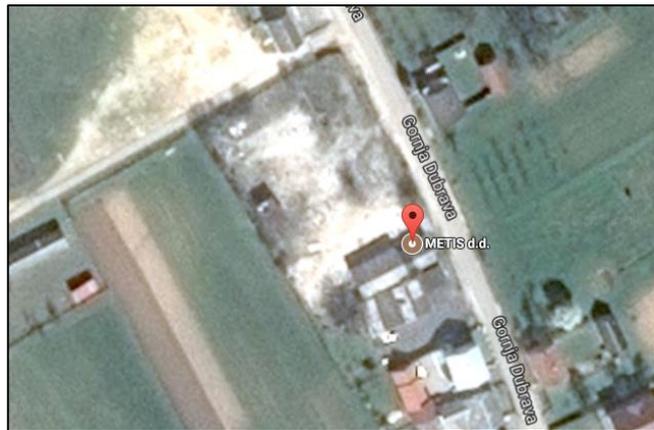
Figure 5. New location – Gornja Dubrava 57, Otočac

The main task of the structural engineer was to use the elements removed from the original structure as much as possible. Longitudinal arrangement of columns in plan is changed. Consequently, the spans of roof beams were also changed. The following arrangement was adopted: The columns in the central part of the canopy are located at span of 14 m. Left and right part of the canopy have the arrangement of columns at span of 6 m. According to adopted arrangement of columns, two main roof truss beams were constructed with the central column. New trusses with new columns are made of steel grade S355. Other roof truss beams are constructed with strengthened old structural elements.

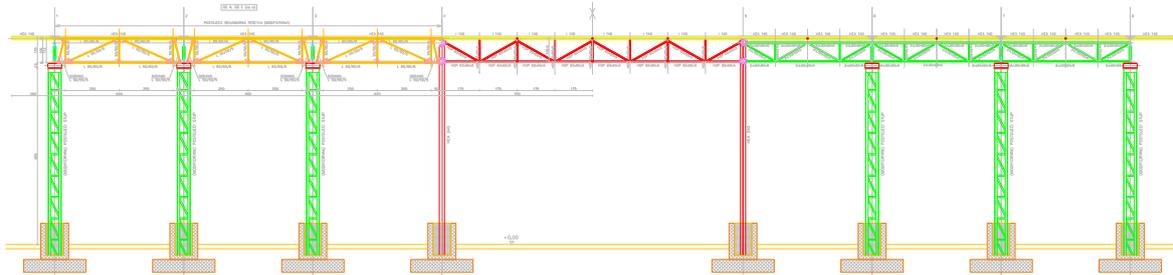
Figure 6. New positions of columns

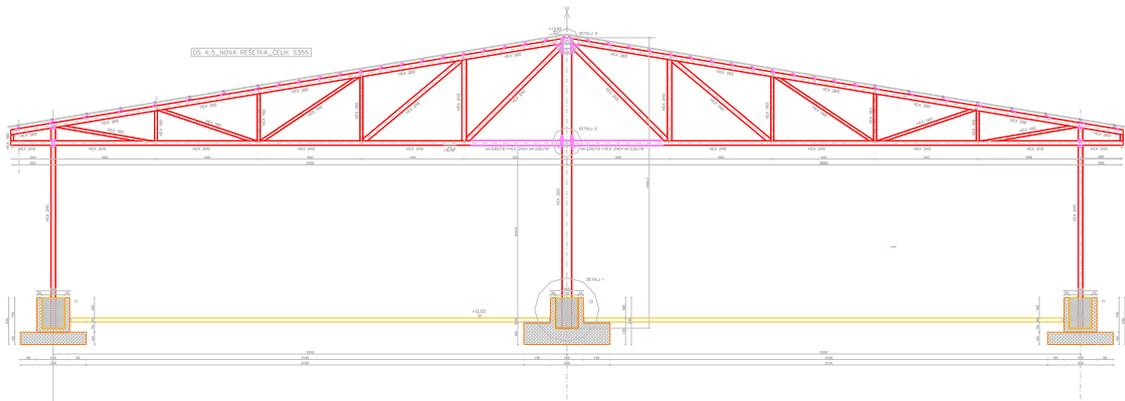
Figure 7. New steel trusses and columns

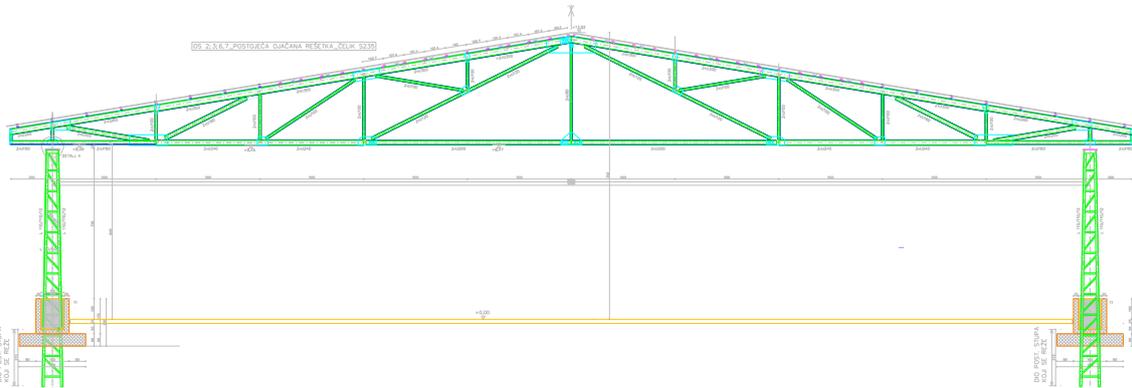
Figure 8. Strengthened existing steel trusses with modified columns

Secondary existing beams supporting trapezoidal sheets are spaced at 1.00 m instead of 1.67 m adopted at old structure. Because of the uplift wind, all bottom cords of secondary trusses have been strengthened due to increased span to 14.00 m.

All the profile sections of the existing trusses are strengthened by welding the plates. On the other positions, the re-installed profile sections did not satisfy stability requirements so strengthening with additional plates were necessary.

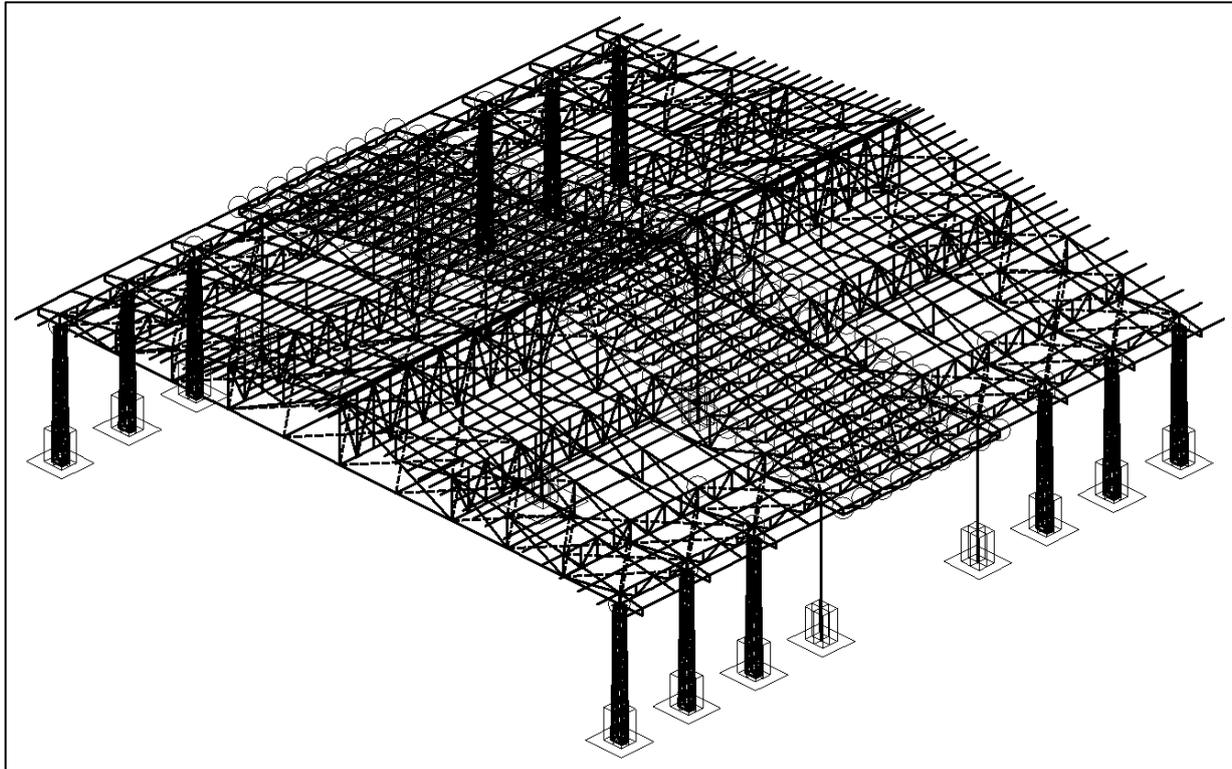
Figure 7. 3D model in Tower

The investor didn't acquire the project documentation so it wasn't known on what loads the structure was dimensioned. Structural analysis, dimensioning, and drawings were made for a new location without the ability to compare them to the original one. The program used for the structural analysis is *Radimpex Tower*.

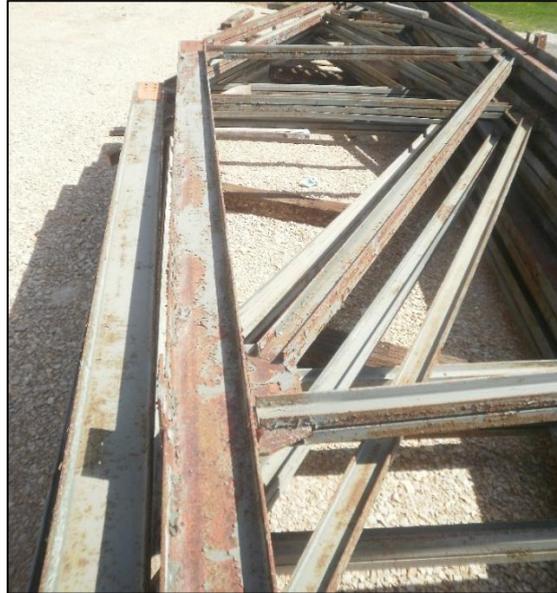
Figure 8. Rust on the trusses

The main problem was to remove the rust and to perform the prescribed protection of the steel profile sections. A particular problem was the removal of the rust between the angle and "U" profile sections. The protection is prescribed after proper cleaning with paint for rusty metal.

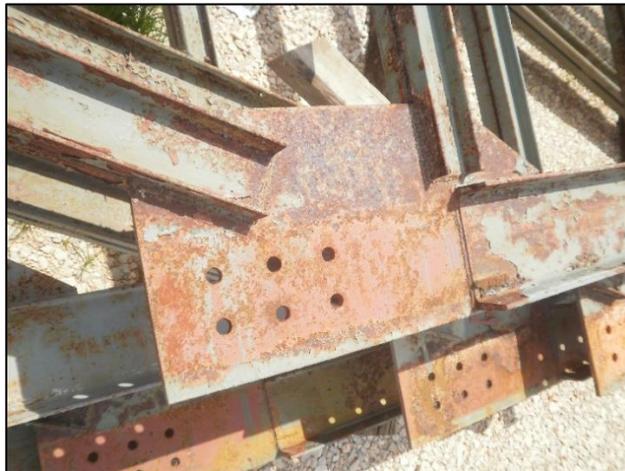
Figure 9. Details

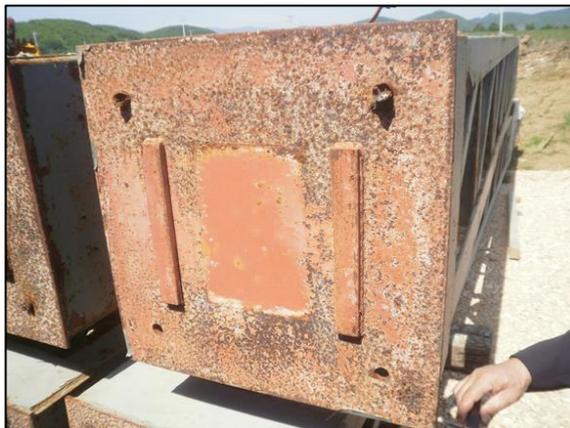
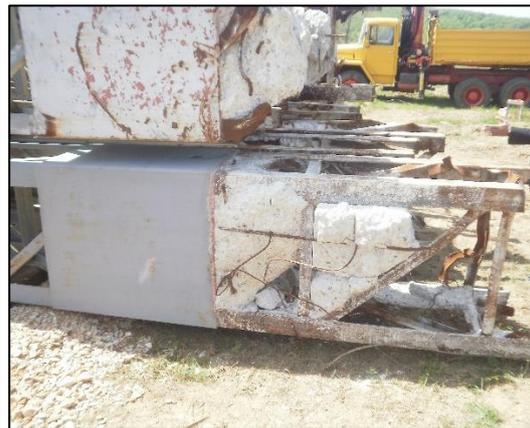
Top of the column

Bottom of the column

Figure 10. Removed columns

The end of the existing columns with welded steel plates is placed into concrete foundations. The project envisages anchoring these columns, as well as the new ones, in reinforced concrete pockets.

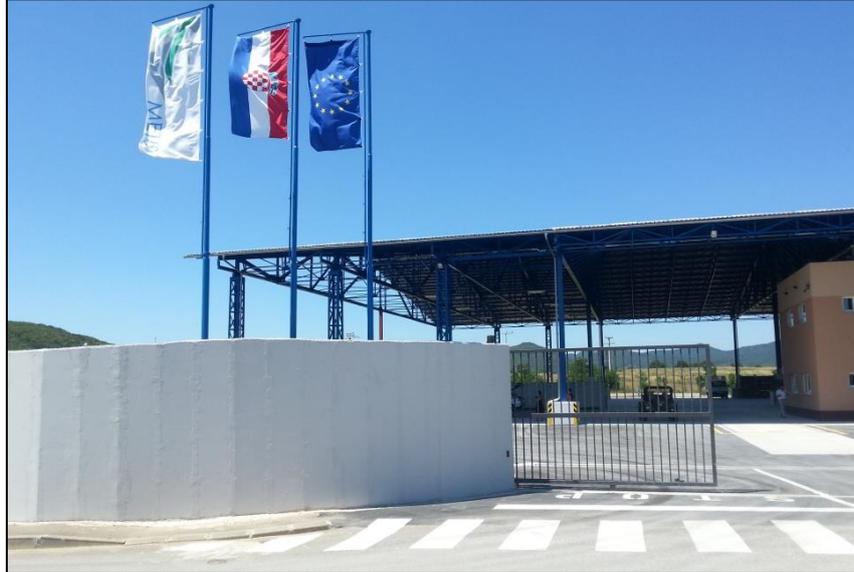
Figure 11. View of relocated canopy

Particular attention is paid to the fixing of aluminium trapezoidal sheets because of the uplift wind pressure of $2,00 \text{ kN/m}^2$ on the edges of the structure.
