Reuse of Steel Case Study no. 3

## The deconstruction for reuse issues of steel girders

### Project summary

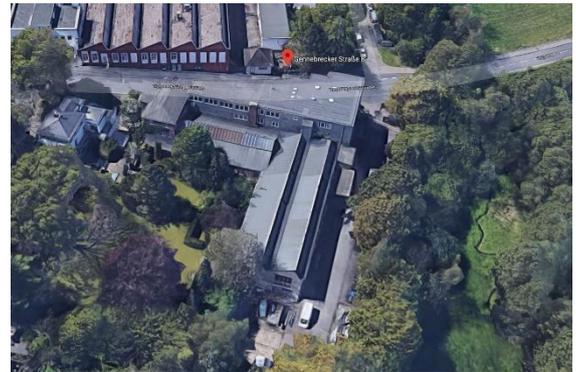
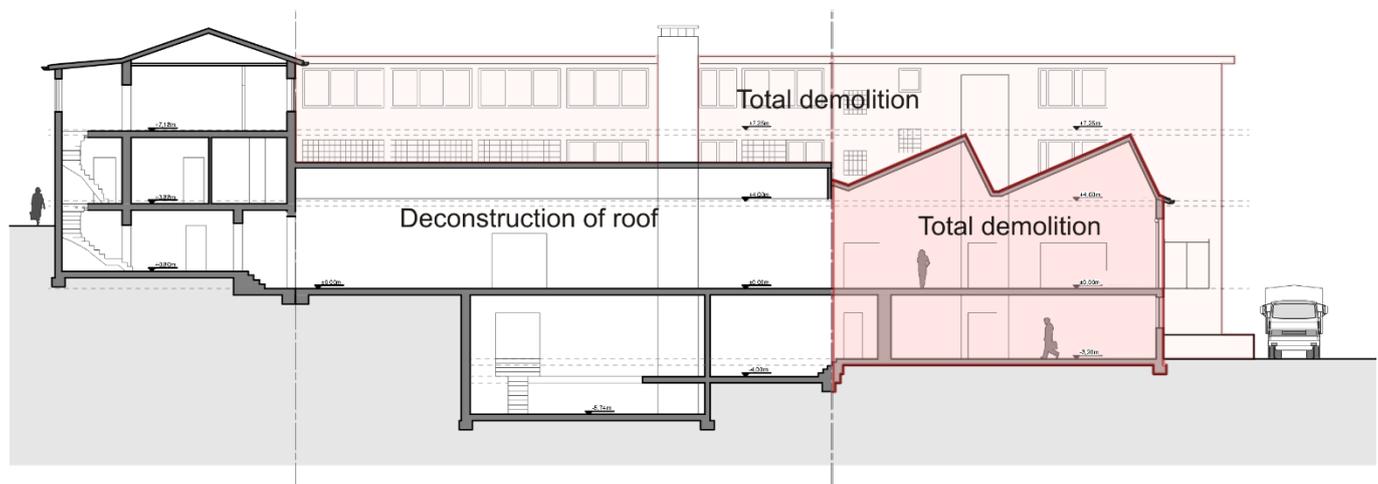
Total there existed 2 halls as well as an office building. While the office building and the greater part of the fabrication halls from the 1950s were planned to be demolished, the oldest hall was planned to keep for historical reasons. Unfortunately, modifications in the 1950s combined the bearing constructions of the office building with the historical hall. Because the

fabrication started once in this hall, there was a deep interest, to keep as least the roof-structure and to integrate this as a remembrance to the beginning of the company.

The demolition project is divided in three parts: (1) The demolition of the 1950s hall, (2) the deconstruction and saving of the roof structure of the 1920s hall including the demolition of the remaining hall and (3) the demolition of the office building.

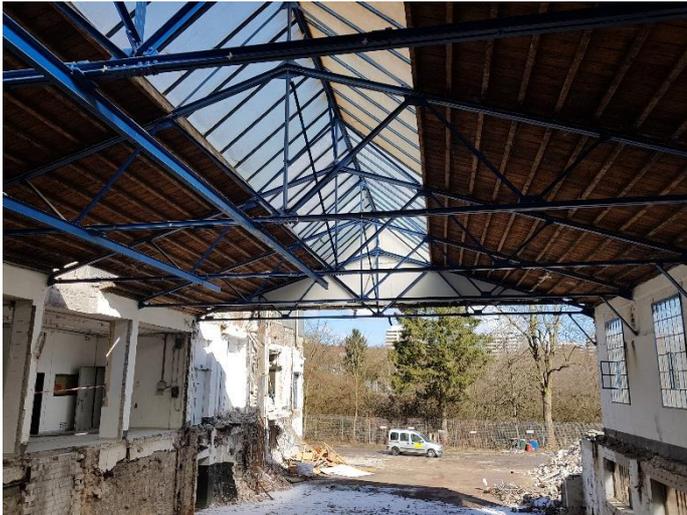
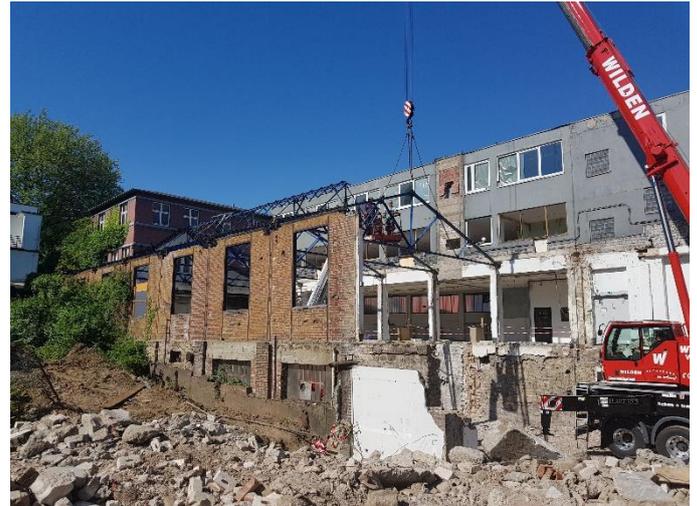
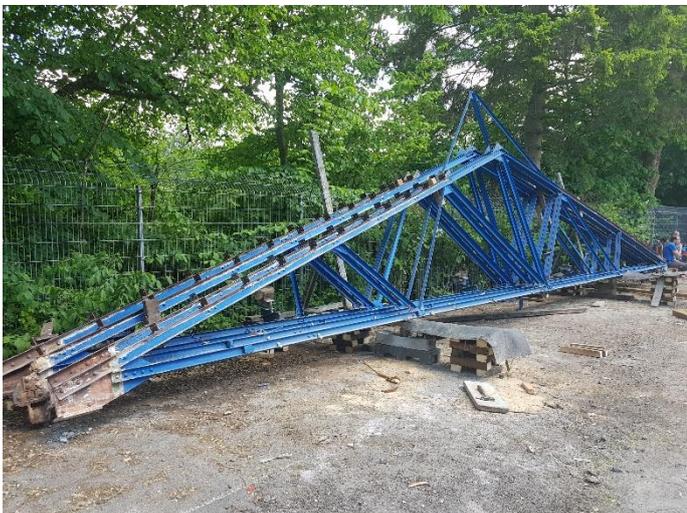
The construction of the roof structure consists of steel-timbering. Up-on the bearing structure, the roof was built of wood with a regular sealing of old tar-based cardboard. Due to the filigree steel-structure preliminary cardboard and wood were deconstructed by man-power. Afterwards, all jointings of the girders to columns were dismantled. Only the horizontal links retained for stability reasons.

The links were dismantled just in time when the girders were removed.

To keep the steel timbering intact after the deconstruction it was evident, to build a construction to store the elements. This construction was fabricated of steel.
