# PROGRESS

PROVISIONS FOR GREATER REUSE OF STEEL STRUCTURES

## Deliverable D7.1

## Report on deconstruction of a single storey hall for reuse

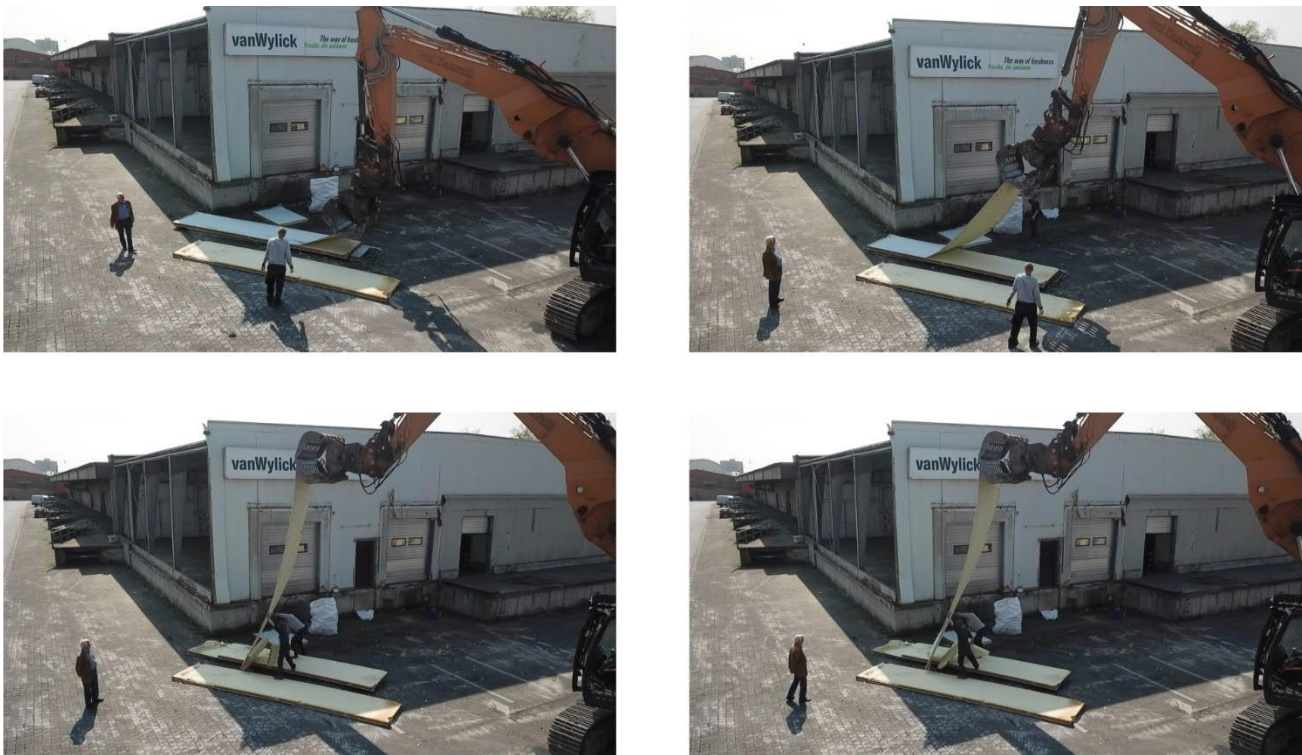
*Figure 15: Separation of metal sheets by help of excavator and two workers*

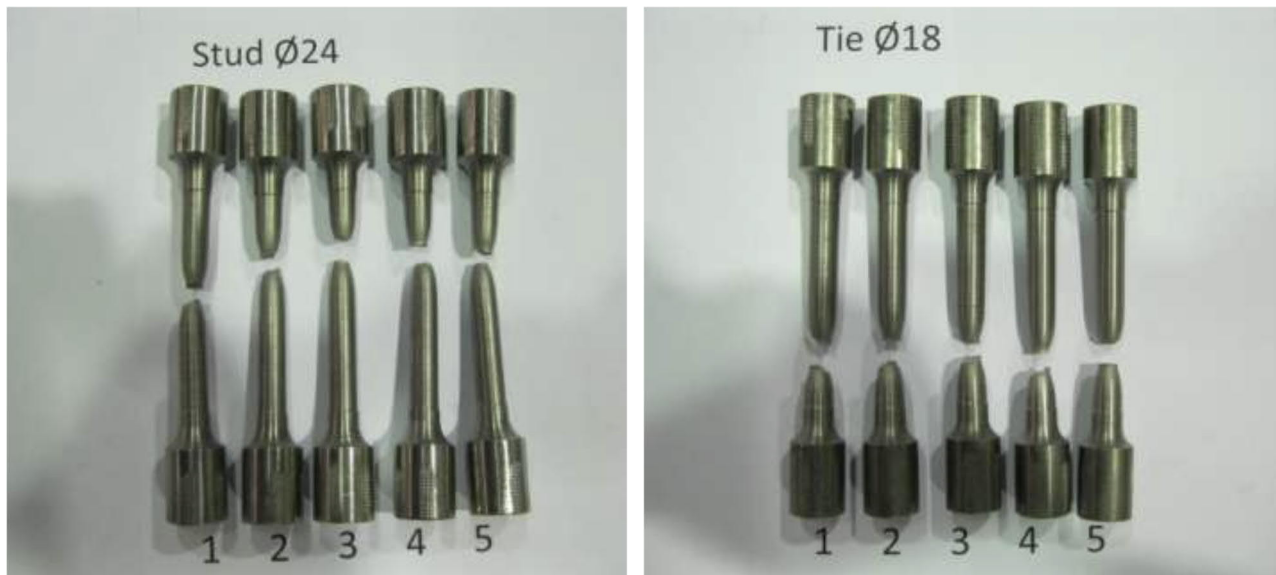
Figure 1 Tensile test specimens *ST-B1* (first on the left) and *ST-B2* (second on the right)

The tensile specimens were tested to rupture in SCIENCE project [2], and one grip end was given for Small Punch testing while the other end went to nanoindentation testing. The grip ends were cylindrical with diameter 20 mm in *ST-B1* and 18 mm in *ST-B2* and the tensile test was performed in hydraulic grips.

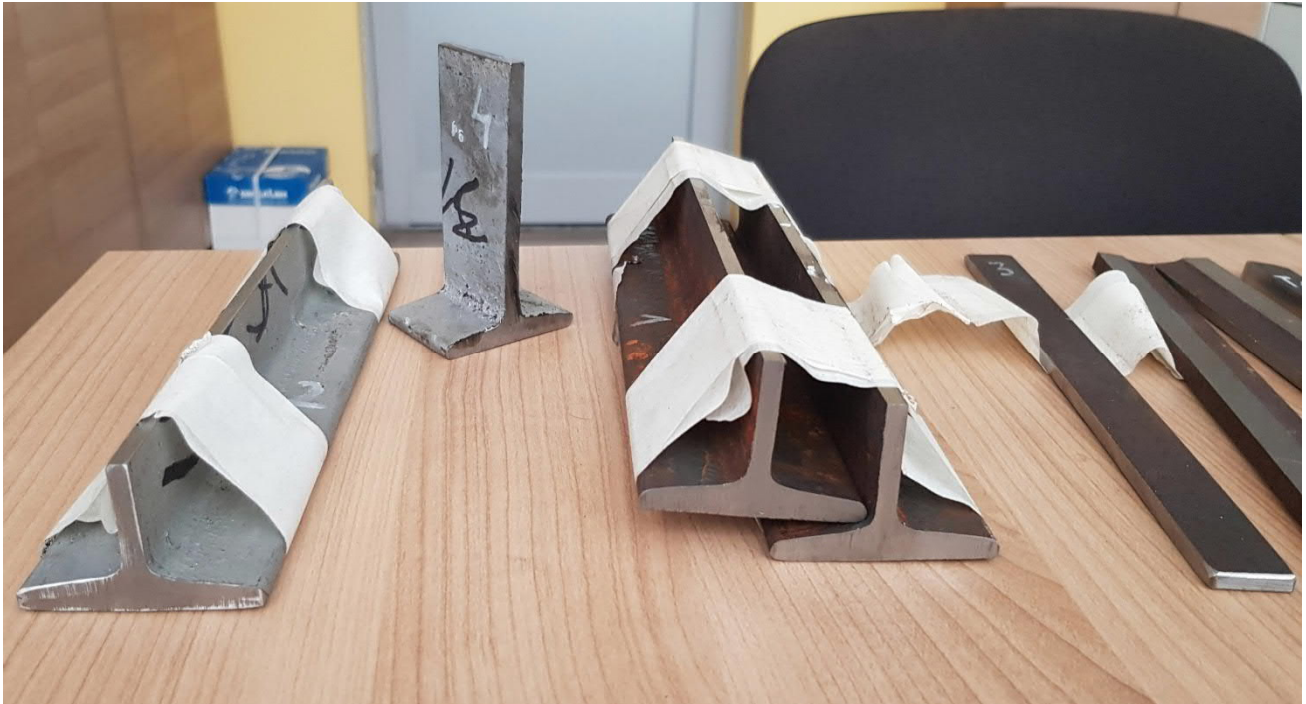
*Figure 2 Structural steel sections for the mechanical testing (from left to right)  
ST-P2, ST-P4 (not tested), ST-P1 and ST-P3*

Four specimens from hot-rolled structural steel sections were prepared for the mechanical testing designated *ST-P1* to *ST-P4* (see Figure 2).

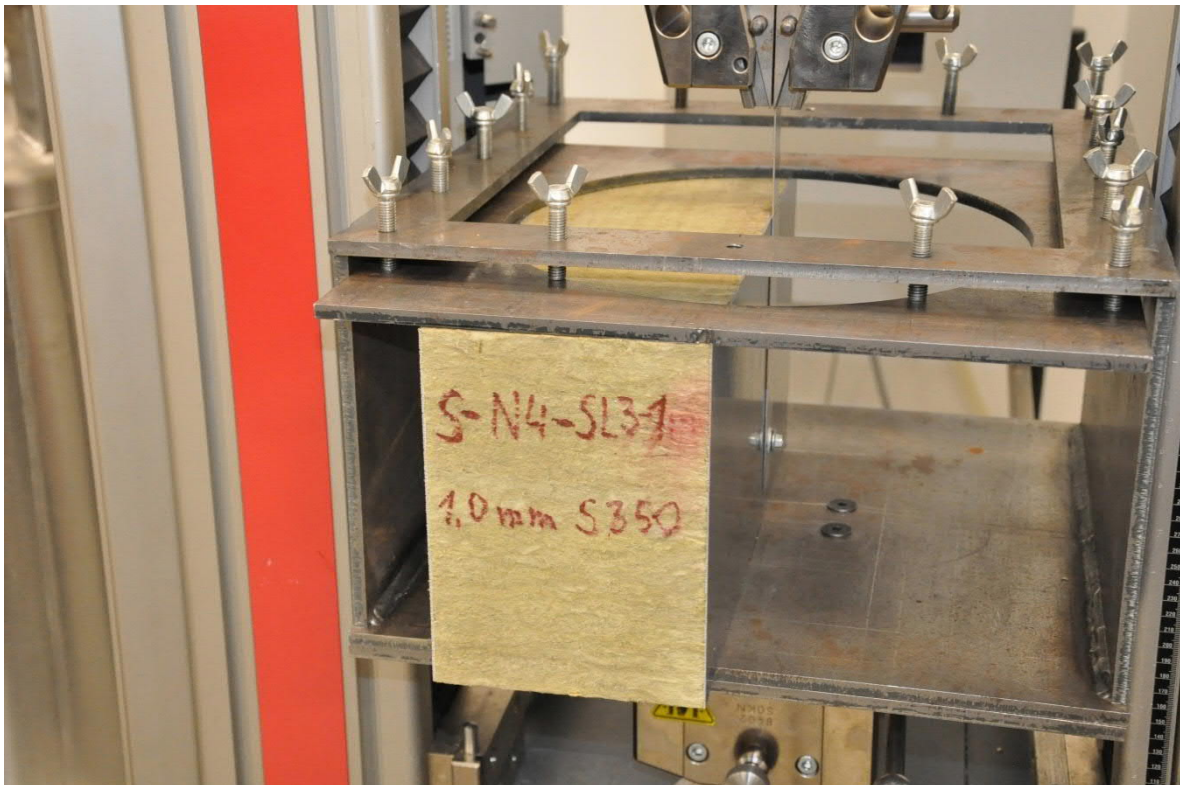
Figure 47 S-N4-SL3-1mmS350-1 test arrangement

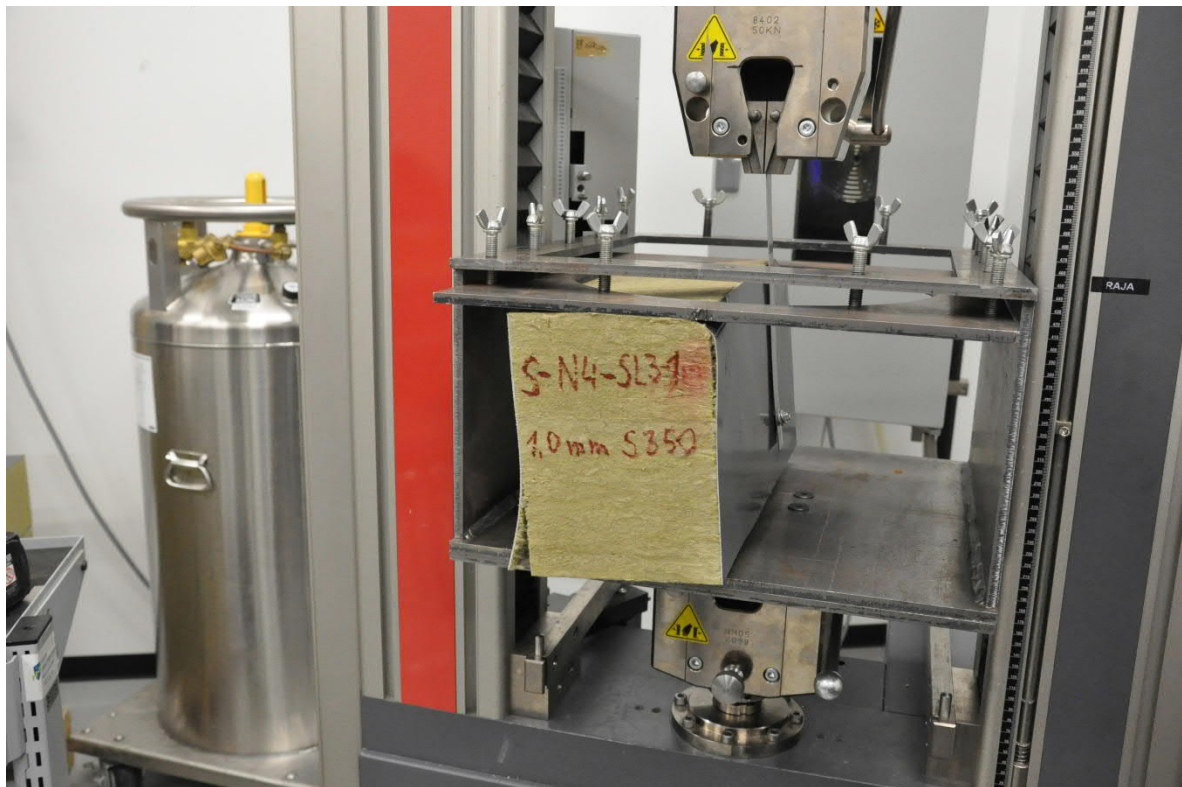
Figure 48 S-N4-SL3-1mmS350-1 panel condition during the test.

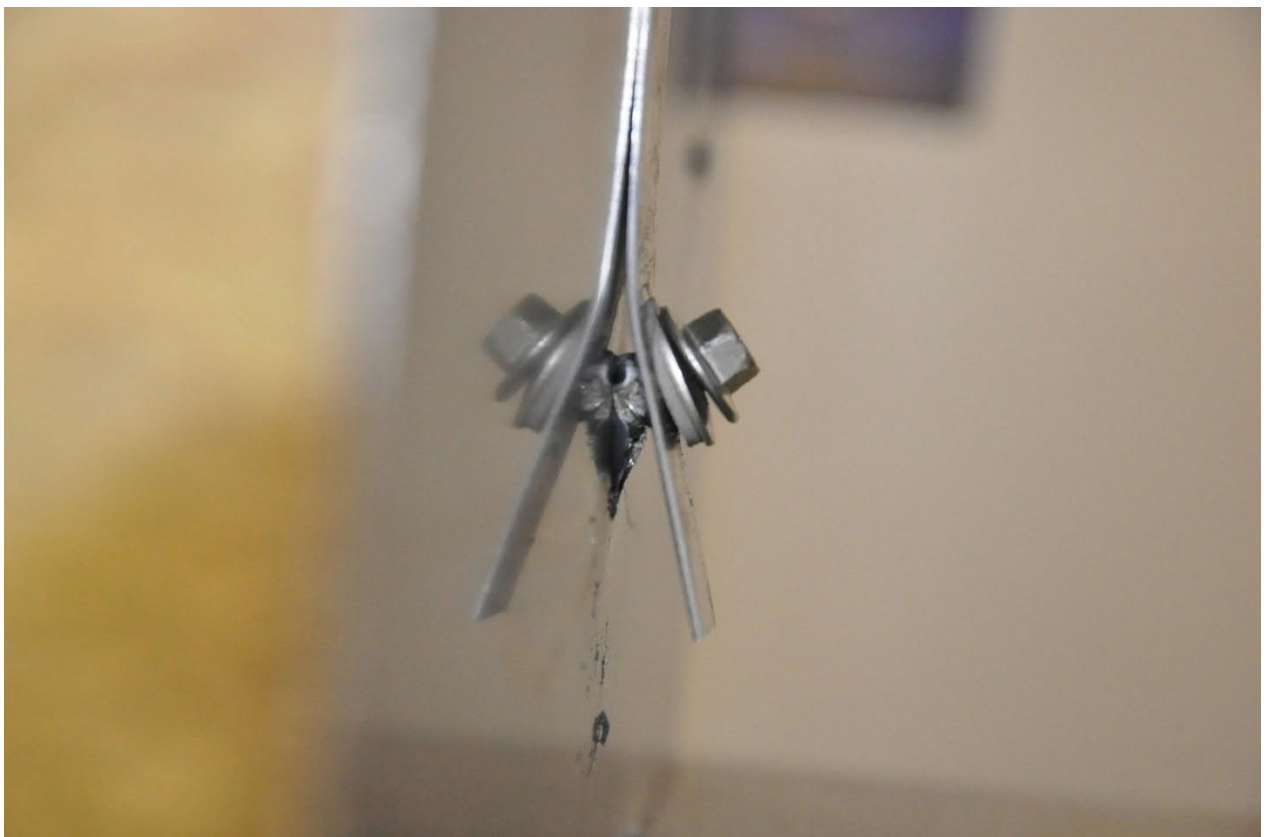
*Figure 51 SL3 screw pull-out failure mode in shear tests.*
