# PROGRESS

PROVISIONS FOR GREATER REUSE OF STEEL STRUCTURES

## Report on deconstruction of a single storey hall for reuse

Deliverable: D7.1a Report on deconstruction of a single storey hall for reuse

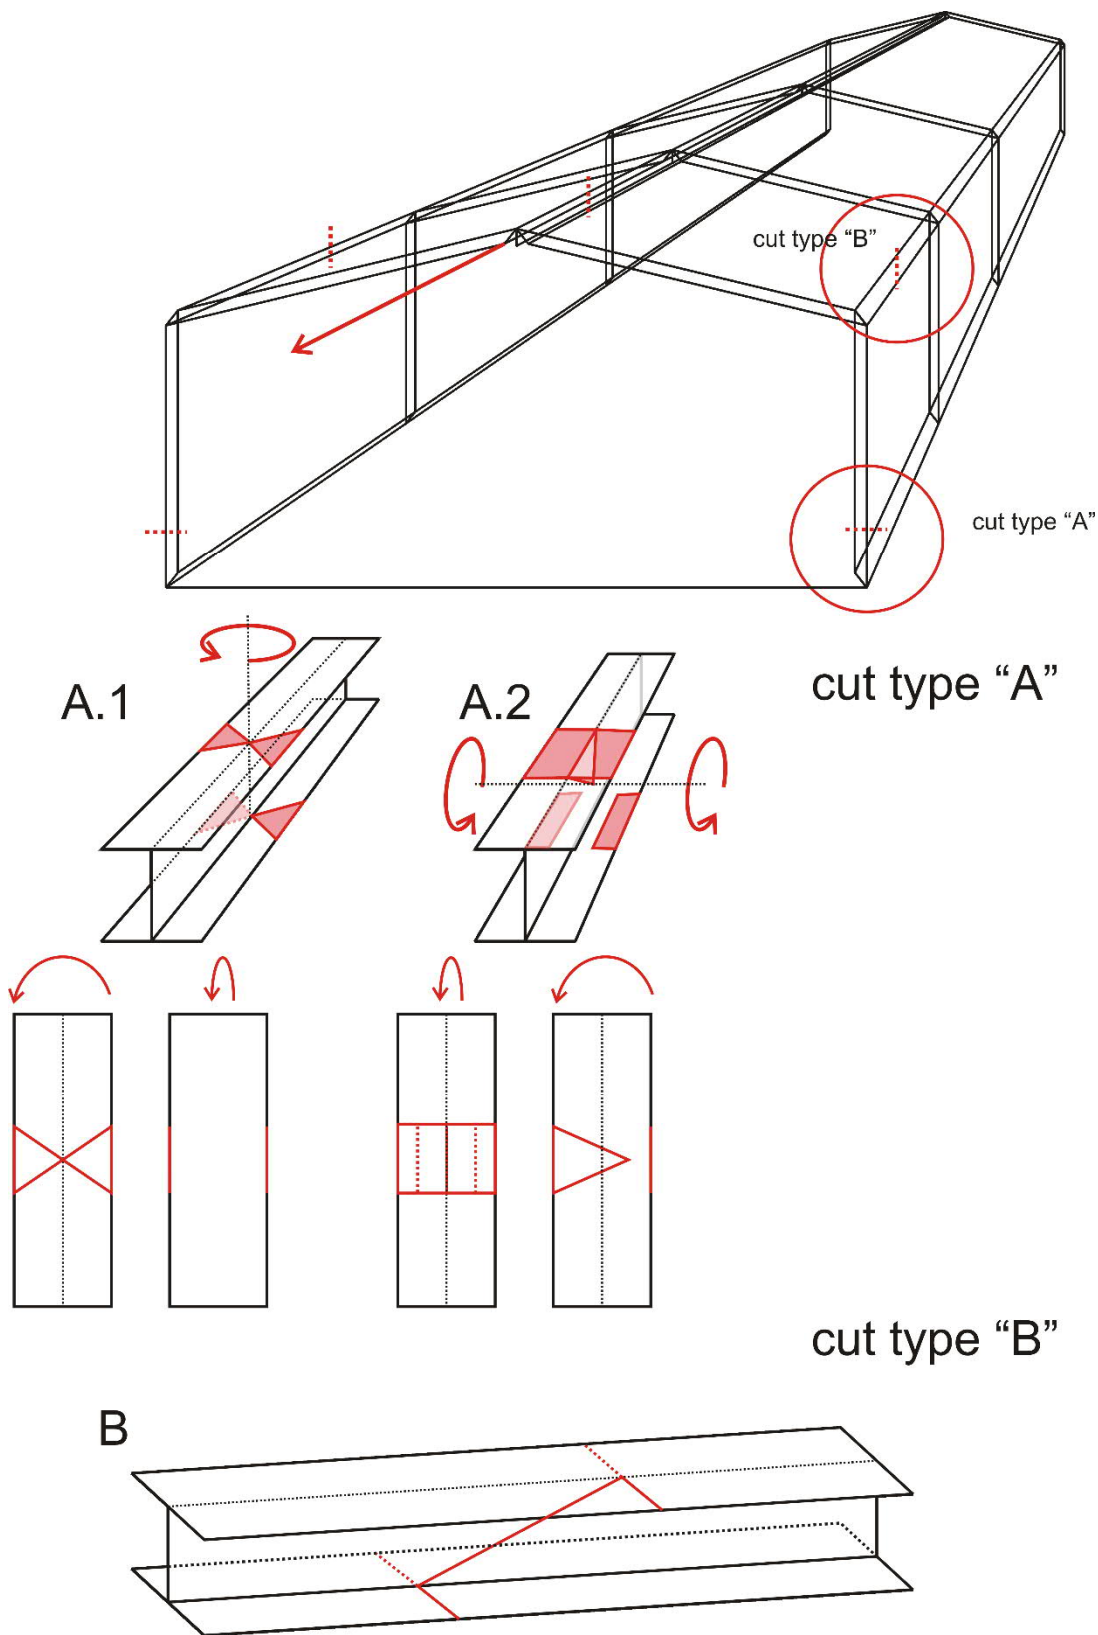
For general demolition of an SSB the safe technique for demolition of the structure is given in fig. 11. The technique is based on flame cutting the adjacent girders and pulling the structure down. If the primary structure is poured in concrete, there exist cutting techniques to create a hinge that allows the needed movement.

Figure 11: Combined technique to dismantle the primary / secondary structure for demolition.

In fact, the technique is the same for deconstruction, except that no flame cutting is used. Instead the joints need to be unscrewed. The poured parts have to be dismantled by small excavators. It is evident

not to release joints of the secondary structure before the anchoring in the ground. As well, deformation may become an issue. Thus, it is recommended to use two excavators for laying the frames on the ground.

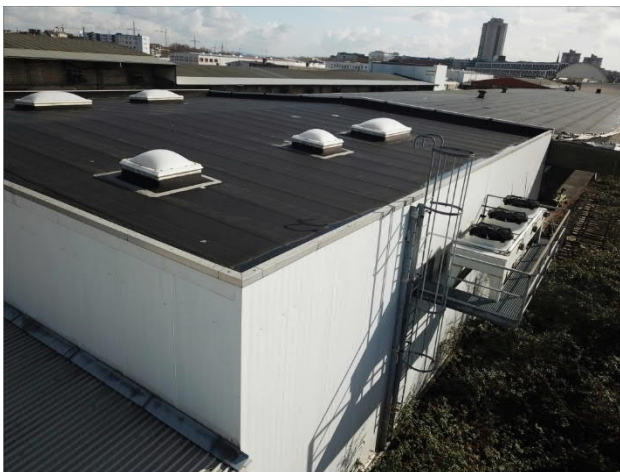
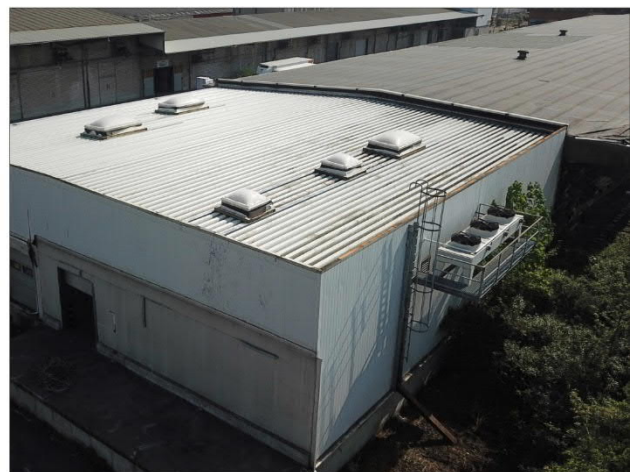
*Figure 12: Removal of roof insulation and sealing; Left picture before removal*

Modern roof structures are insulated by a 30cm or more thick insulation of styrofoam. Removal by machines causes parts of the styrofoam to be destroyed and being blown away. To avoid the waste to be blown away it is recommended to remove the insulation by manual work. After the insulation removal, above the trapezoidal sheets all non-steel materials are deconstructed.

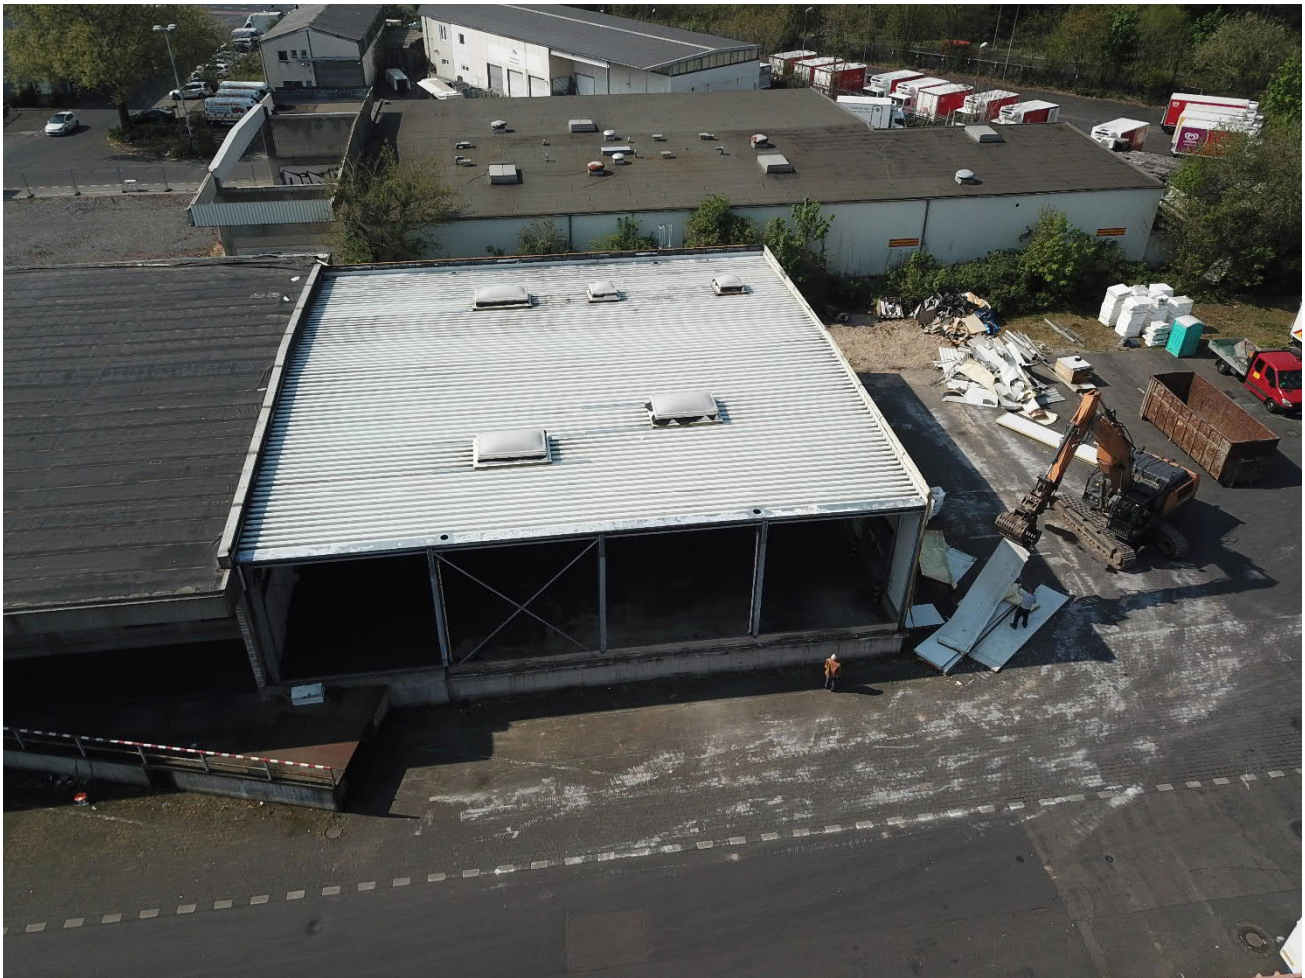
After the insulation of the roof the side walls were dismantled. During the dismantling by excavators with an attached gripper it was tested, whether the sandwich elements can be dismantled without damage. Thus, it was tested, if those elements were usable for reuse. In fact, the gluing between the metal sheet and the insulation was weathered so much, that the connection was not stable anymore. Some parts were transported to RWTH Aachen to undergo more technical tests. At least, the metal sheets were separated from the insulation. This separation helped to lower the total mass of general waste and increase the steel, which could be recycled.

*Figure 13: SSB with removed roof insulation and removed walls of sandwich elements. On the right, an excavator is starting to separate the metal sheets from the inner insulation of the sandwich elements.*

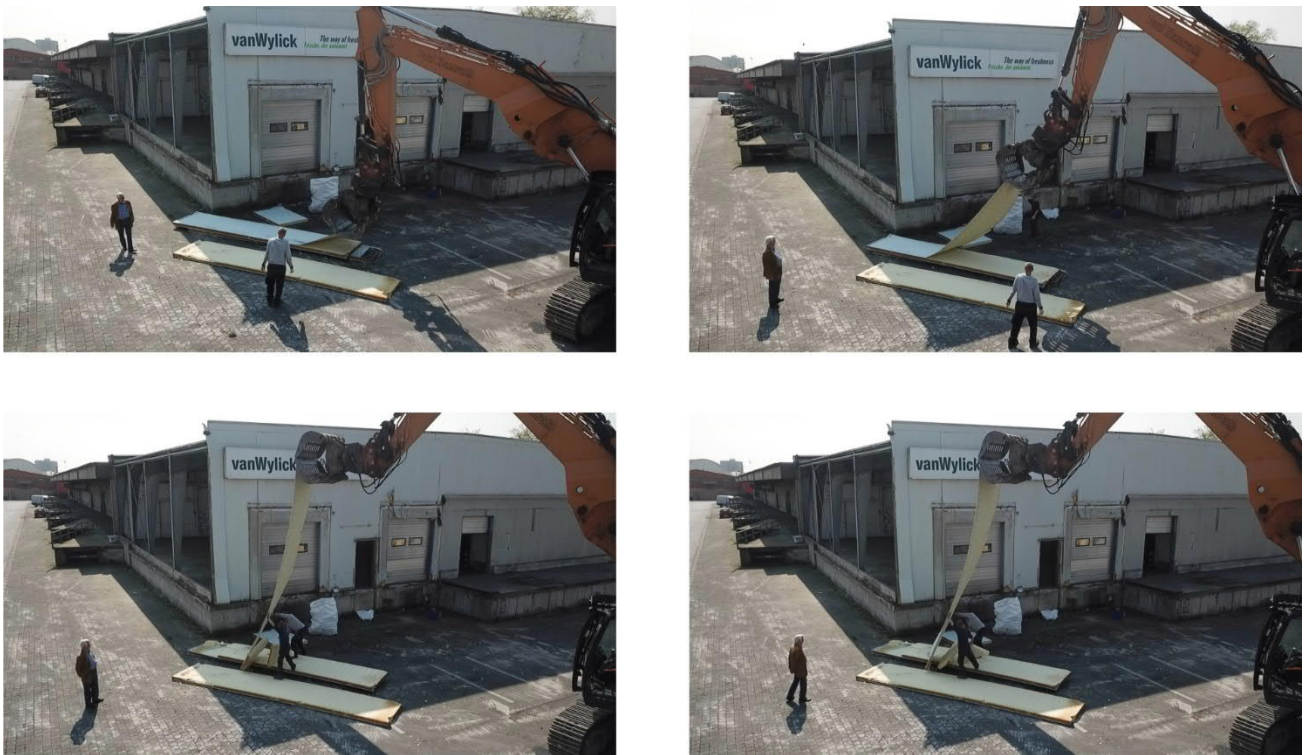
Figure 14 shows the dismantling by excavator without deforming the sandwich elements. It was determined that separation of the different materials is best function, if the elements are not badly brought up but mostly in shape. Figure 15 illustrated the process of separation.

*Figure 15: Separation of metal sheets by help of excavator and two workers*

Thus, although in this example the sheets could not be reused, in general a dismantling technique open for reuse is recommended for the sheets. Even if reuse seems not practicable separating the materials will be easier if the elements are not deformed yet.

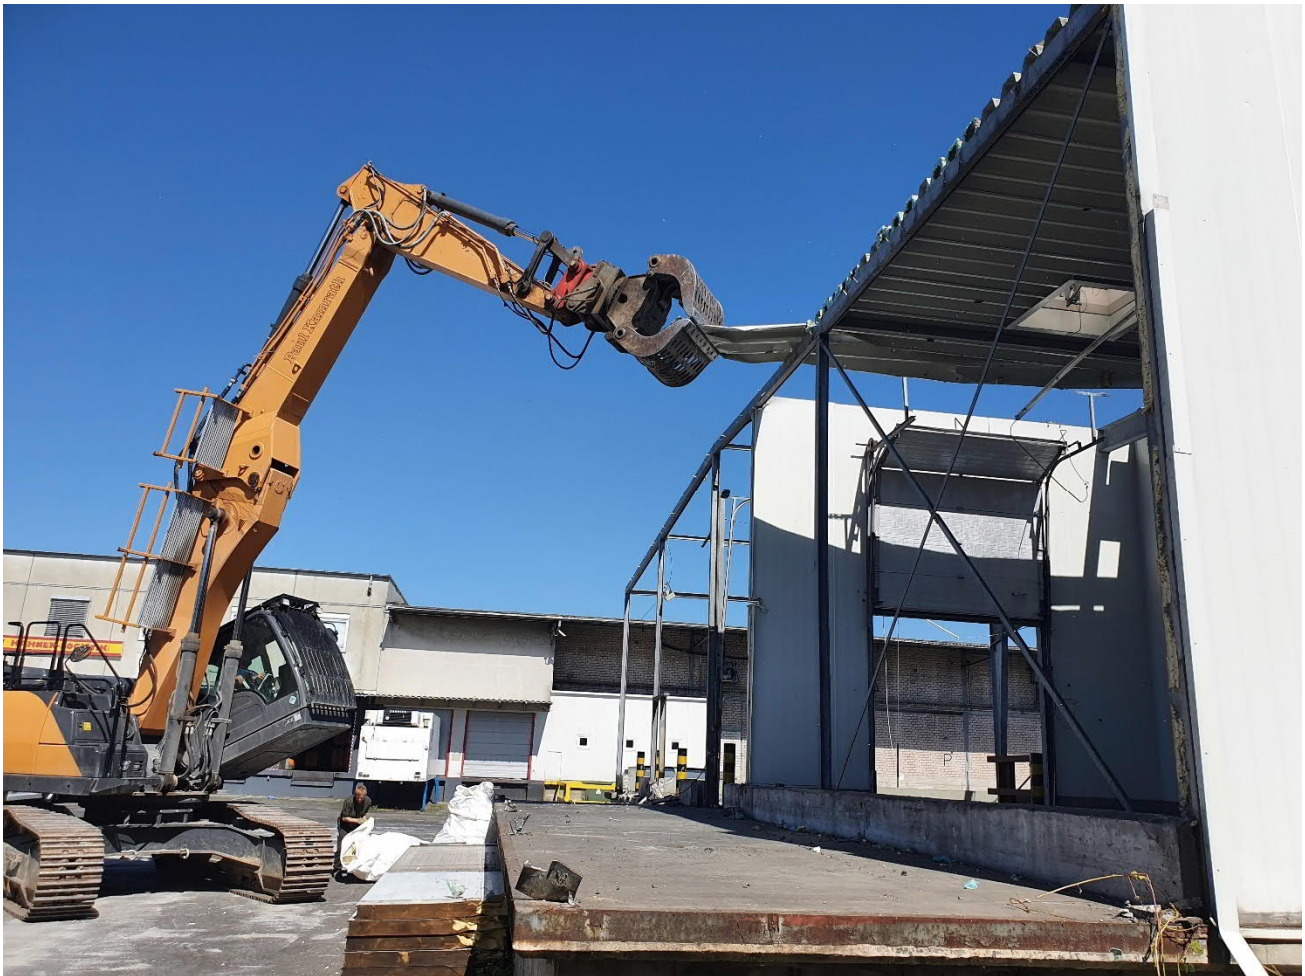
- 1) Thickness of flat parts. Parts to be reused should be able to be handled without too much care. If parts tend to deform the chance is high that a certain percentage does not fit the claim of later reusing. If the parts are sold later for reusing but are not reusable due to deformation, they might be returned. The effort to deconstruct parts with zero deformation would be higher than the costs for generally new parts.
- 2) Especially the cladding on walls and roof are used during the first life for connecting certain building equipment parts to it. That causes changes in original colour, holes from connections and scratches to the sheets. While the bearing structure is mostly as on the first day of usage, the metal sheets look used. Reusing means that the whole SSB never will fit the definition of a new building.

*Figure 16: Dismantling old trapezoidal sheets just before deconstruction of structure.*

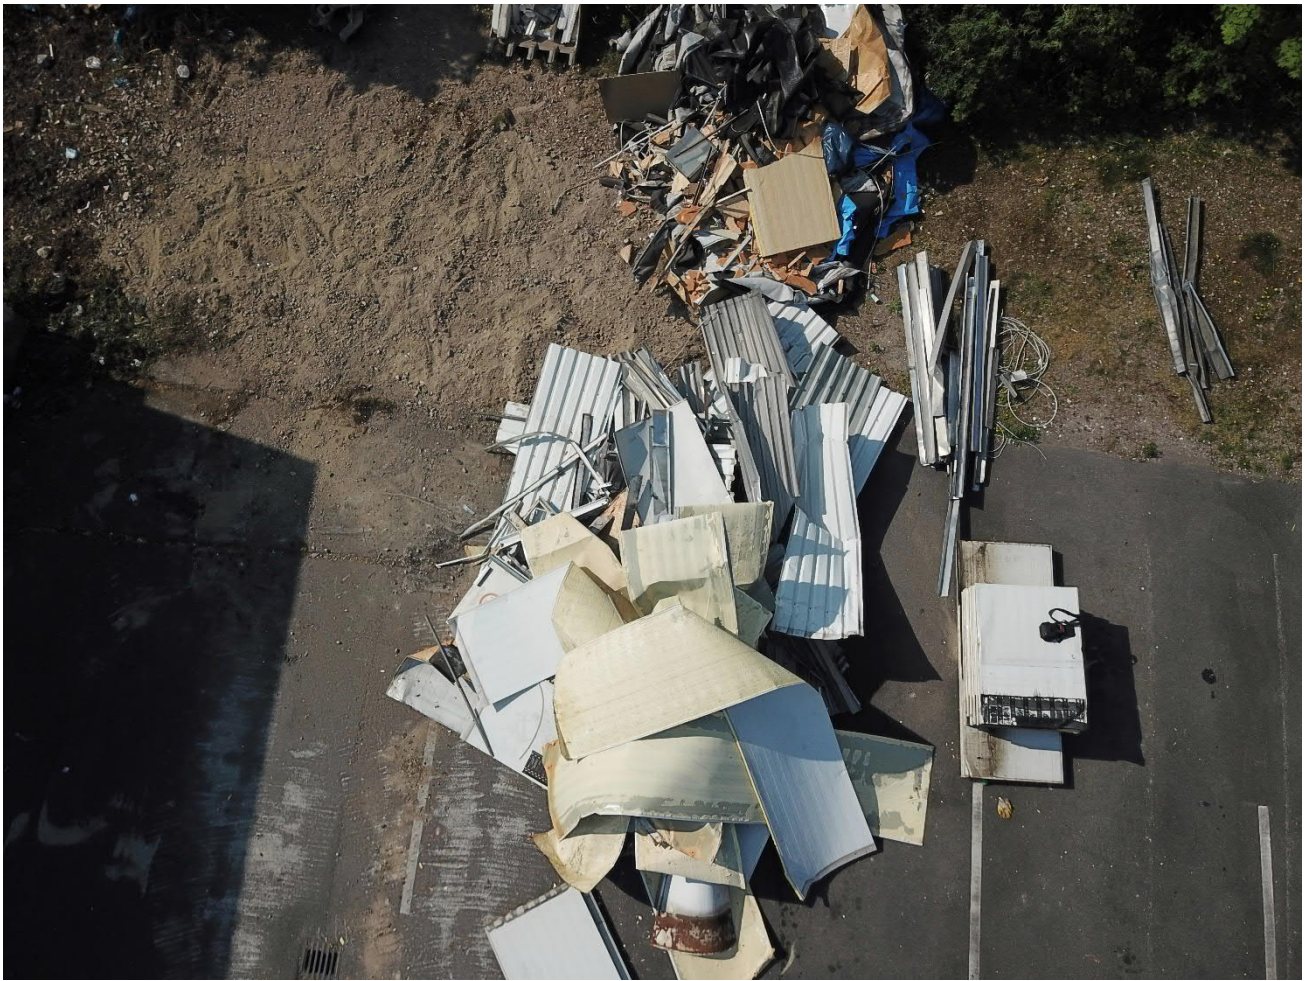
At this stage, most materials from the object became waste. All metals became part of the recycling process and are put back into the cycle for re-melting. All insulation was used for energy recovery – in other words the styrofoam was burned and only used as energy source.

*Figure 17: Sorted waste for recycling. Mixture of trapezoidal sheets and sheets from sandwich elements.*

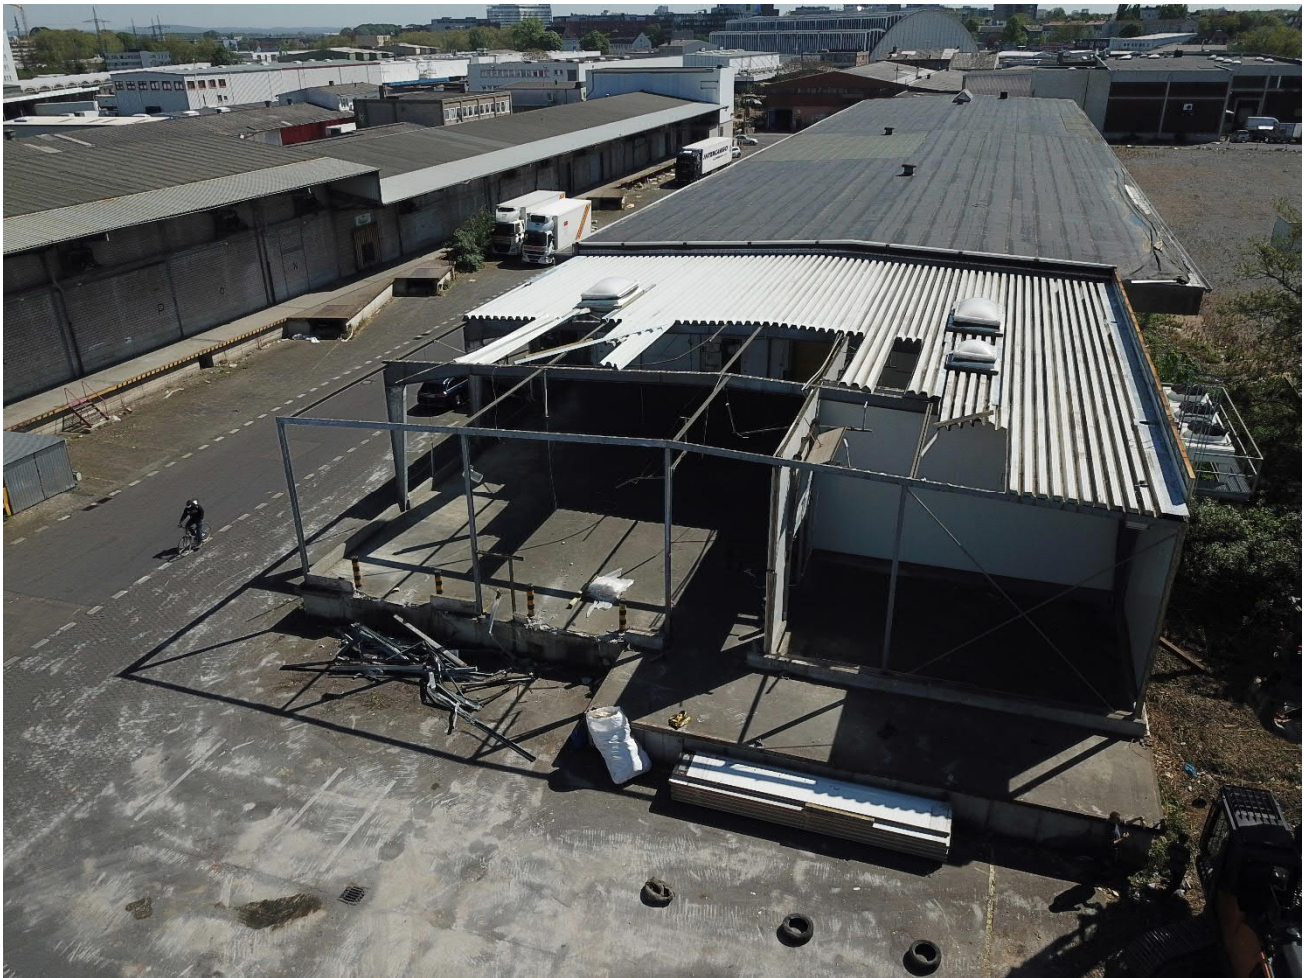
*Figure 19: The hall during the process of dismantling just before deconstruction of the structure. The trapezoidal sheets are being removed by 50%. Only the structure is remaining. After the removal of the trapezoidal sheets all remaining steel parts are considered for reuse.*

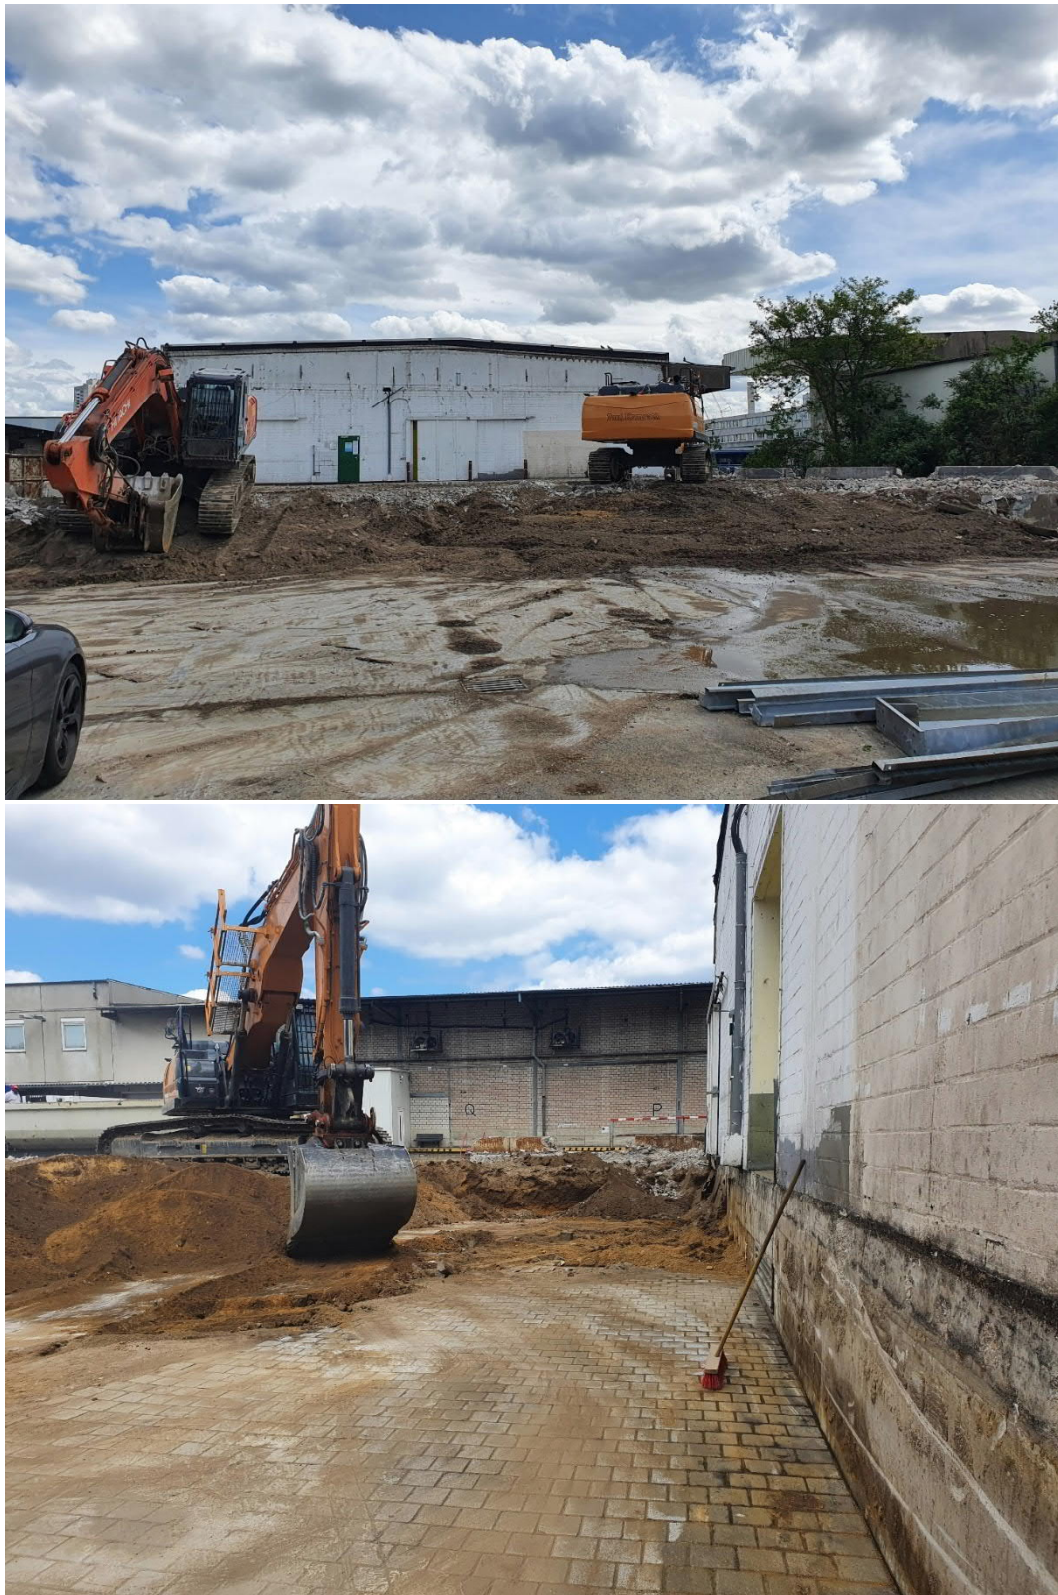
Below the sand filling there exists still the old pavement from the times before the hall was created. This pavement was not removed, so that today you will find a pavement as 25 years ago again.

*Figure 24: Demolition of concrete slab and removal of sand filling. Below the old pavement was recovered.*

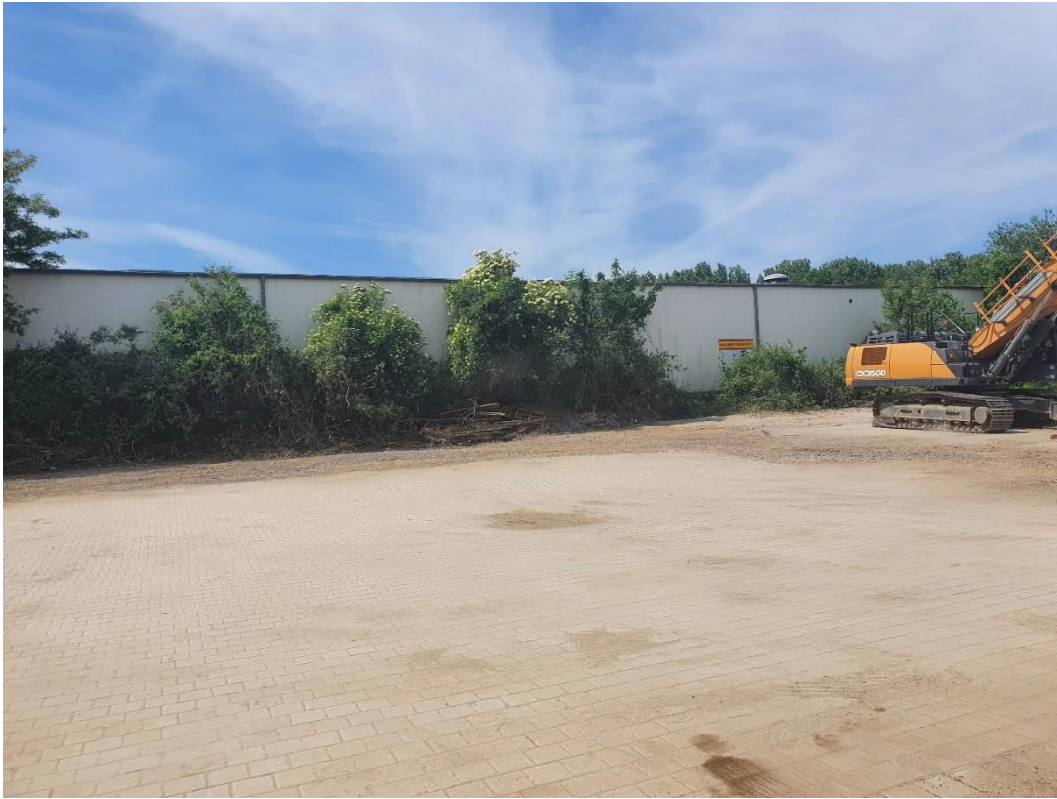
*Figure 25: Area of the SSB afterwards. The site is cleaned up.*

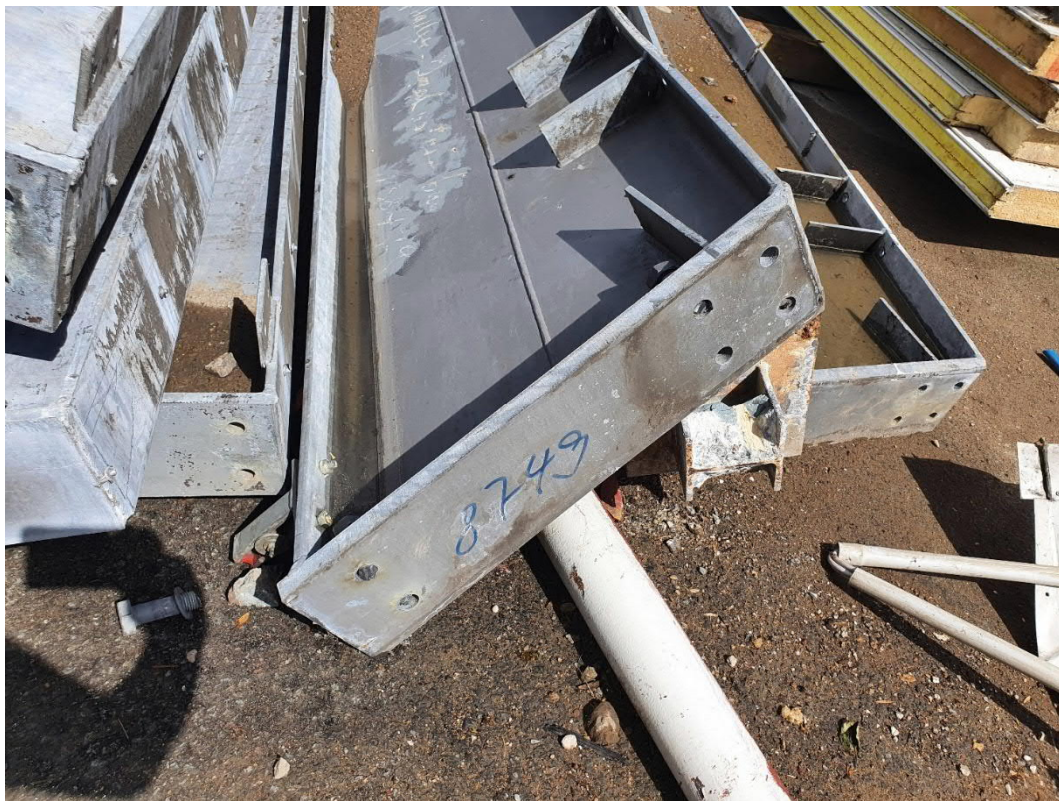
All parts identified for reuse needed to be checked afterwards. In general, all parts suited the quality needed. No parts were deformed. Some screw holes were damaged during flame cutting. Flame cutting was used, if unscrewing was not possible due to rust, mechanical errors, or impaired supply of the threaded rods.

*Figure 27: Detail. Connection of frames*

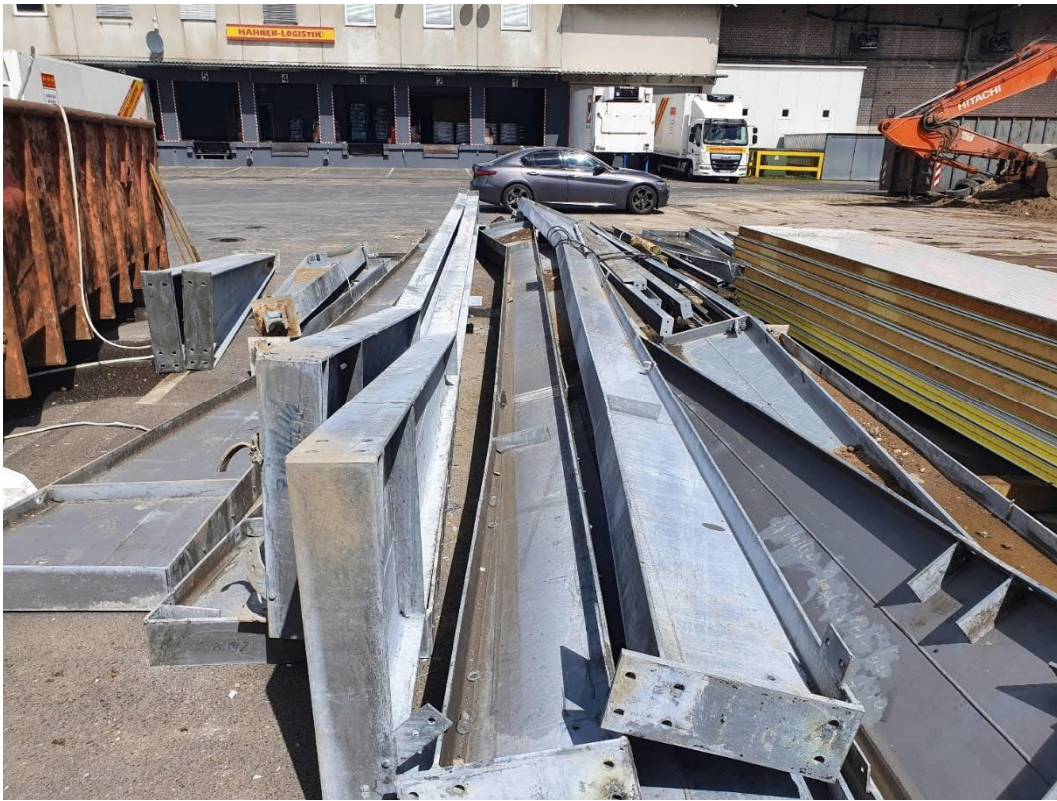
*Figure 28: Parts before transportation to the warehouse*

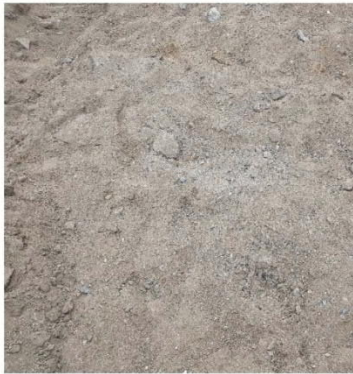
| 14 | Foto | <div style="display: flex; justify-content: space-between;"> <div> <p>probe:</p> <p>Site:</p> <p>Reason:</p> <p>Where:</p> <p>Whether:</p> <p>Type of sample:</p> <p>Tool:</p> <p>Nr. Of samples: One mixture</p> <p>Depth:</p> <p>Color:</p> <p>Mass:</p> <p>Container:</p> </div> <div> <p>Sand filling from Cologne</p> <p>Cologne, Bischofsweg 48a</p> <p>Analysis of material following the German LAGA / DK0 classification</p> <p>Middle of heap</p> <p>sunny, dry, 16°</p> <p>Mixture of sand</p> <p>shovel</p> <p>40cm</p> <p>brown / yellow</p> <p>3,5 kg</p> <p>bucket</p> </div> </div> | | | |
