2017-2020  
**PROGRESS**  
PROVISIONS FOR GREATER REUSE OF STEEL STRUCTURES

Experiences  
and  
Lessons  
learned from the past

***Viorel Ungureanu***

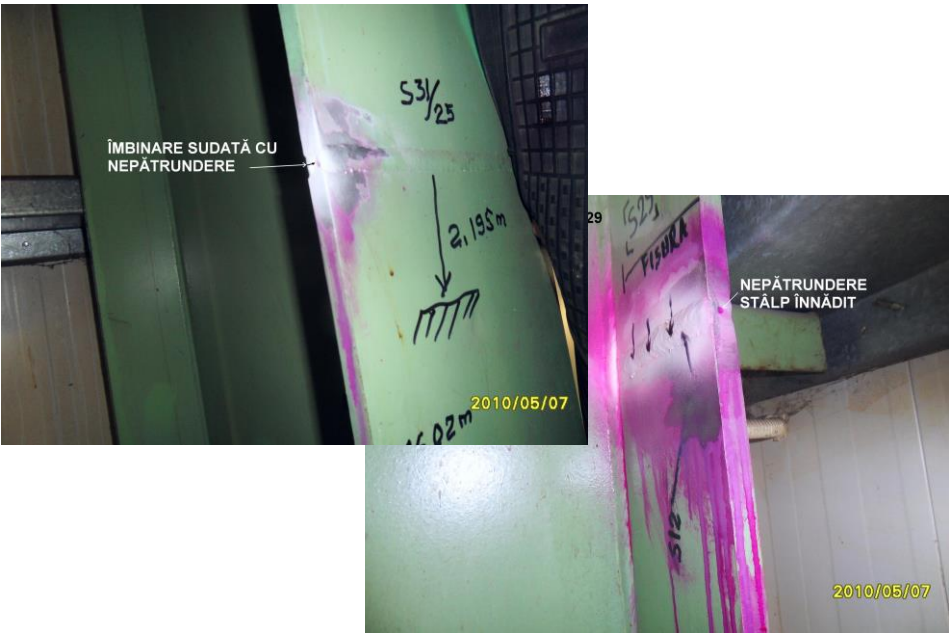
The Non-destructive inspection

- Detailed verification of welds and bolts of the beam-to-column connections;
- Ultrasonic investigation of cracks initiation;
- Checking of the lengths of bolts core;
- Special attention will be paid to the first two rows of bolts placed on the tensioned side of the connection (the top side)
- Random investigation of the welded connection along the columns.
