## Factsheet no. 10: S-Market, Urjala, Finland

### Project summary

Client: SOK Pirkanmaa  
 Contractor: Rakennusliike Ari Hiltunen  
 Architect: Seppo Kangasniemi  
 Structural engineers: Tamratek Oy / Aulis Virtanen  
 Construction year 2009  
 Construction cost: About 2M€

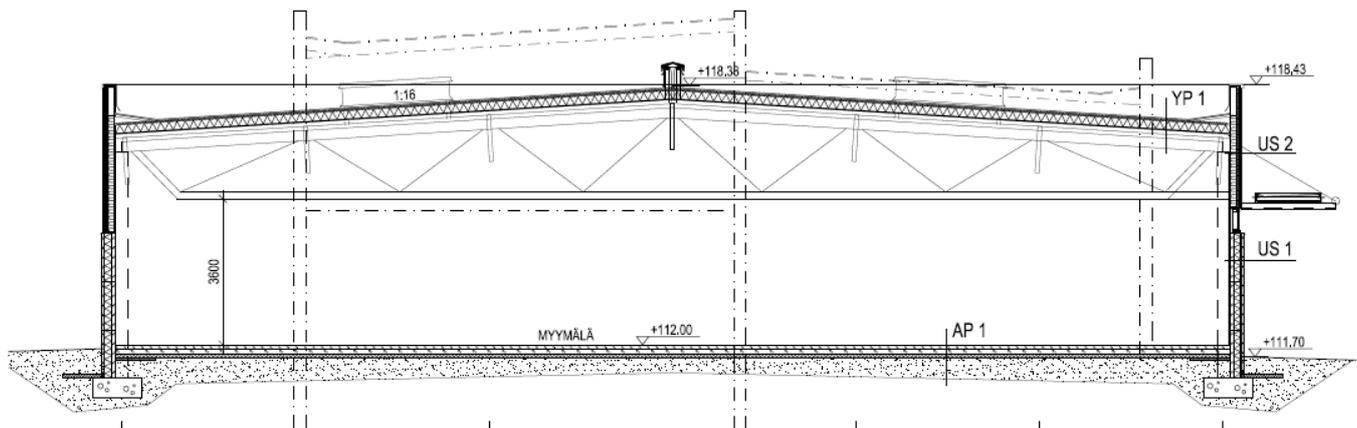
Cross-section of the new building

The owner of the existing discount store building (~2000 m<sup>2</sup>) in Tampere, Finland, SOK, planned to replace it with a new Prisma hypermarket (~10000 m<sup>2</sup>). At the same time, SOK also intended to build a new supermarket of similar size in Urjala (about 60 km from Tampere). It was decided to design the new building with a target that part of the main structural components of the disassembled building could be reused in the new location. The existing building was built in 1980's. The main structure consists of composite RHS columns and RHS steel trusses. The walls were made of prefabricated concrete elements and the roof was built in-situ with trapezoidal sheeting, mineral wool insulation and bitumen membrane. The main span of the building was 27 m and total height of 6.3 m. The frames were spaced at cc 12 m with secondary trusses between main trusses with cc 4.5 m. The building was deconstructed and re-assembled between 2008 and 2009.

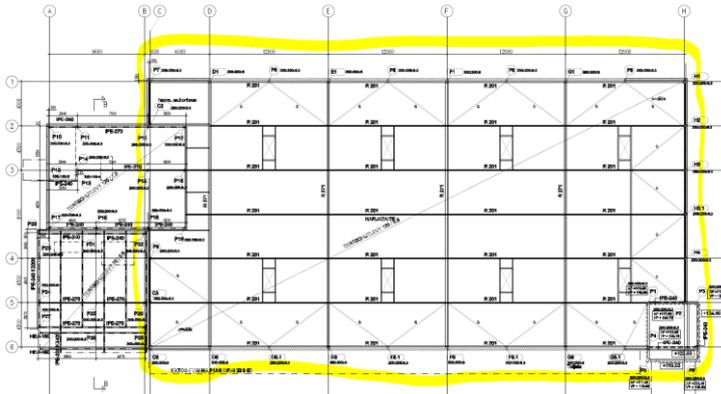
Floor plan of the new building, re-used part high-lighted

A small part of the new building consisting of shelter and storage spaces was built from new components.

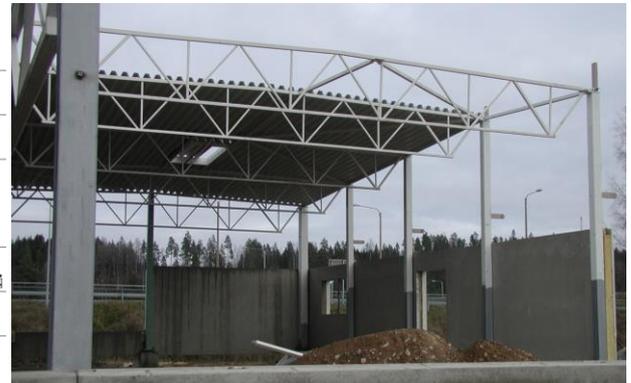
Erection of the steel frame in new location

The same contractor was responsible for disassembling the steel structures from the old building and construction the new building. The disassembling process was well prepared and most of the structures were recovered in a very good condition. The main and secondary trusses with bolted connections to the columns were easily removed. The composite columns had bolted foundation connections that were also possible to remove without failures. Double core concrete wall elements and plinth elements (with insulation) were grouted together and were not possible to remove without damage. Also, the U-value requirements were changed from 1980's that made reusing of wall elements difficult. Screw connected trapezoidal roofing decks were removed in a good condition and were easily reused in the new location. Original roofing was hot-galvanized sheeting and the sheeting was painted from underneath in the new location. Also, the main part of the mineral wool insulation was reused. All wall structures in the new location were built from new components: lower parts from double core concrete elements and upper parts from steel sandwich panels.

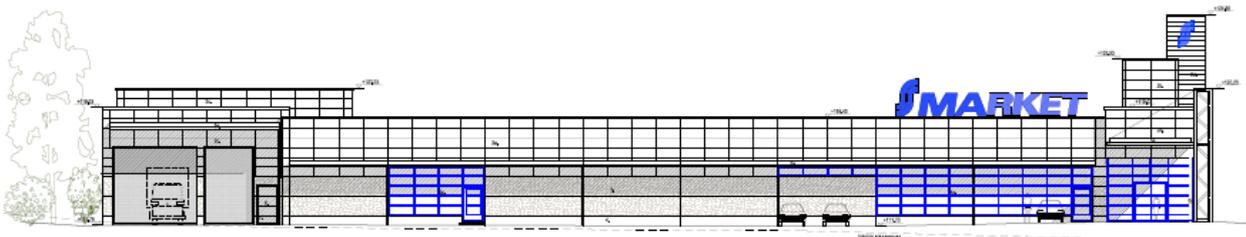
South facade of the new building

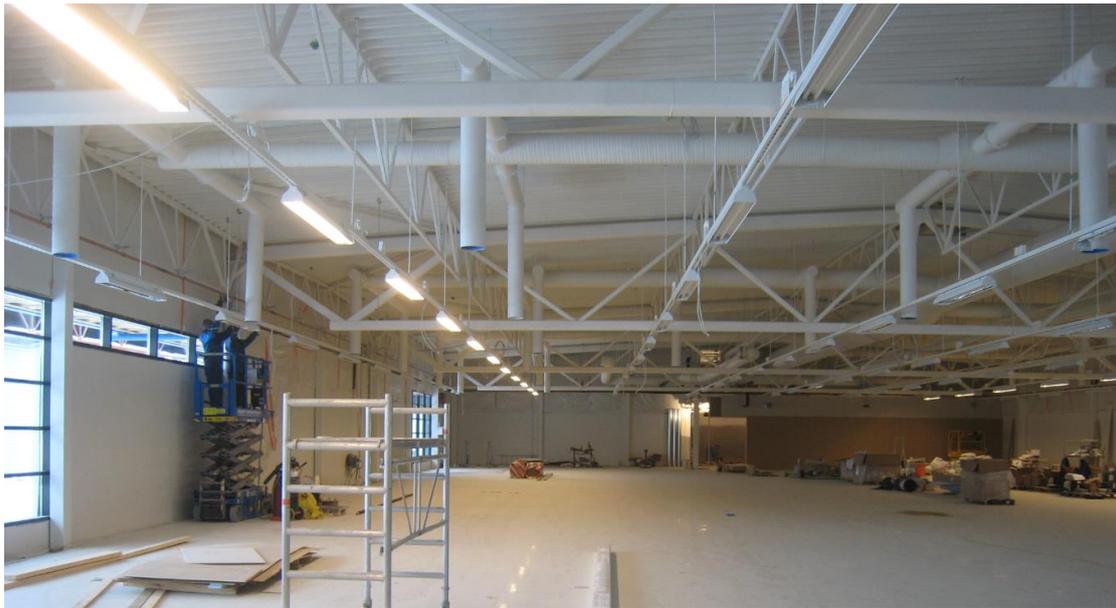
Internal view of the new building
