Factsheet no. 3: HIDROTIM office, Timisoara, Romania

Project summary

Description of the existing building

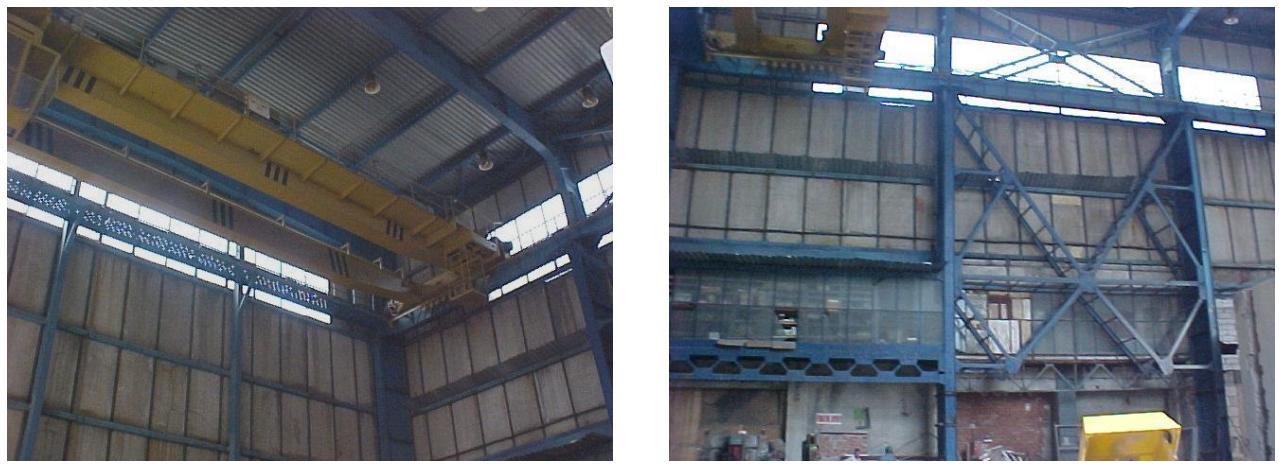
Existing hydraulic laboratory building - industrial hall with crane

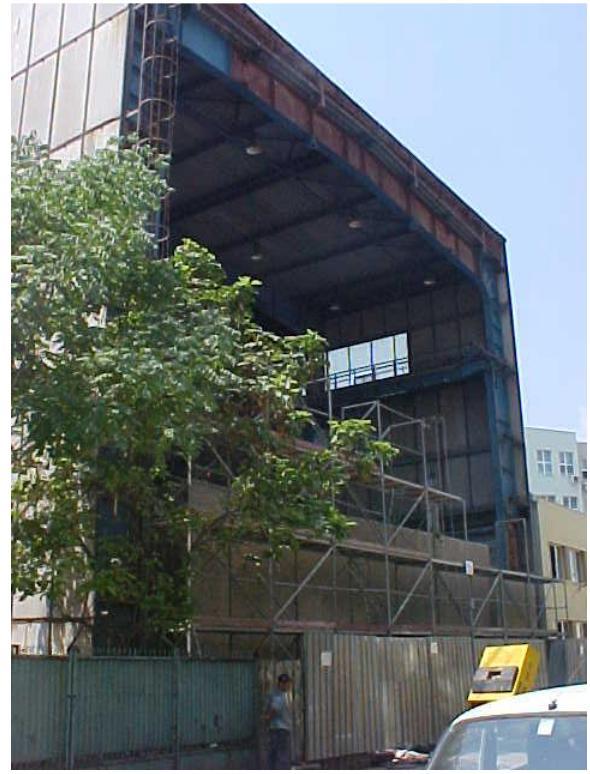
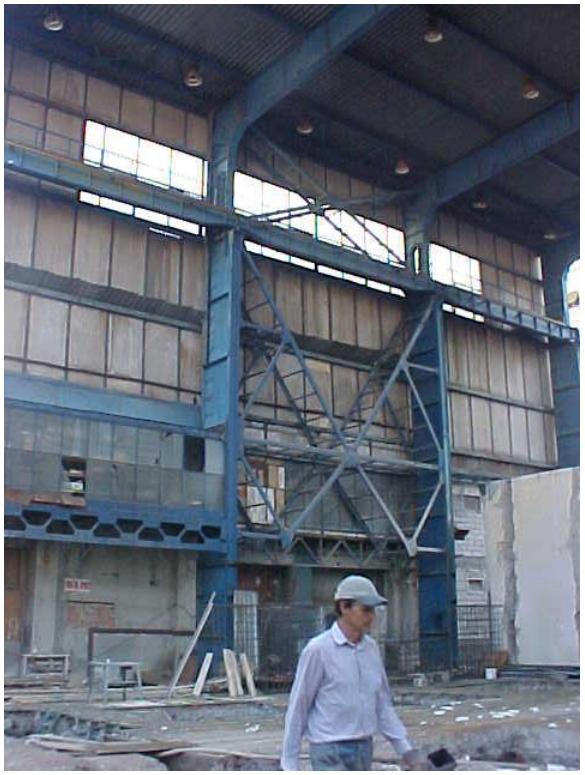
Existing hydraulic laboratory building - transversal and longitudinal frames

An electric crane of 12.5 tones capacity was provided, with a span of 19,25 m. The level of crane girder rail was +14,00 m. In view of supporting the crane girder the columns were designed with variable built-up cross-section as described in next figures. The column base was restrained supported on the foundation block at level –0,90 m by means of four anchoring bolts M48 grade 4.6.

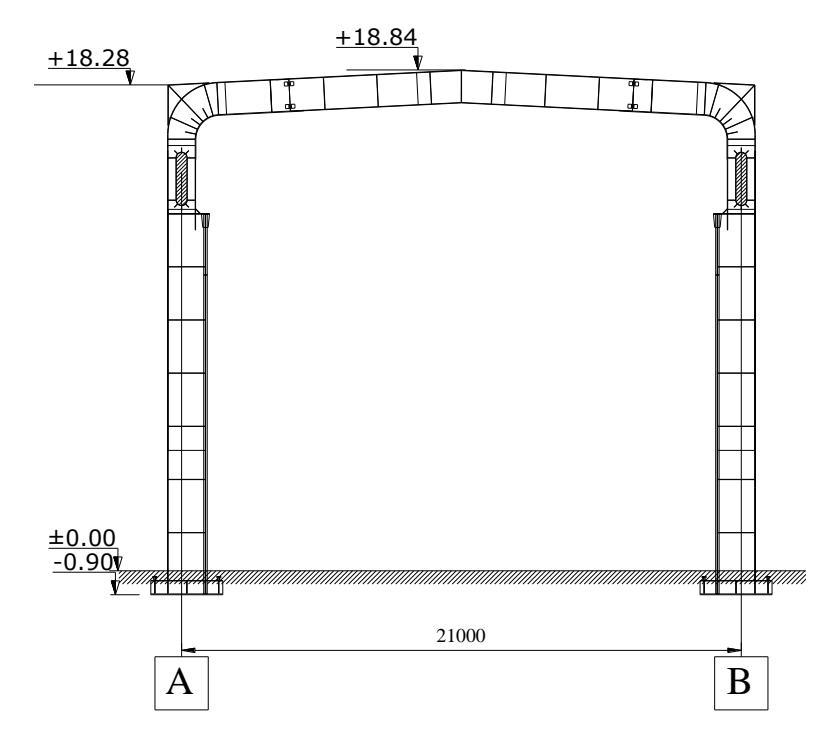
Existing transversal frame – measured dimensions

+18.28 +14.00 +10.50 +4.25 +4.25 +0.00 -0.90

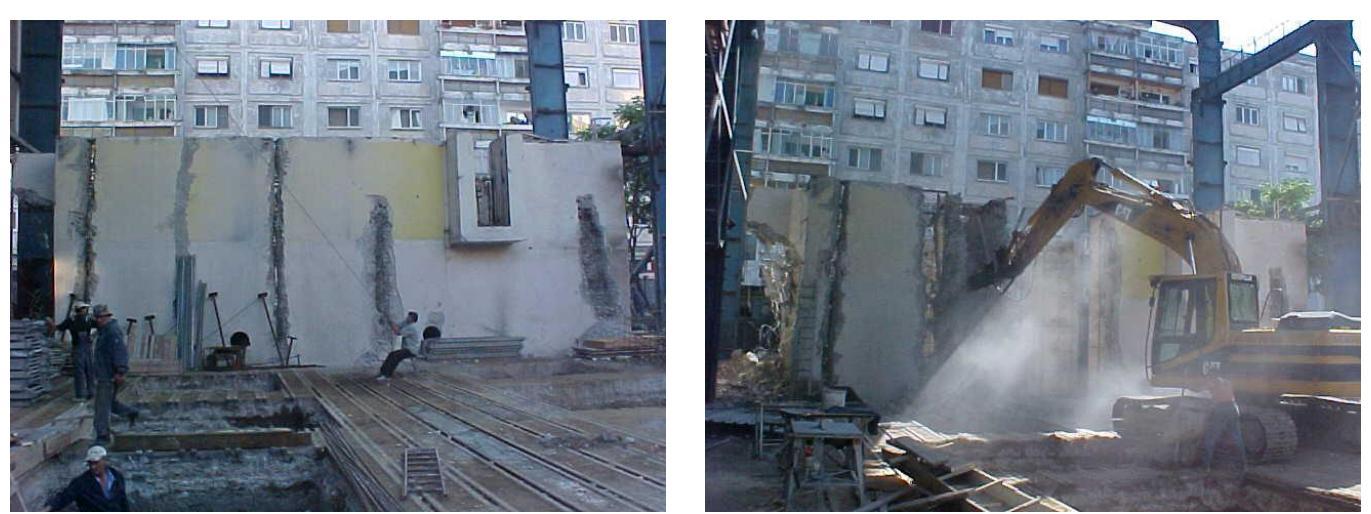
Demolition of the existing concrete pull used for hydraulic experiments

- partial demolition of the laboratory infrastructure including a very solid experimental pull built of reinforced concrete and existing ground floor decking (with embedded steel rails serving to previous laboratory procedures);
- complete deconstruction of the existing cladding and roofing of the laboratory building (already obsolete and incapable of serving the new function);
- complete deconstruction of the runaway crane and crane girder (built of steel);
- complete deconstruction of the existing bracing system that unfit to serve the new function, leaving the main frame system and its foundations to serve as a basis for the conversion / reconstruction

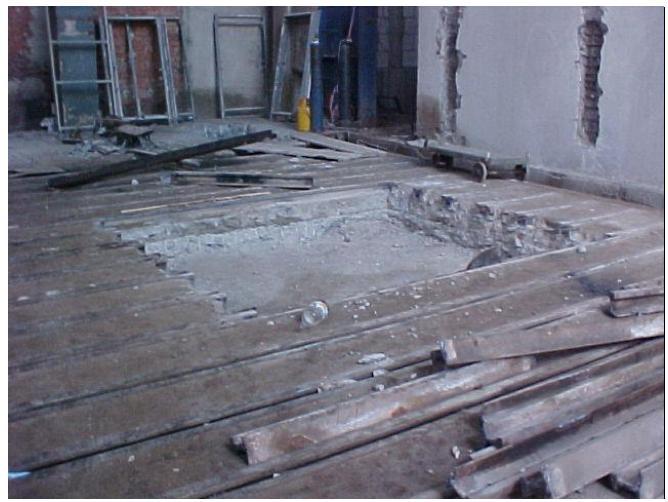
Partial demolition of the existing decking with embedded steel rails for laboratory use

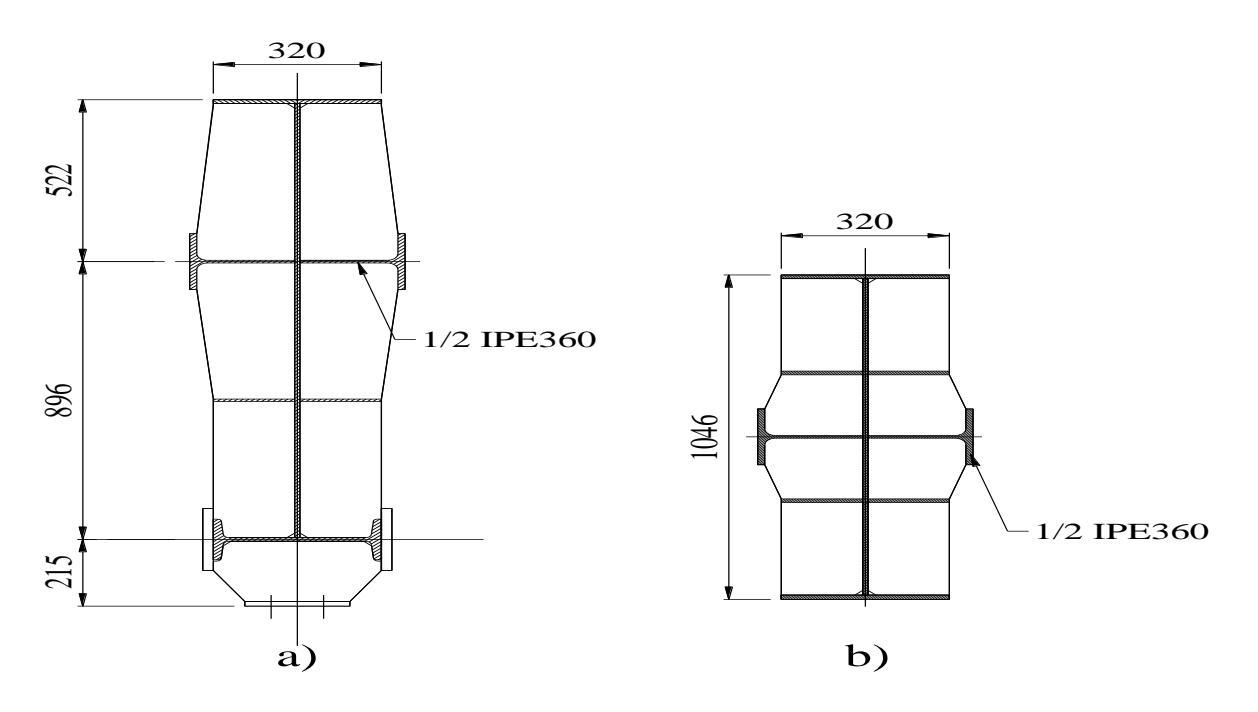
Consolidation of the existing columns cross section: (a) bottom, (b) upper branch

The condition of web framing into class 3 was not fulfilled, revealing a class 4 wall. Consequently, the cross-section has been consolidated according to figure below to provide:

- Web class modification by wall slenderness reduction (in order to reach at least class 3), i.e. web depth is divided in three as presented in the figure;
- Outer flange consolidation by to halves of IPE 360 European profile to undertake important axial and shear forces (coming mainly from the longitudinal bracing);
- Inner flange consolidation by two welded, plates also to undertake important axial and shear forces (coming from the new structural configuration of the existing frame with reversed V bracing).

The upper branch of the existing column was also made of welded steel plates. Class 3 was found for the crosssection as a result of web class. The cross-section consolidation and obtainment of class 2 was achieved by means of the two halves of IPE 360 (continued from the bottom branch as shown in figure). Also the circulation openings in the web has been closed by a welded steel plate of thickness 10 mm.

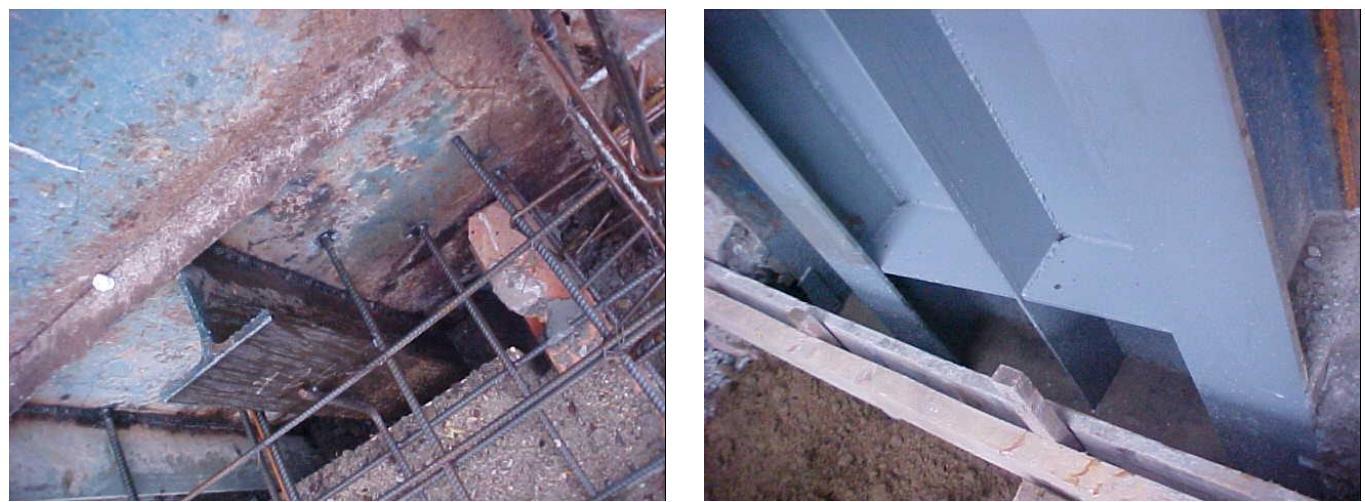
Consolidation details (as built)

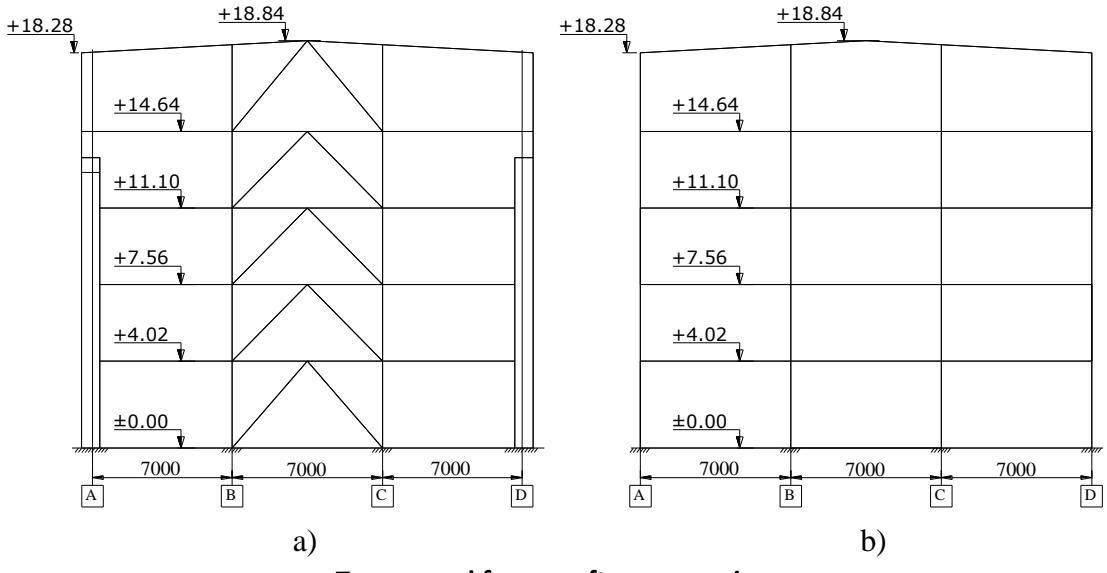
Transversal frames after conversion

- a) Two intermediary steel columns of European hot rolled profiles were provided inside each of the 4 existing frames at 1/3 and 2/3 of the span (figure below);
- b) Steel beams were provided at each of the required levels to sustain the new composite decks. These beams are rigidly connected to the new central columns and pinned to the existing columns. Vertical V bracing elements were also provided (figure below).

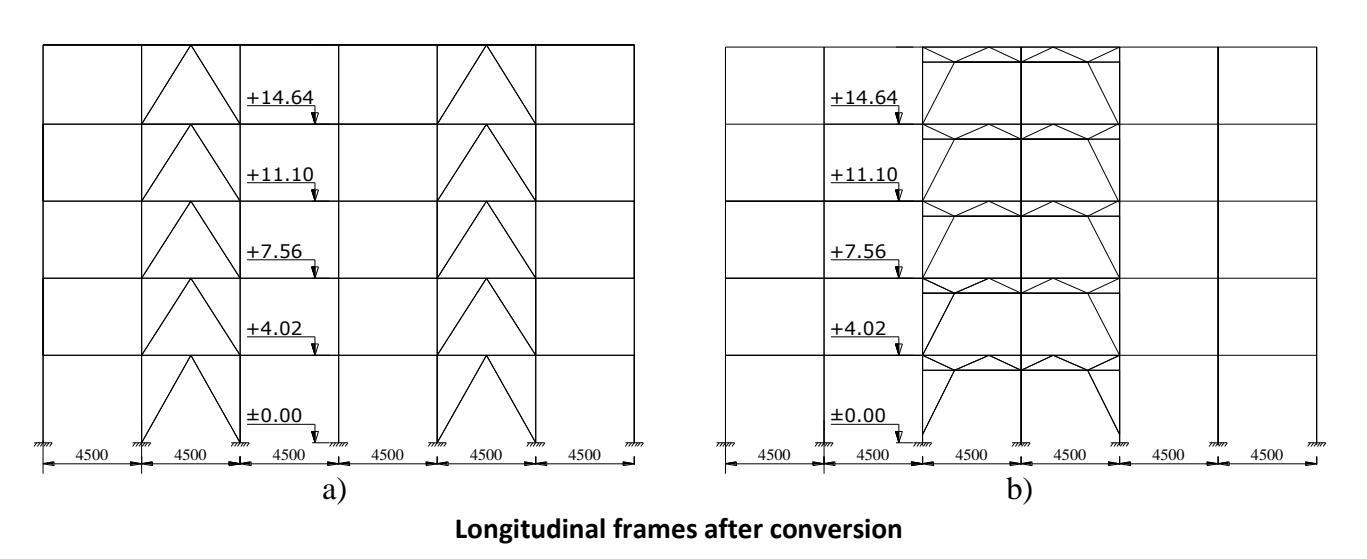
- c) Three new intermediate frames were provided at mid-bay, between the existing frames (figure below). Thus, the bay of the new building becomes 4.5 m instead of 9.0 m;
- d) Secondary beams at approx. 2.35 m centres, connected to the main beams by hinges, were provided at each level to sustain the decking;

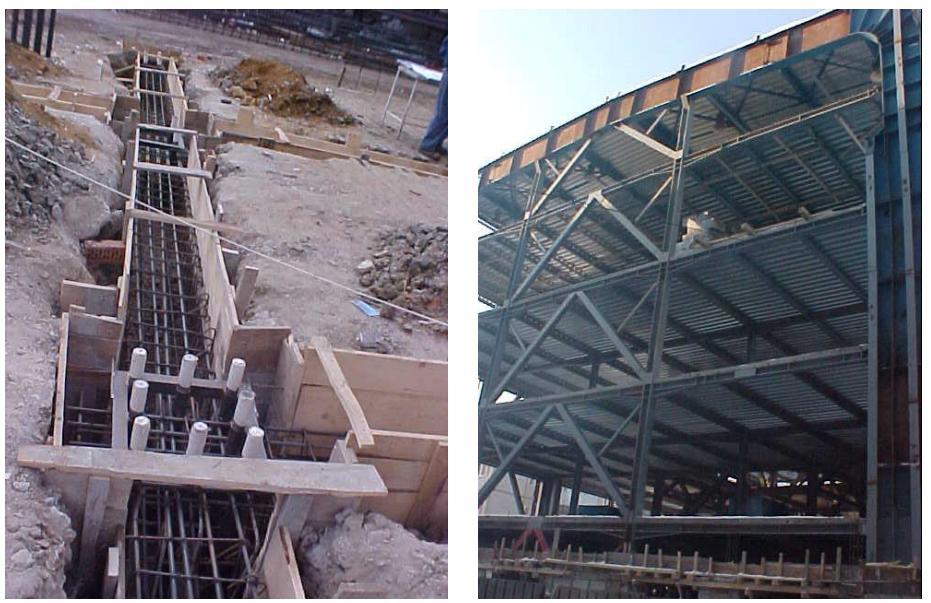
Supplementary foundations cast in situ

Besides the reinforcing measures for the steel, supplementary foundations were cast on site to support the new inserted structural elements

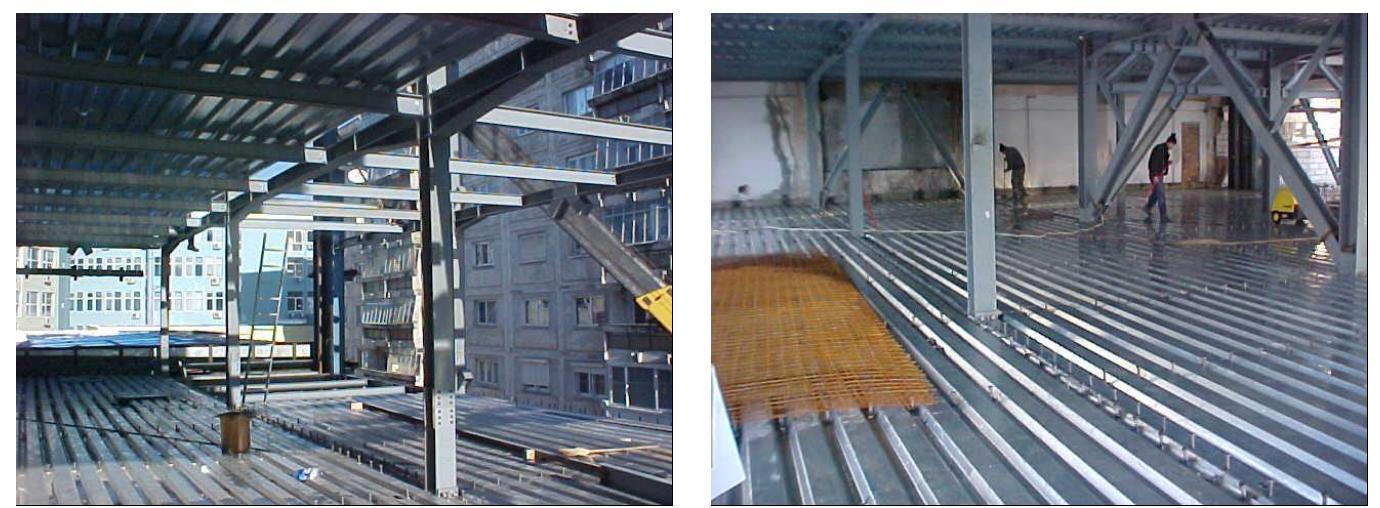
Trapezoidal steel sheet and Nelson shear connectors

The composite decking (concrete + steel) which was chosen as a solution to sustain the loading of each story, also plays a very important role in the space work of the structure. A trapezoidal sheet of 1.0 mm thickness (steel with f_y = 320 N/mm2) working also as form work, together with Nelson shear connectors of 19 mm diameter and 90 mm height (steel S235 J2G3+C450 with f_u = 450 N/mm²) placed on the main beams and on the secondary beams were chosen.

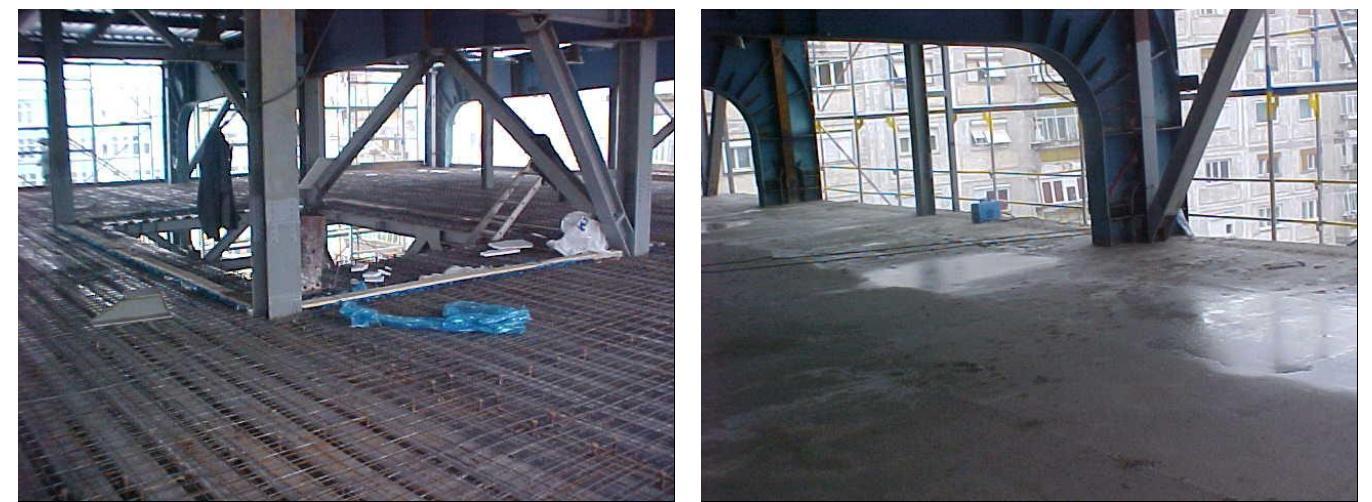
Construction phases of the composite decking at the 4th level

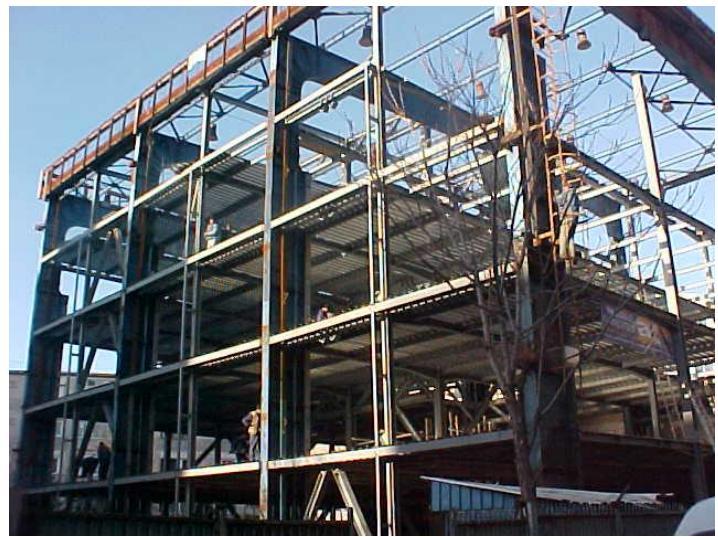
Combination of existing and newly added steel structures by reconversion

- Reuse of the existing building means that the steel for the new project come from what is already on site. For the particular situation, an estimated 50% of the steel was already existing (plus subsequent infrastructure);
